06 November 2018

Fire Risk Assessment

Adair Tower

Royal Borough of Kensington & Chelsea

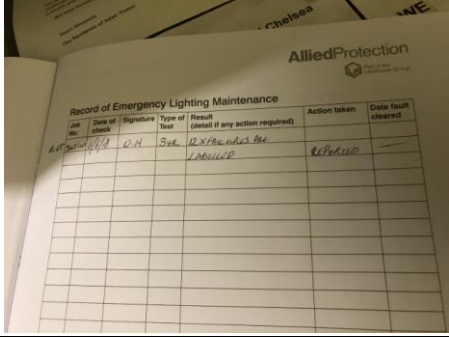
27.3	The Logbook indicated that a 3hr annual test of the emergency lighting was completed on 06/06/2018. The logbook indicated that there were 12 failures. There was no information provided to demonstrate that these failures had been rectified. No monthly test record provided.

27.3	06/11/2018	The Logbook indicated that a 3hr annual test of the emergency lighting was completed on 06/06/2018. The logbook indicated that there were 12 failures. There was no information provided to demonstrate that these failures had been rectified. No monthly test record provided.	MEDIUM	RBKC to ensure that records are available to demonstrate that the emergency lighting has been maintained in accordance with BS5266 Part 1 and all unit failures have been rectified.

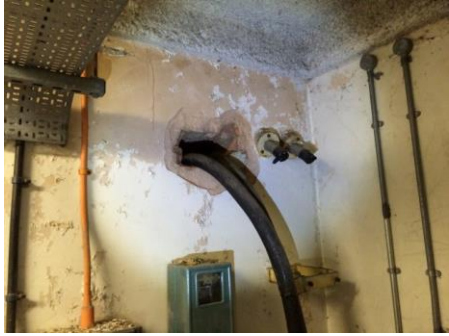
32.1	In general the compartmentation within the plant rooms appeared adequate. However HV cables between the Landlords Switch Room and Sub-Station were not sealed. There were two fire doors between the Landlords Switch Room and the GF lobby so this is considered low risk.
