Appendix D Walkover Photolog and Sample Logs & Photos

Treadgold House and Avondale Park
Gardens Walkover Survey

Project No.
60632092

Grenfell Potential Land Contamination: Stage 2 Sampling Notes and Photographic Record

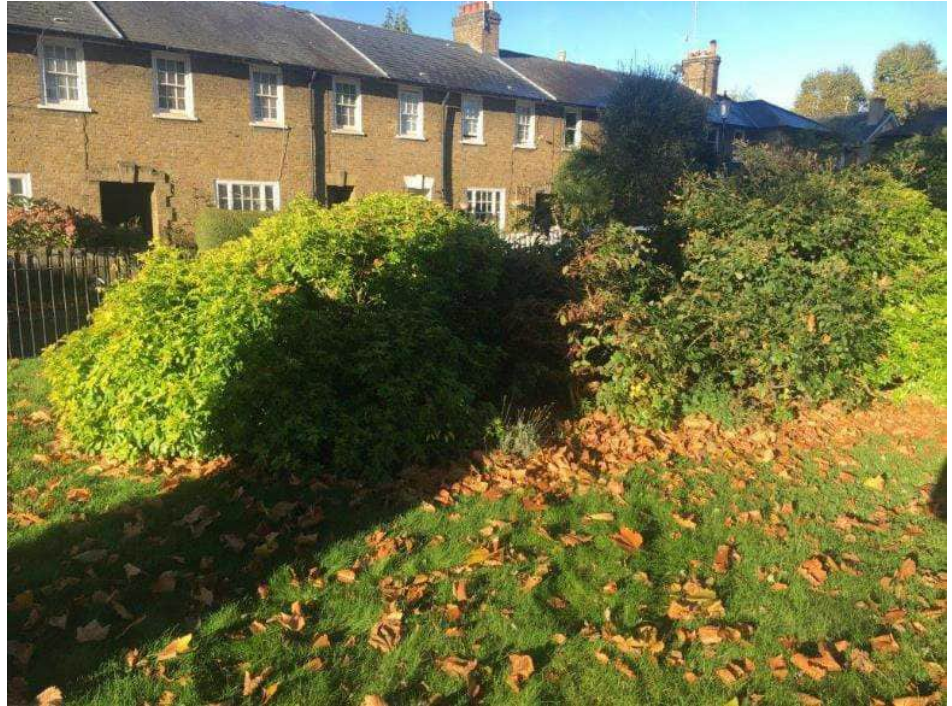
Photo No.
1

Avondale Park
Gardens
[NW facing
towards shrubs
and proposed
locations APG109,
APG111 and
APG113]

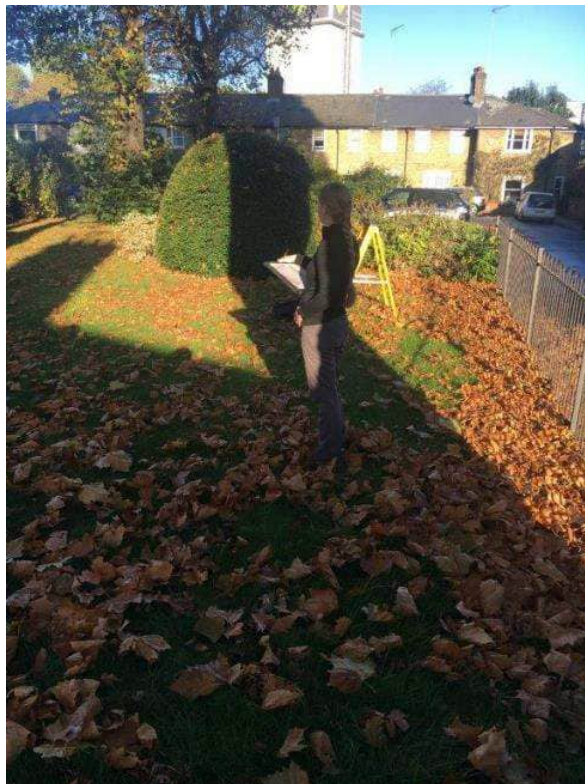
Photo No.
2

Avondale Park
Gardens
[NNW facing,
towards housing
and shrubbery,
running parallel to
metal fencing.
Looking towards
locations APG110
and APG108]

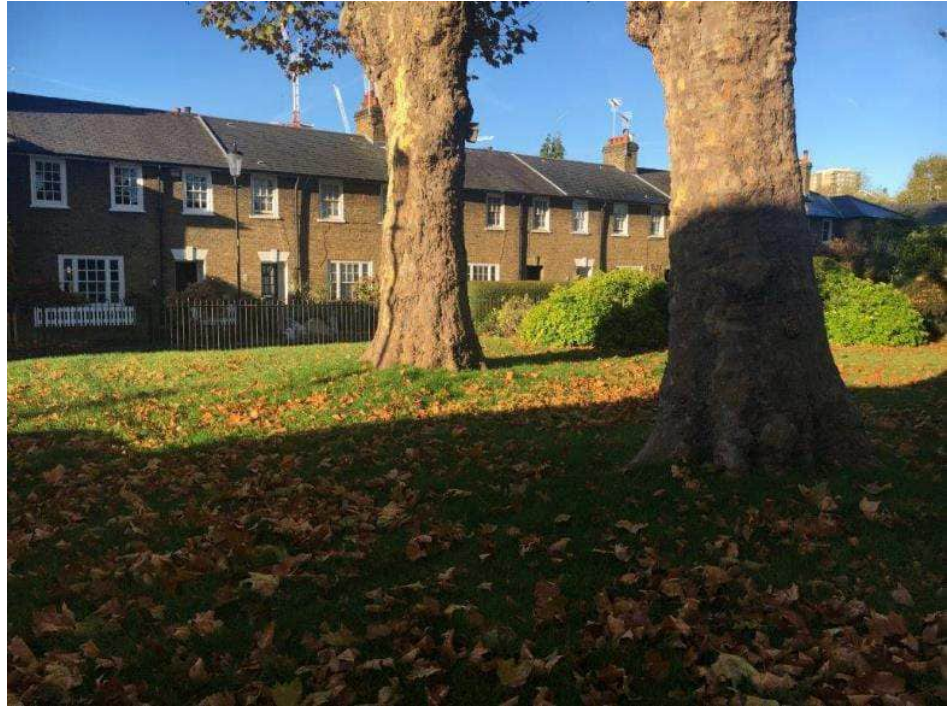
Photo No.
3

Avondale Park
Gardens
[W facing, looking
towards trees, and
proposed
locations APG115
and APG116]

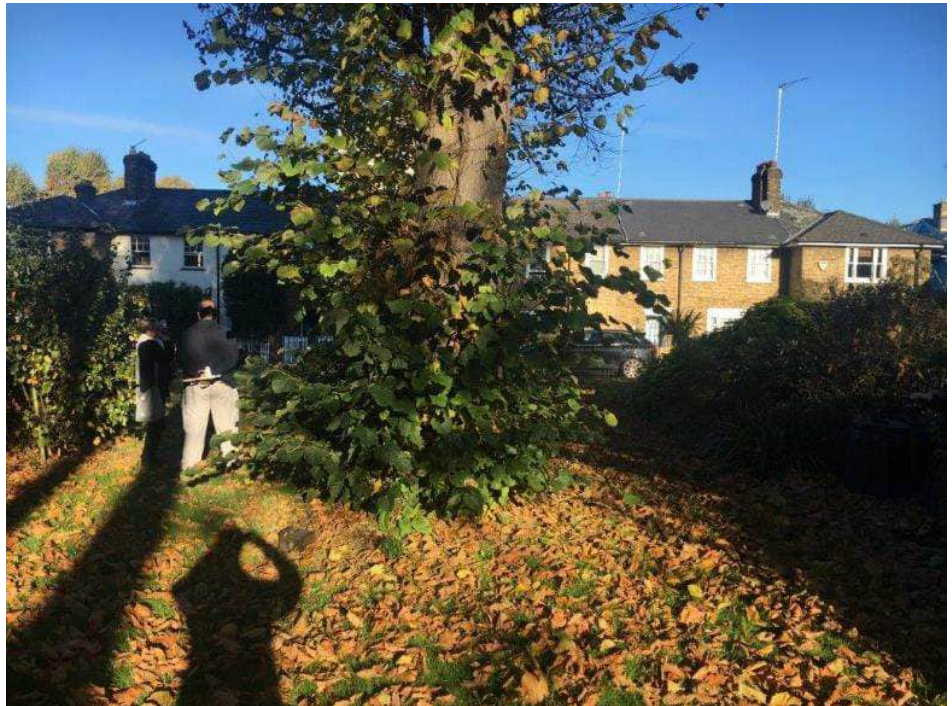
Photo No.
4

Avondale Park
Gardens
[NNW facing
towards a tree and
housing. Looking
towards area for
APG106 and
APG107]

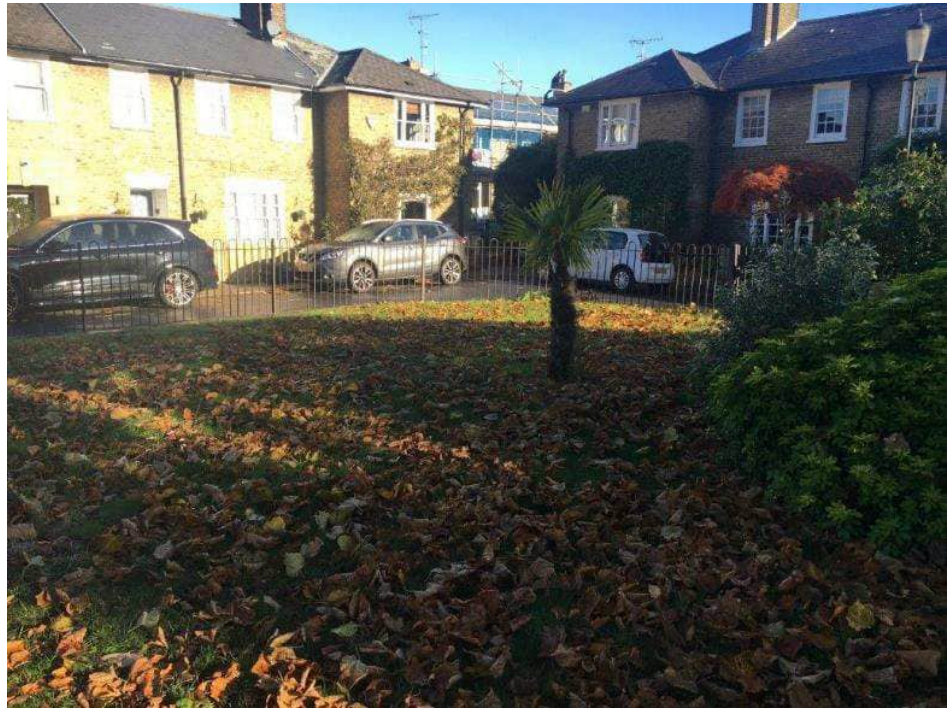
Photo No.
5

Avondale Park
Gardens
[ENE facing
towards the corner
of the square of
residential
housing. Looking
towards locations
APG101 and
APG103]

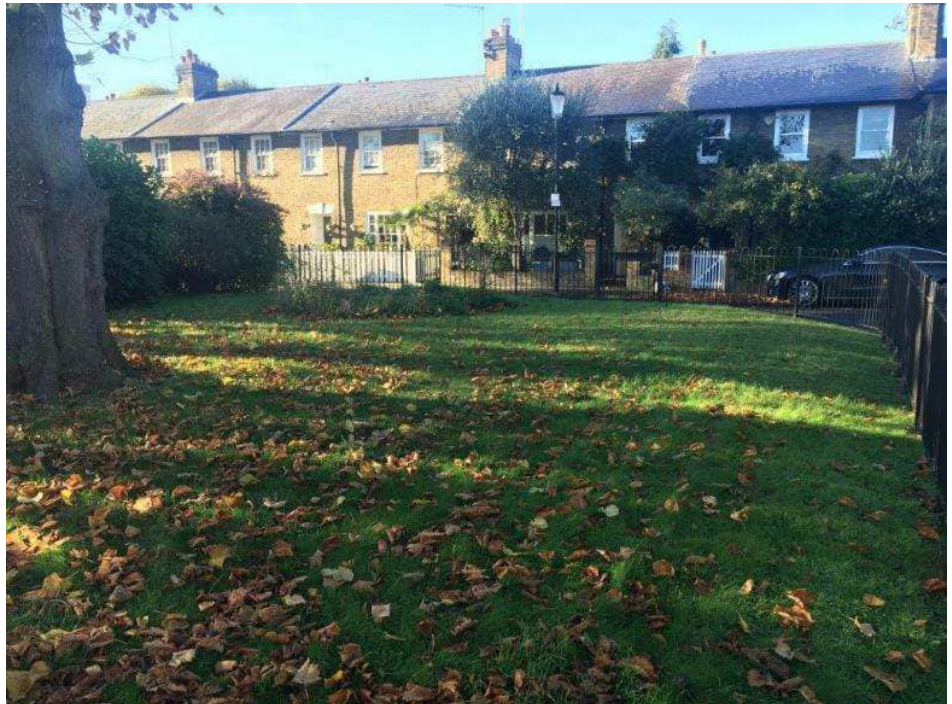
Photo No.
6

Avondale Park
Gardens
[WSW facing,
pointing off centre
towards housing.
Looking towards
locations APG102,
APG104 and
APG105]

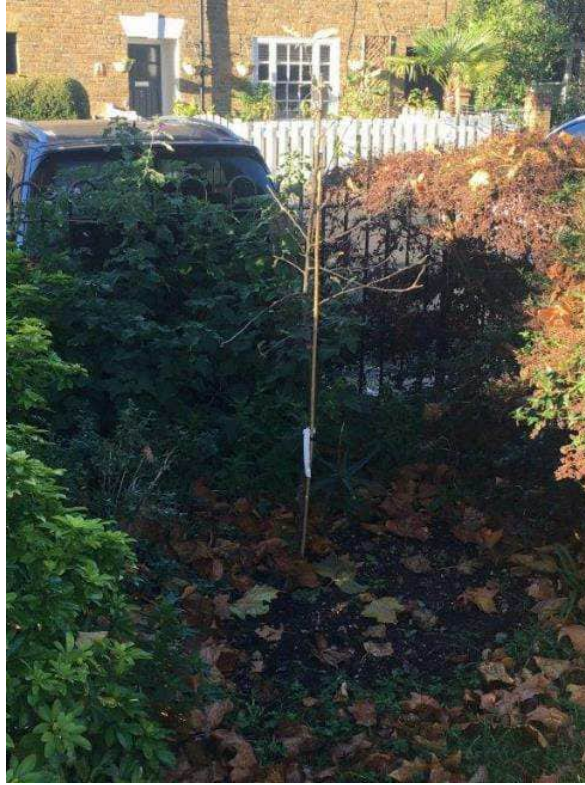
Avondale Park
Gardens
[NWW facing
towards,
displaying a
relatively newly
planted tree –
evidence that
garden is
accessed and
maintained by the
community]

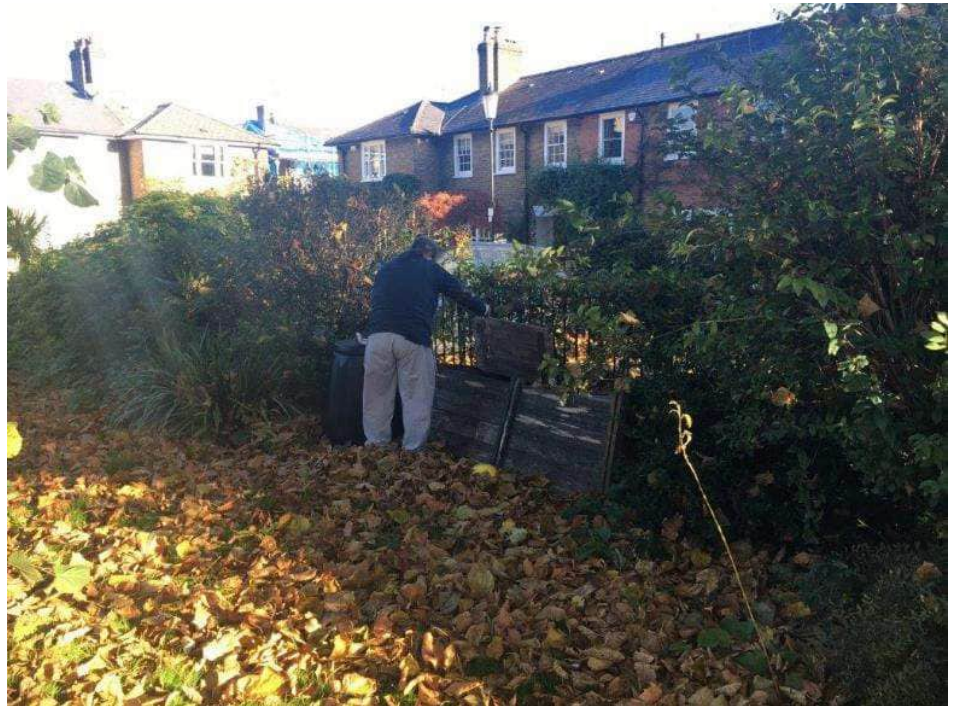
Photo No.
8

Avondale Park
Gardens
[NNW facing,
towards
composting bins]

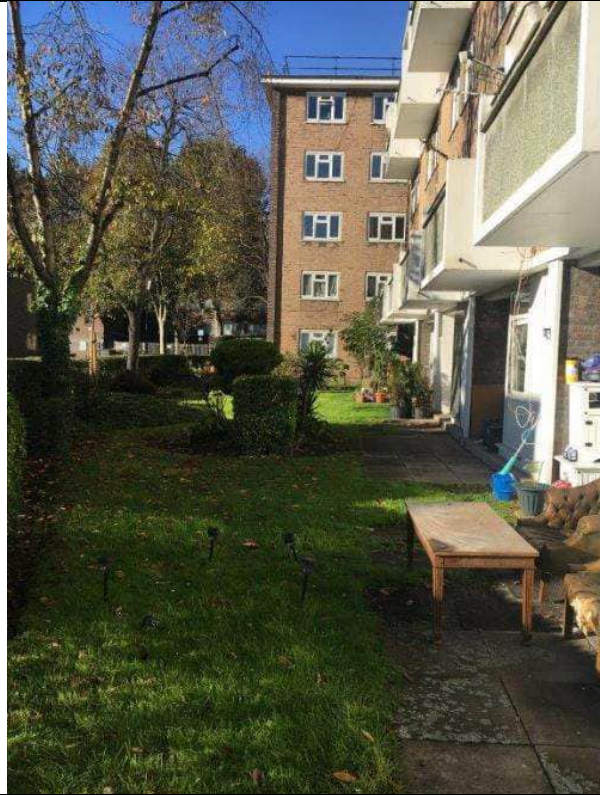
Treadgold House
[SW facing,
running parallel to
housing, looking
at the side of a
building. Looking
across several
'plots' (Plots 1, 2,
3, 4, 5 and 6 from
foreground to
background) –
evidence of
residents using
the garden area]

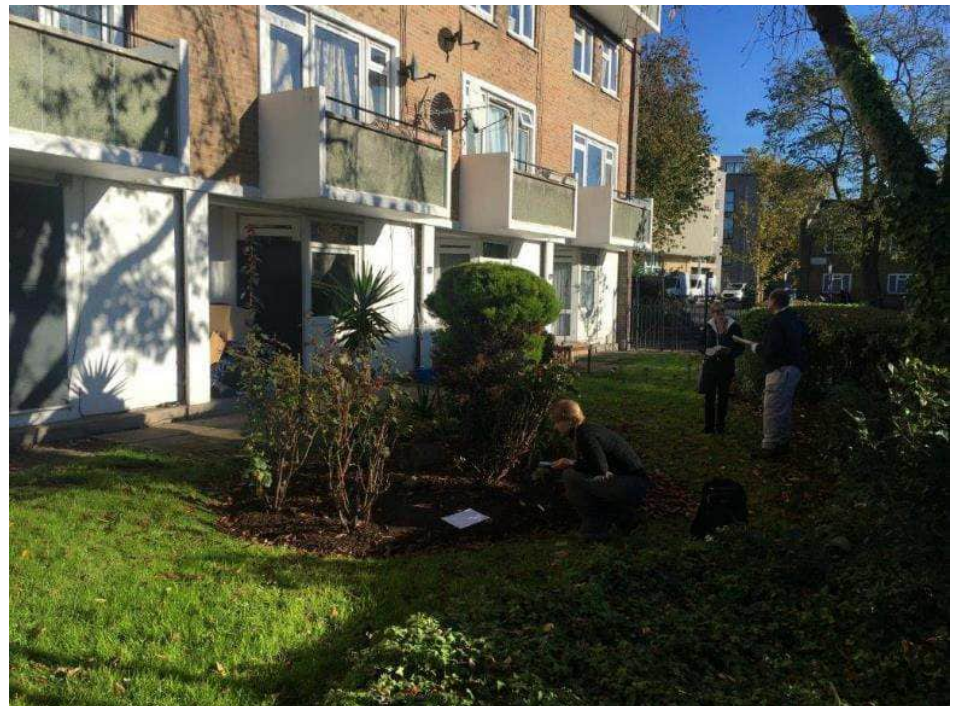
Photo No.
10

Treadgold House
[NNE facing at a
slight angle away
from a block of
flats. Looking
across various
plots (4, 3, 2 and 1
from foreground to
background)
locations including
TH148, TH149,
TH150 in flower
bed]

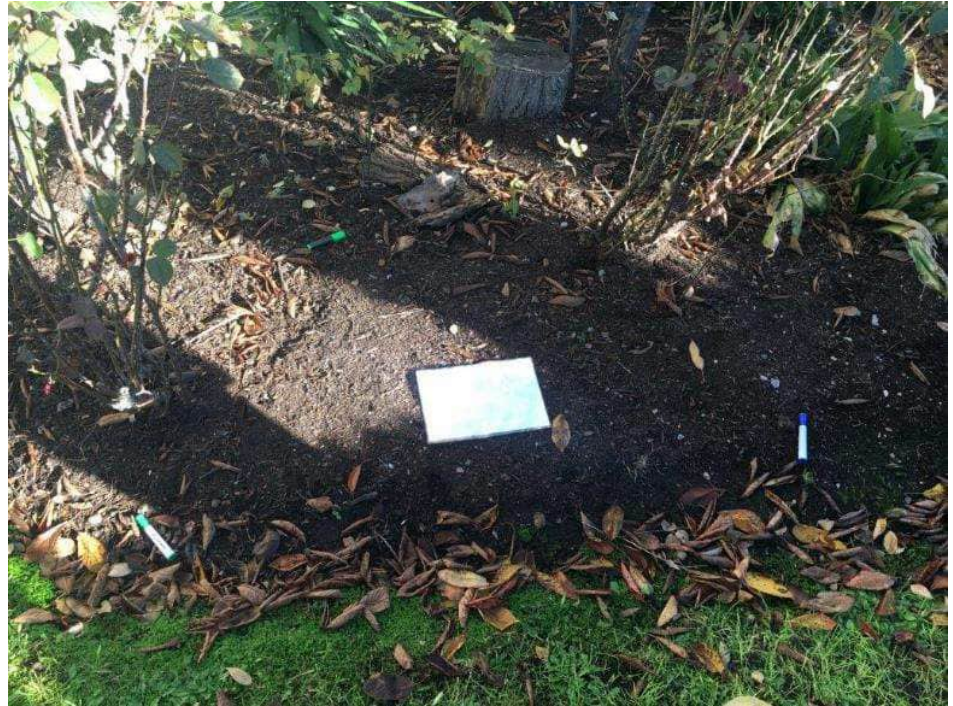
Treadgold House
[section of soil
which has been
sampled
previously and
proposed
locations TH148,
TH149 and TH150
marked by pens
laid on ground]

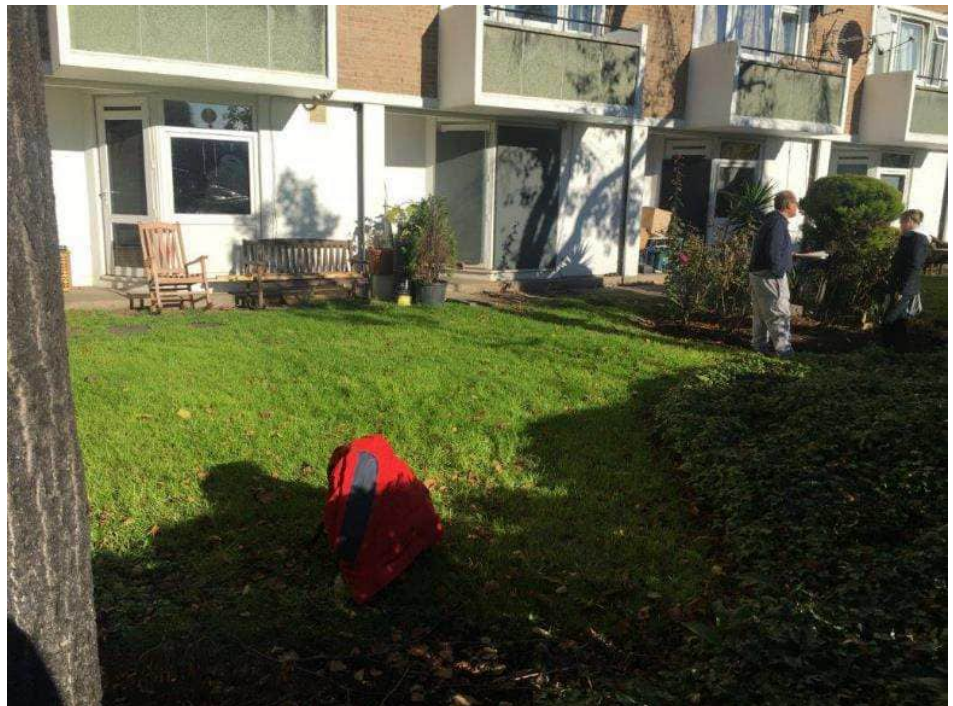
Photo No.
12

Treadgold House
[NNE facing. At a
slight angle facing
the block of flats.
Bench suggests
use of garden
area by residents.
Looking over
various locations
including TH131
to TH140 (Plots 5
and 4)]

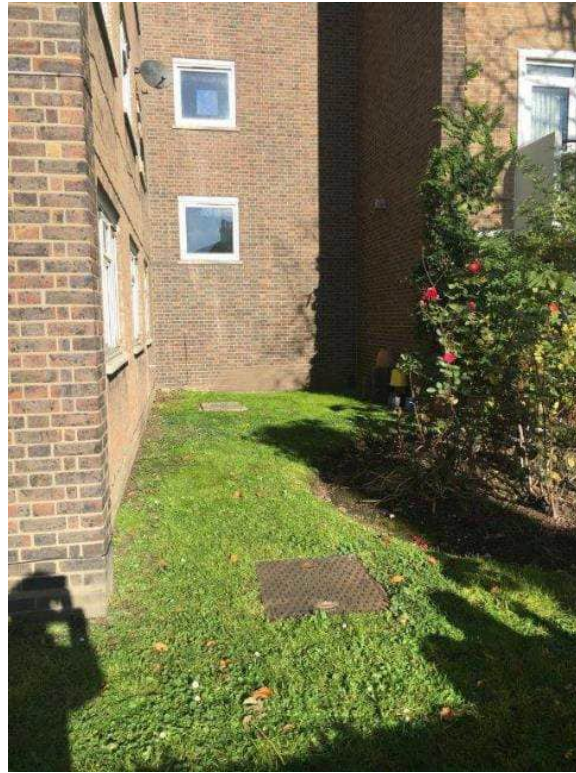
Treadgold House
[N facing, towards
locations TH169
and TH170.
Evidence of
services indicated
by manholes, This
area is not
designated as a
plot as is between
Plot 6 and Plot 7]

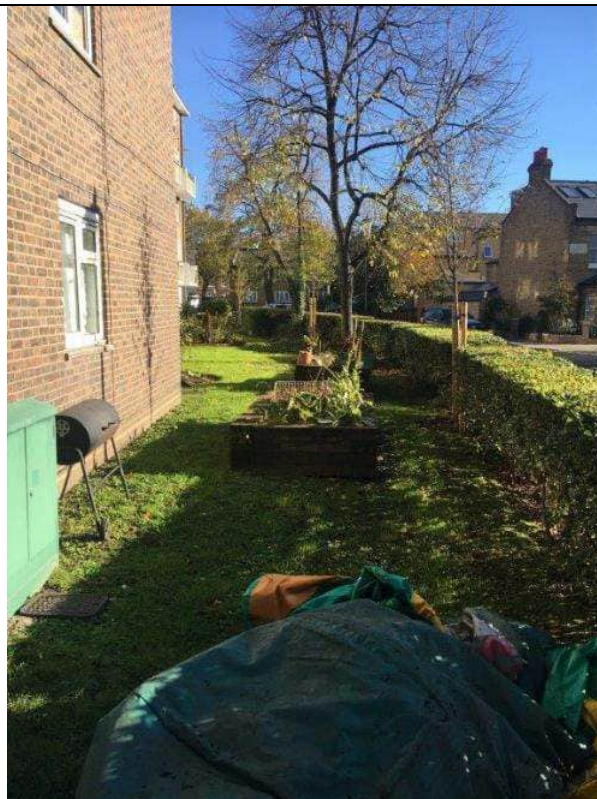
Photo No.
14

Treadgold House
[W facing, towards
a raised planter,
parallel between a
hedge and the
side of the block
of flats. The area
in this photo is not
designated as a
plot – is taken
from the edge of
Plot 7]

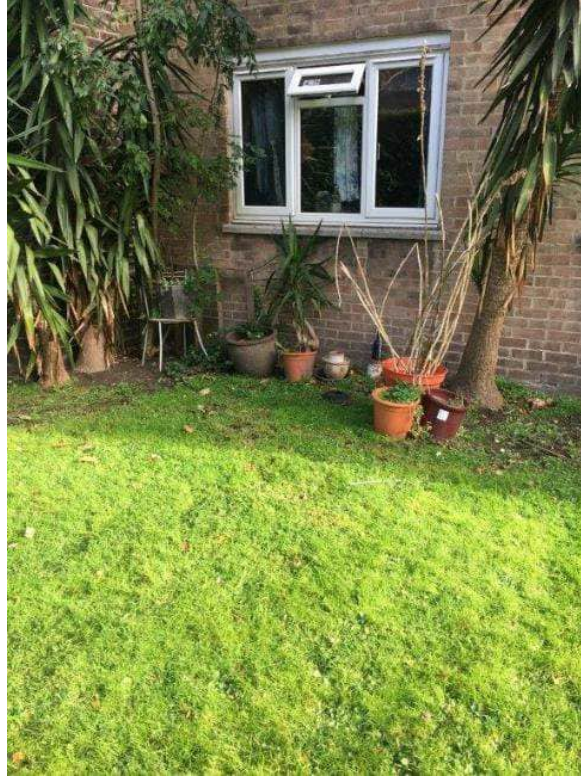
Treadgold House
[E facing. In a
front garden
looking towards a
window with
potted plants
beneath it, within
Plot 8]

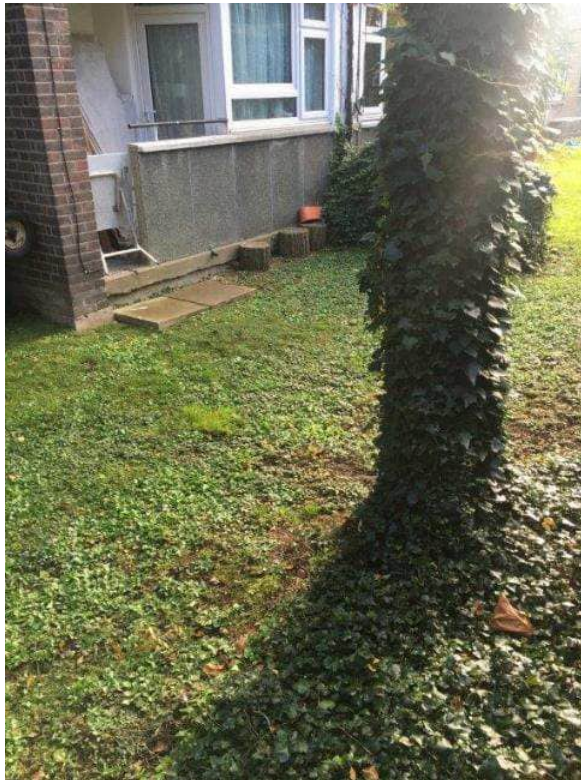
Photo No.
16

Treadgold House
[SSE facing,
towards a tree and
location TH110,
part of Plot 9]

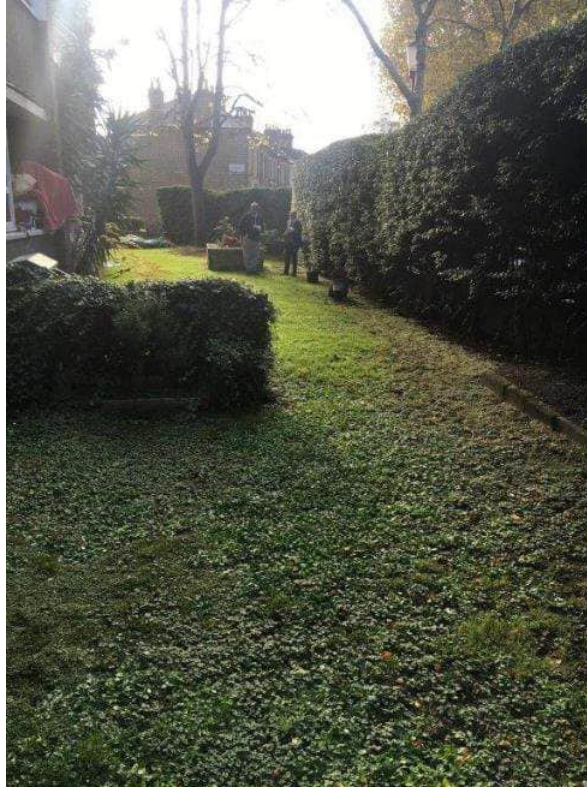
Treadgold House [SSE facing, at the end of garden surrounded by hedges and the apartment building. Looking towards proposed locations including TH111, TH112, TH113 and TH114. This photo covers Plot 9, with Plot 8 and 7 beyond]

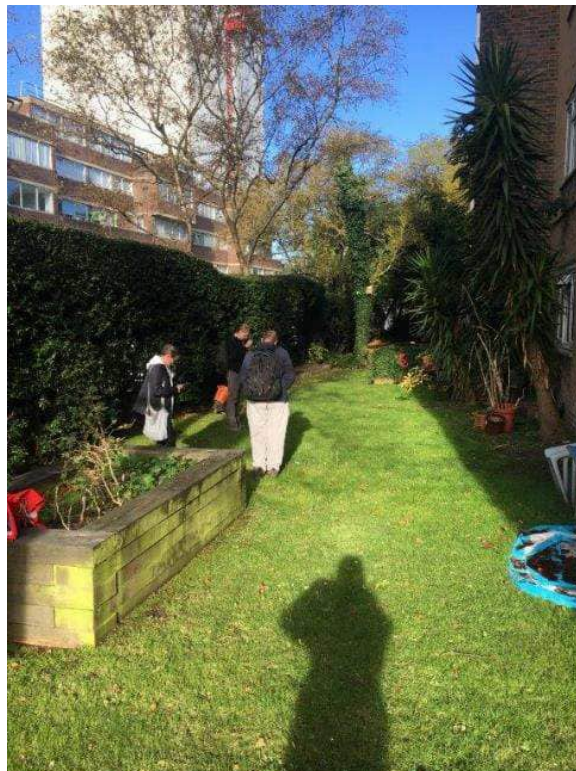
Photo No.
18

Treadgold House [N facing, looking towards raised planter and proposed locations TH114, TH115, TH116, TH117 and TH119. This photo covers Plot 7 and 8]

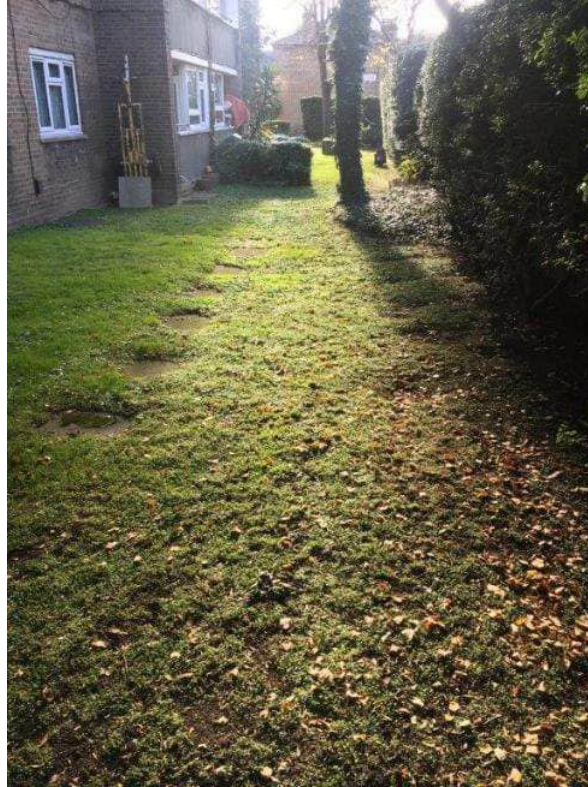
Treadgold House
[S facing, running
parallel to a
footpath within
garden next to the
block of flats.
Looking towards
proposed
locations TH103
to TH110. This
photo covers Plot
10 and 9, with Plot
8 in the
background]

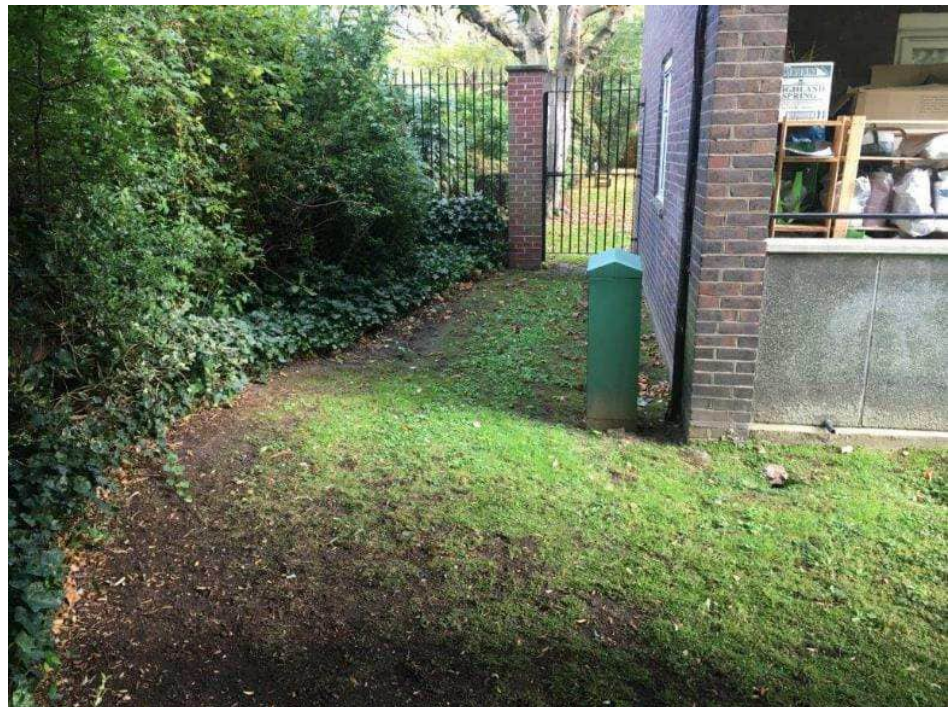
Photo No.
20

Treadgold House
[W facing, round
the side of
building, pointing
towards a gate
and proposed
locations TH101
and TH102. This
photo covers the
northern part of
Plot 10]

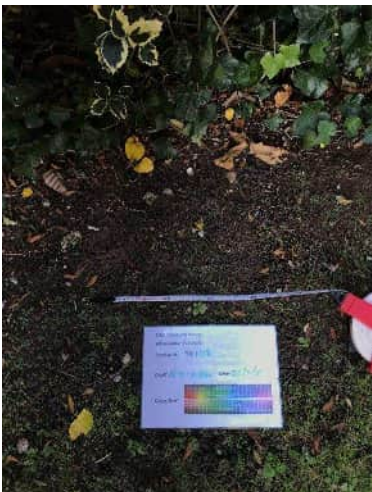
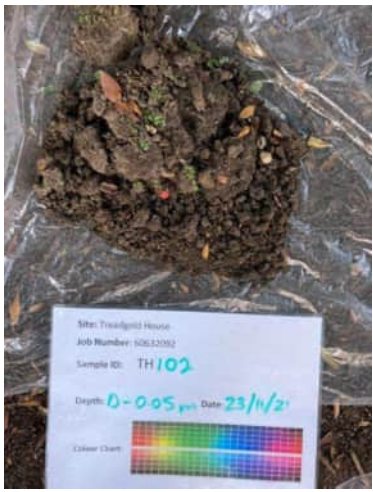
Sample Log:	0 – 0.1m: TOPSOIL. Dark brown slightly sandy, silty CLAY. No visual or olfactory evidence of contamination. 0.1 – 0.7m: MADE GROUND. Dark brown, firm sandy, gravelly clayey SILT. Chunks of natural clay from 0.6m. Gravel is fine to coarse of brick and concrete with rare cobbles of brick and concrete present. No visual or olfactory evidence of contamination.
Observed CoPC:	None
Notes:	Bare soil Testing scheduled: 0-0.05m – Asbestos & 13 metals (including Lead) 0.1-0.2m – Lead 0.3-0.4m – Lead 0.6-0.7m – Lead

Photo 1: Location prior to sampling	Photo 2: Excavated soil for sampling (0-0.05m)

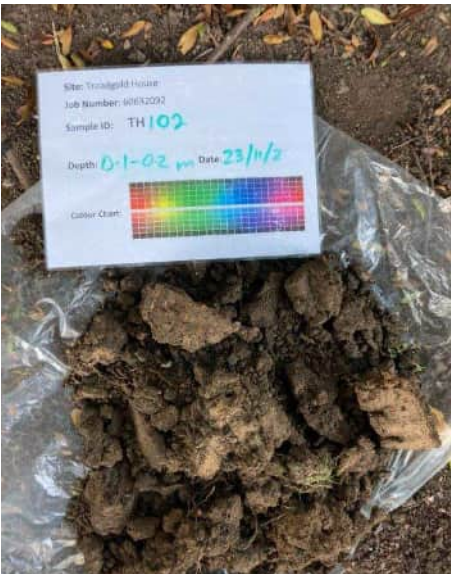
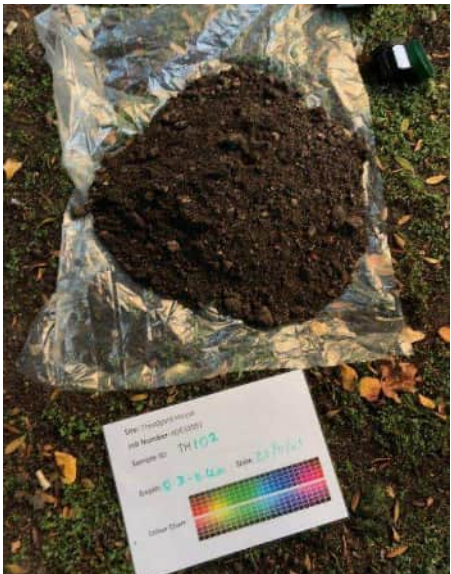
Photo 3: Excavated soil for sampling (0.1-0.2m)	Photo 4: Excavated soil ready for sampling (0.3-0.4m)

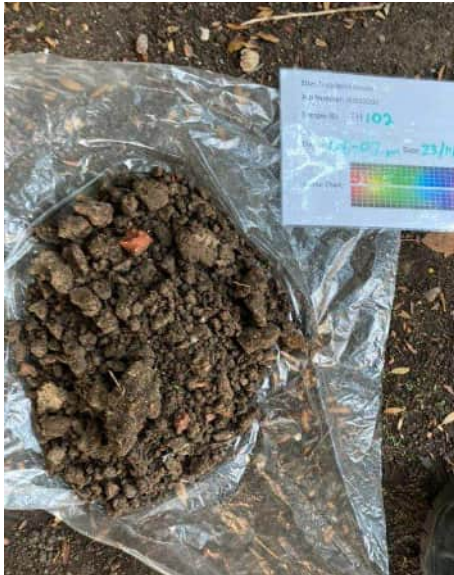
Photo 5: Excavated soil for sampling (0.6-0.7m)

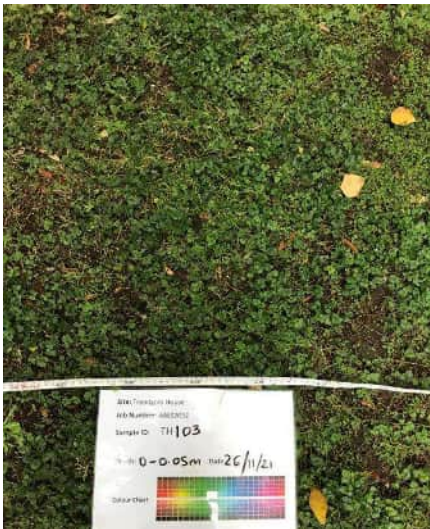
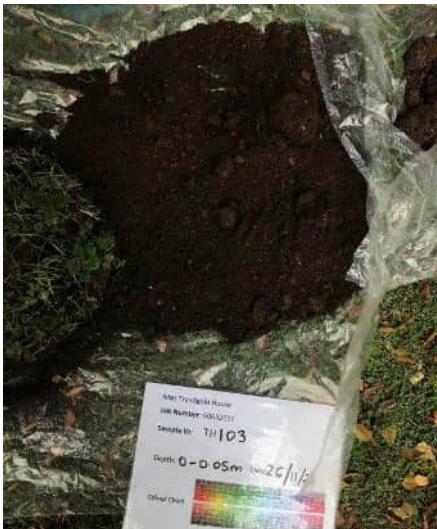
Sample Log:	<p>0 – 0.2m: TOPSOIL. Dark brown sandy, gravelly SILT. Gravel is fine to medium, subrounded of concrete and brick, with the occasional cobble of brick. The occasional pocket of natural clay was present. No visual or olfactory evidence of contamination.</p> <p>0.2 – 0.4m: MADE GROUND. Medium brown, sandy, gravelly clayey SILT. Gravel is medium, rounded of brick and concrete.</p> <p>From 0.3m – as above with increased sand and brick content. Flint is also present as a gravel (<5 cm).</p>
Observed CoPC:	None
Notes:	<p>Partial turf (weed covered soil / bare turf)</p> <p>Testing scheduled:</p> <p>0-0.05m – 9 metals (including Lead)</p> <p>0.1-0.2m – Lead & asbestos</p> <p>0.3-0.4m – Lead</p>

Photo 1: Undisturbed location	Photo 2: Excavated soil ready for sampling (0-0.05m)

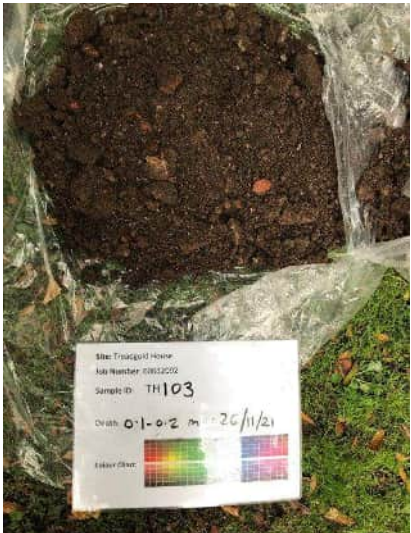
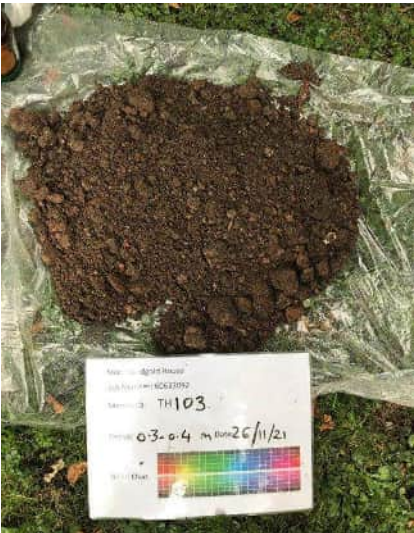
Photo 3: Excavated soil ready for sampling (0.1-0.2m)	Photo 4: Excavated soil ready for sampling (0.3-0.4m)

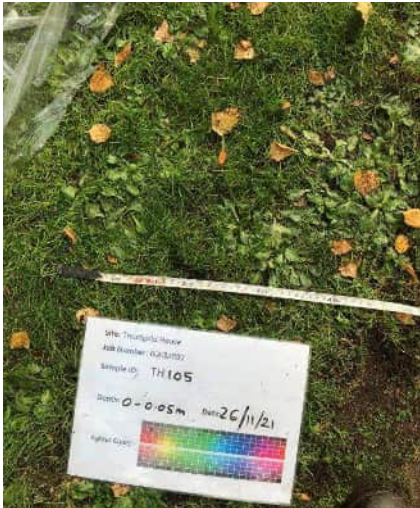
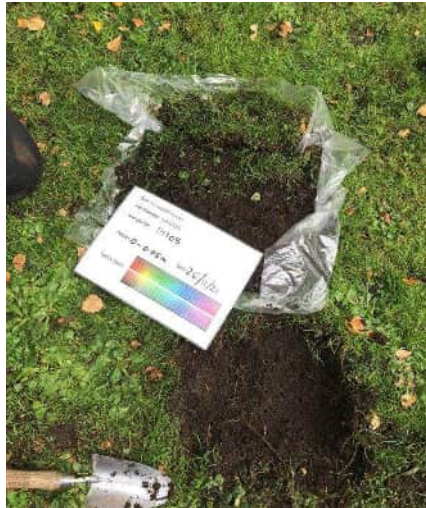
Sample Log:	0 – 0.2m: TOPSOIL. Dark brown, loose sandy SILT. Occasional coarse gravel of flint and fragments of old, rounded, clear glass. No visual or olfactory evidence of contamination. Rare ceramic and plastic fragments. From 0.1m: occasional ash.
Observed CoPC:	Possible ash (up to 1cm) from 0.1m
Notes:	Turf Testing scheduled: 0-0.05m – Lead & asbestos 0.1-0.2m – Lead

Photo 1: Location prior to sampling	Photo 2: Excavated soil for sampling (0-0.05m)

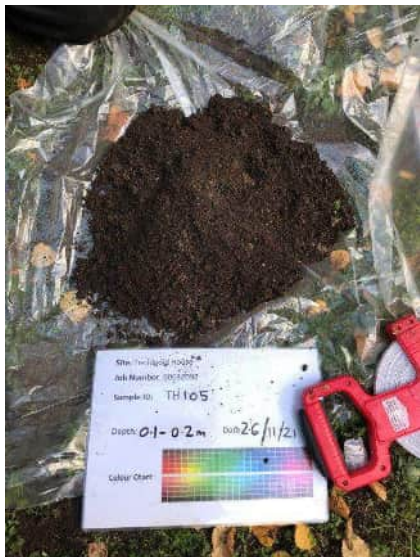
Photo 3: Excavated soil for sampling (0.1-0.2m)	Photo 4: Reinstated location

Sample Log:	0 – 0.1m: TOPSOIL. Dark brown sandy, clayey SILT. Occasional coarse gravel of flint. Fragment of pink plastic and ceramic. One penny. No visual or olfactory evidence of contamination. 0.1 – 0.2m: MADE GROUND. Light to dark brown, loose gravelly SAND. Gravel is medium to coarse, subangular to subrounded of brick, slate, flint, and ash. Pockets of soft dark brown clay.
Observed CoPC:	Clear glass fragment at 0.05 m – possibly recent. Possible ash.
Notes:	Turf Testing scheduled: 0-0.05m – Lead & asbestos 0.1-0.2m – Lead

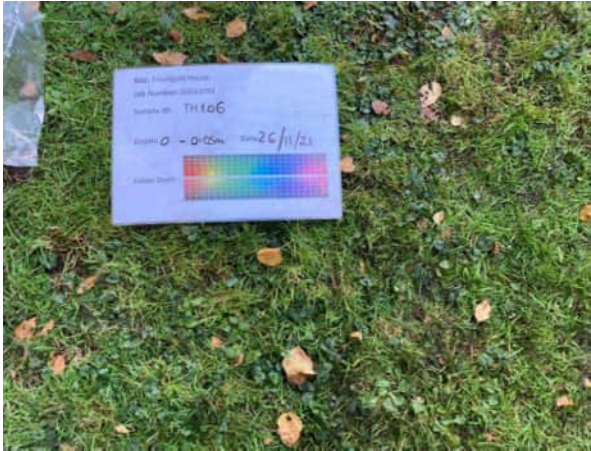
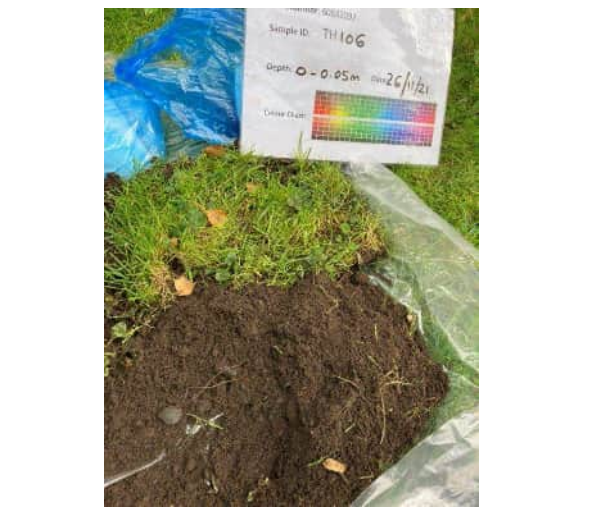
Photo 1: Location prior to sampling	Photo 2: Excavated soil for sampling (0-0.05m)

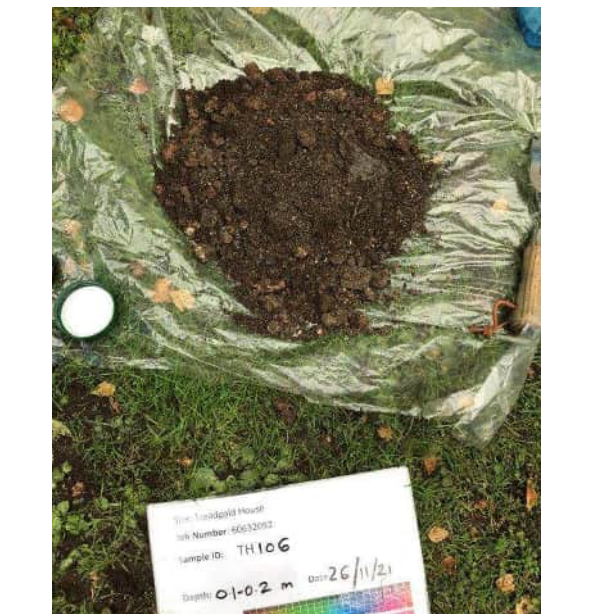
Photo 3: Excavated soil for sampling (0.1-0.2m)	Photo 4: Reinstated location

Sample Log:	0 – 0.1m: TOPSOIL. Dark brown sandy, clayey SILT. Occasional coarse gravels of flint, brick, slate and ash. Glass fragment <3 cm. Ceramic fragment <3 cm. No visual or ofactory evidence of contamination. Pocket of light brown clay. 0.1 – 0.2m: As above, with cobble sized concrete and brick fragments. Rounded coal gravel <2 cm. Rounded glass shards (old) present.
Observed CoPC:	Possible ash.
Notes:	Turf Testing scheduled: 0-0.05m – Lead & asbestos 0.1-0.2m – Lead

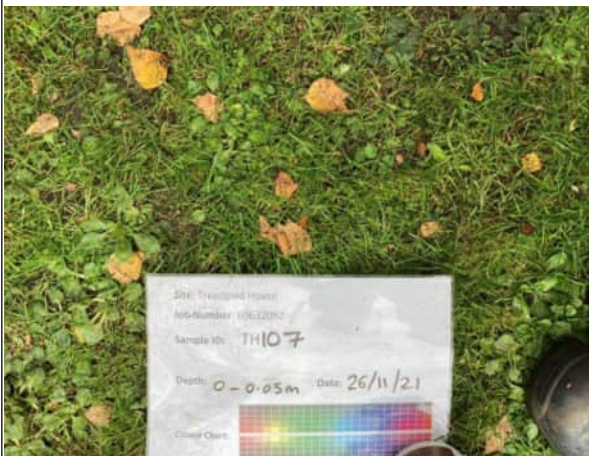
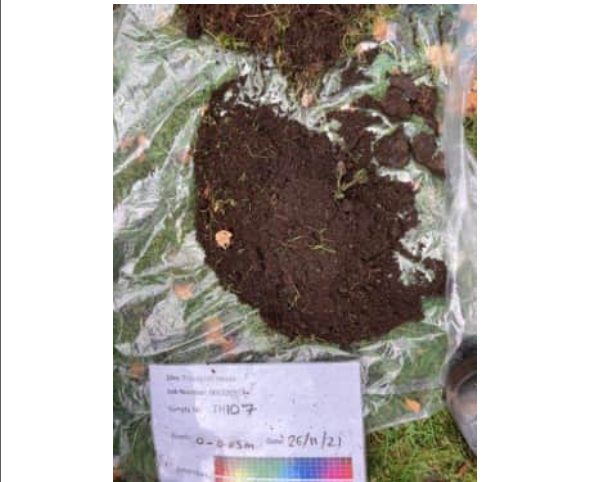
Photo 1: Location prior to sampling	Photo 2: Excavated soil ready for sampling (0-0.05m)

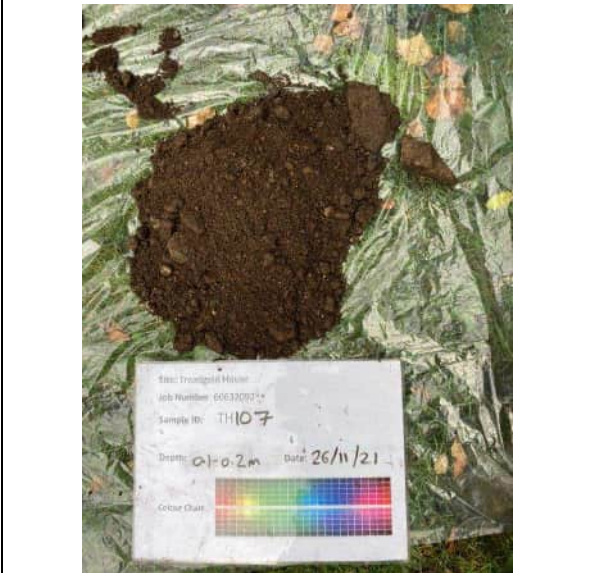
Photo 3: Excavated soil ready for sampling (0.1-0.2m)	Photo 4: Reinstated location

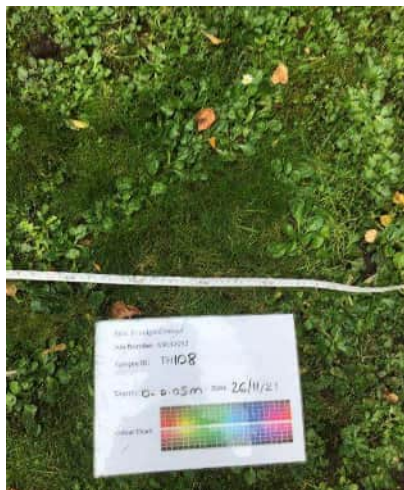
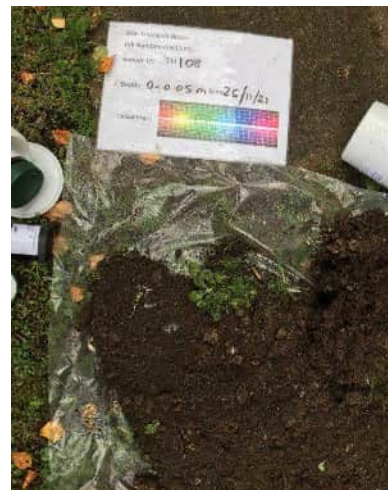
Photo 1: Location prior to sampling	Photo 2: Excavated soil ready for sampling (0-0.05m)
--	---

Sample Log:	<p>0 – 0.2m: TOPSOIL. Dark brown sandy, gravelly SILT. Gravel is fine to medium, rounded to subrounded and comprised of brick, flint and quartzite. The occasional rounded glass shard (<3 cm) is present, ceramic fragments and one cigarette butt. No visual or olfactory evidence of contamination.</p> <p>0.2 – 0.4: MADE GROUND. Sandy, gravelly SILT. Gravel is as described above but larger, now mostly medium sized with cobbles of brick and slate. Occasional clay pockets and ceramic fragments (3-5 cm). No visual or olfactory evidence of contamination.</p>
Observed CoPC:	None
Notes:	<p>Turf</p> <p>Testing scheduled:</p> <p>0-0.05m – Lead & asbestos</p> <p>0.1-0.2m – 13 metals (including Lead)</p> <p>0.3-0.4m - Lead</p>

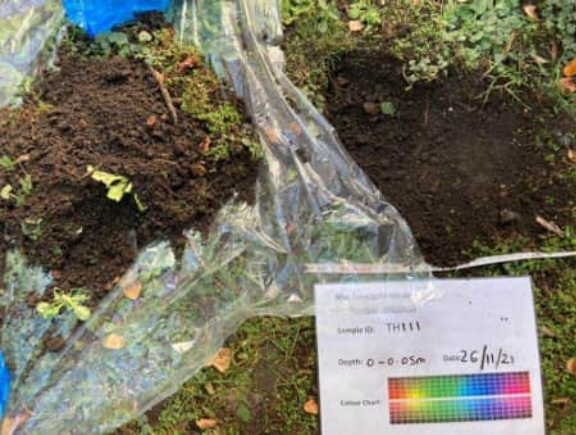
Sample Log:	0 – 0.2m: TOPSOIL. Dark brown gravelly clayey SILT. Gravel is fine to medium, mostly subangular of ceramic, brick and slate. No visual or olfactory evidence of contamination. Small fragment of plastic, fragment of glass (old, rounded, up to 3cm). From 0.1m: as above with medium to coarse gravel with the occasional cobble of brick.
Observed CoPC:	None
Notes:	Turf Testing scheduled: 0-0.05m – Lead and asbestos 0.1-0.2m – Lead

Photo 1: Location prior to sampling	Photo 2: Excavated soil ready for sampling (0-0.05m)

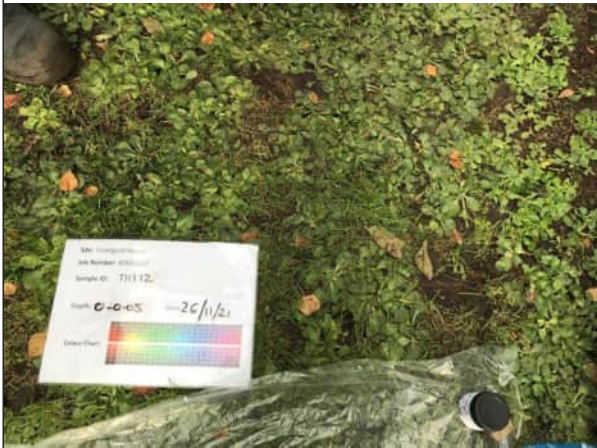
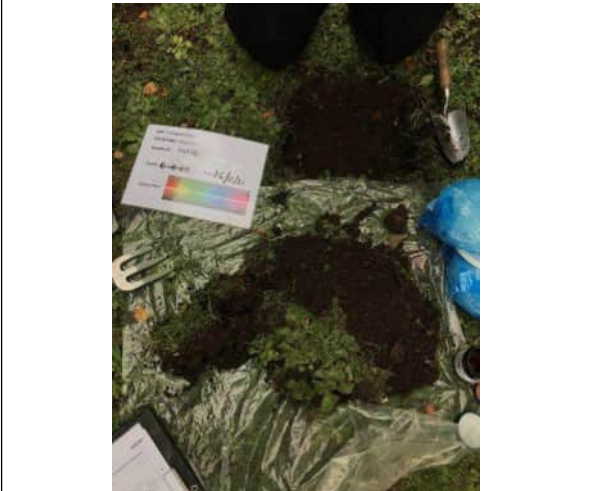
Sample Log:	<p>0 – 0.1m: TOPSOIL. Dark brown loose clayey SILT. Occasional medium to coarse gravel, subangular of flint and brick. No visual or olfactory evidence of contamination. Fragments of ceramic (<1 cm).</p> <p>0.1 – 0.2m: TOPSOIL. As above but slightly darker brown possibly increased organic content. The sample also contained cobbles of brick and rare fragments of plastic. No visual or olfactory evidence of contamination.</p>
Observed CoPC:	None
Notes:	<p>Turf</p> <p>Testing scheduled:</p> <p>0-0.05m – Lead and asbestos</p> <p>0.1-0.2m – Lead</p>

Photo 1: Location prior to sampling	Photo 2: Excavated soil for sampling (0-0.05m)

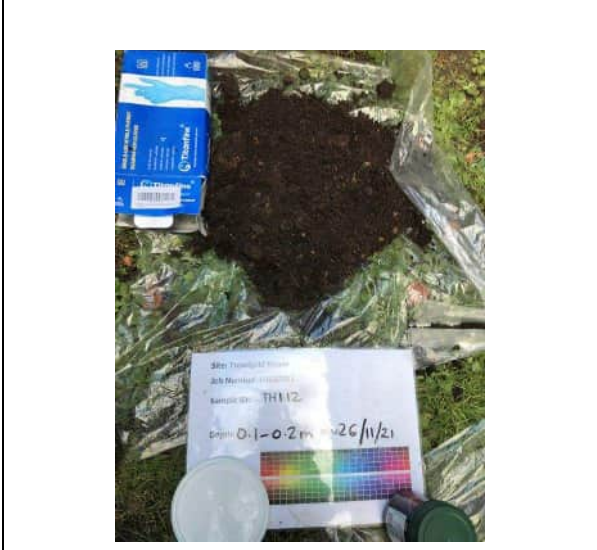
Photo 3: Excavated soil for sampling (0.1-0.2m)	Photo 4: Reinstated location

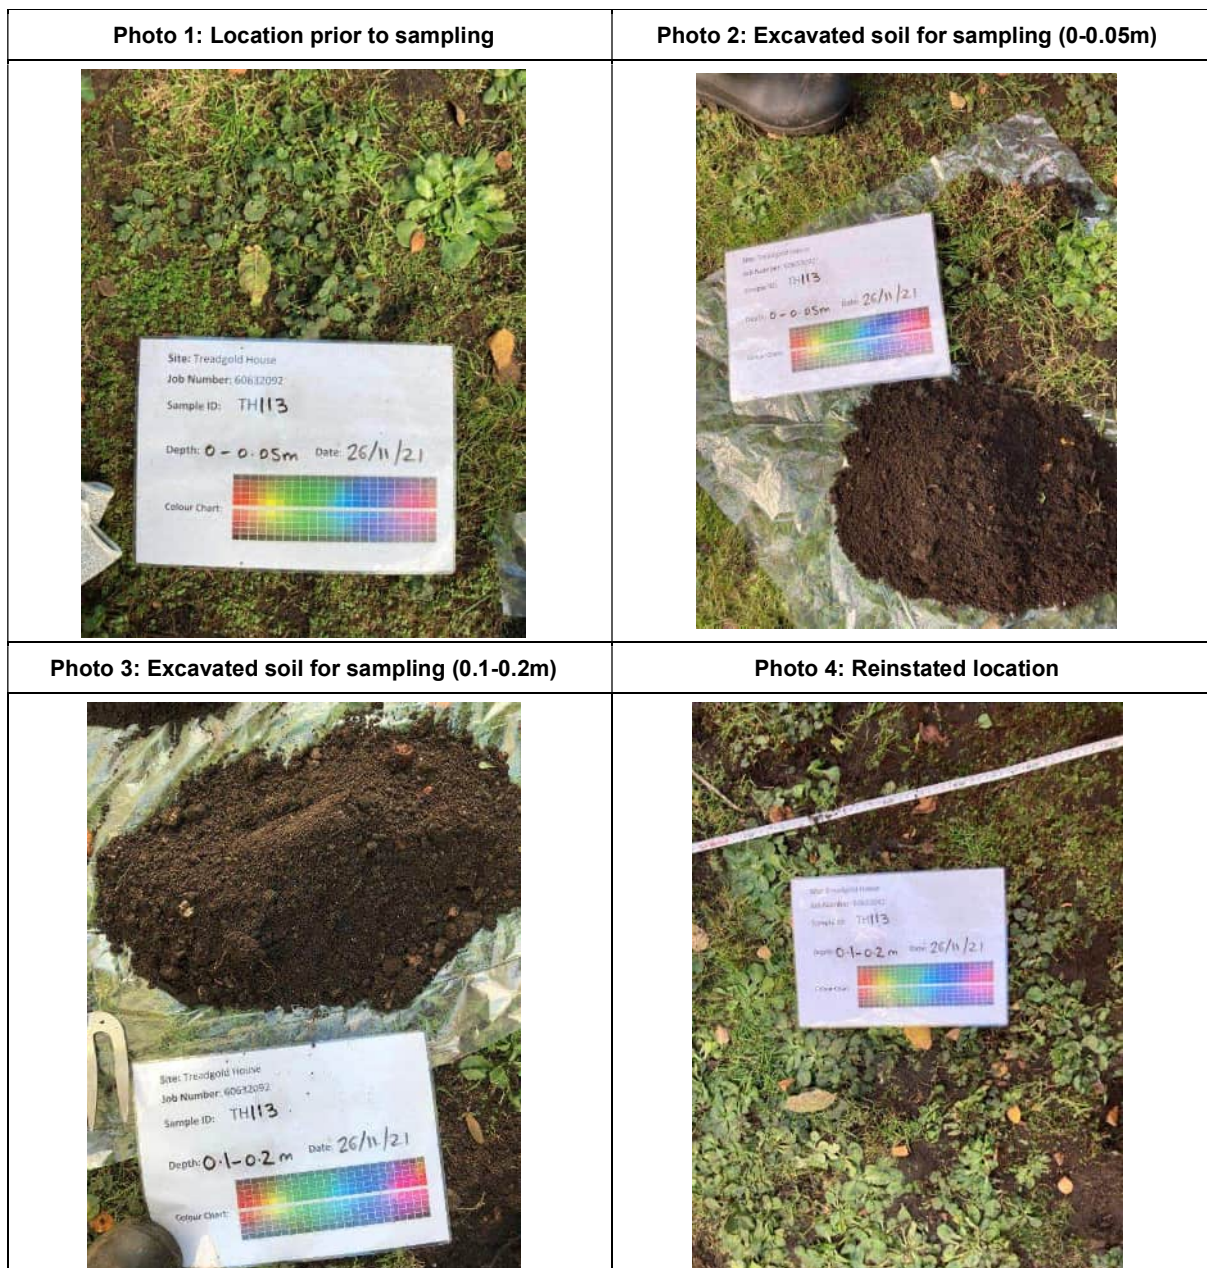
Sample Log:	0 – 0.2m: TOPSOIL. Dark brown loose sandy, gravelly SILT. Gravel is fine, subangular of flint and brick with the occasional medium sized slate. No visual or olfactory evidence of contamination. Rare, rounded glass fragments (old). Below 0.1m: as above but gravel is coarse with an increased sand content.
Observed CoPC:	None
Notes:	Turf Testing scheduled: 0-0.05m – Lead and asbestos 0.1-0.2m – Lead

<p>Date / Time</p>	<p>26 November 2021, 12:15</p>	<p>Sampling Area</p>	<p>Treadgold House</p>
<p>Photo 5: Sample collected in containers (0-0.05m)</p>		<p>Photo 6: Sample collected in containers (0.1-0.2m)</p>

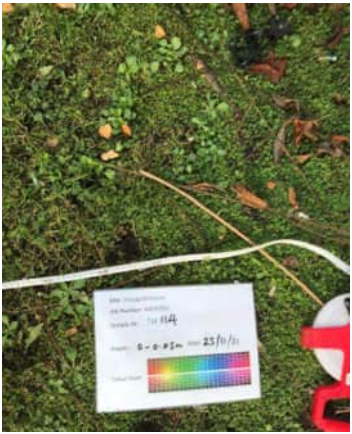
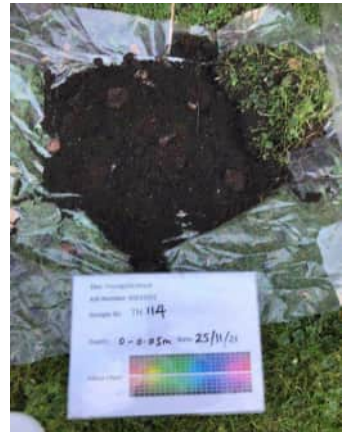
Photo 1: Location prior to sampling	Photo 2: Excavated soil ready for sampling (0-0.05m)

Sample Log:	<p>0 – 0.2m: TOPSOIL. Dark brown loose sandy, clayey SILT. Occasional fine to coarse gravel, angular to subrounded, of flint and brick. No visual or olfactory evidence of contamination. Fragments of ceramic (<1 cm). Rare clear glass fragments (old, rounded).</p> <p>0.2 – 0.4m: MADE GROUND. Dark brown loose gravelly sandy, clayey SILT. Gravel is fine to coarse, subangular of brick, flint, concrete, ash, ceramic and glass (clear and rounded). A 5 cm piece of bent metal was within the sample. Cobbles of concrete and tile.</p>
Observed CoPC:	Bent metal piece and ash both within the Made Ground (below 0.3m bgl)
Notes:	<p>Partial turf (thin weed covering over soil)</p> <p>Testing scheduled:</p> <p>0-0.05m – 13 metals (including Lead) and asbestos</p> <p>0.1-0.2m – Lead</p> <p>0.3-0.4m – Lead</p>

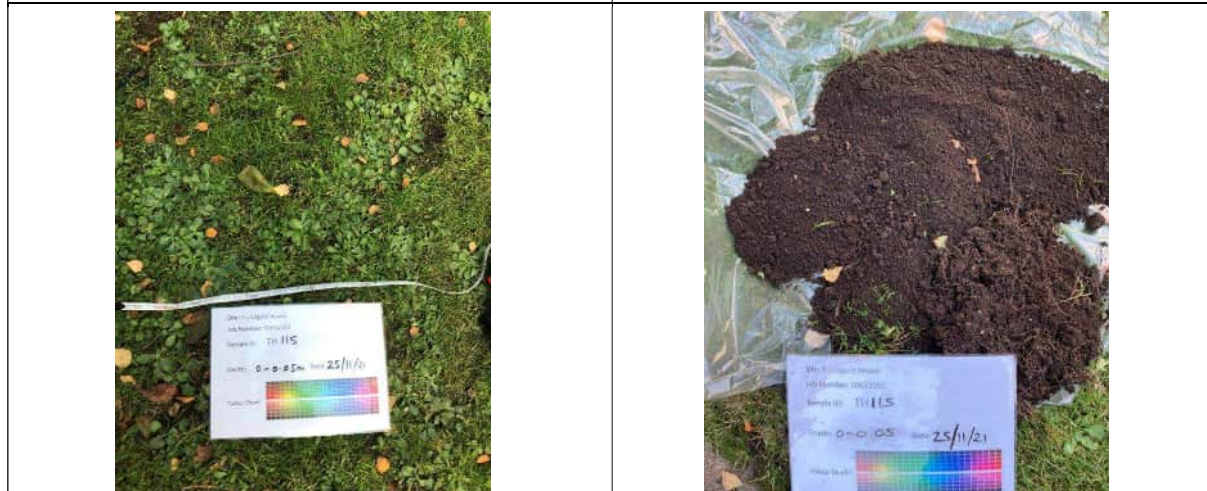
Sample Log:	<p>0 – 0.25m: TOPSOIL. Dark brown loose sandy, clayey SILT. Coarse gravel sized slate fragment. Rare ceramic fragments. No visual or olfactory evidence of contamination.</p> <p>0.25 – 0.4m: MADE GROUND. Orangish brown silty gravelly SAND. Gravel is fine to coarse, subangular to angular of brick, concrete, cement. No visual or olfactory evidence of contamination. Cobbles of concrete (>10cm).</p>
Observed CoPC:	None
Notes:	<p>Turf</p> <p>Testing scheduled:</p> <p>0-0.05m – 9 metals (including Lead) and asbestos</p> <p>0.1-0.2m – Lead</p> <p>0.3-0.4m – Lead</p>

Photo 1: Location prior to sampling **Photo 2: Excavated soil ready for sampling (0-0.05m)**
