Appendix D Walkover Photolog and Sample Logs & Photos

Treadgold House and Avondale Park
Gardens Walkover Survey

Project No.
60632092

Grenfell Potential Land Contamination: Stage 2 Sampling Notes and Photographic Record

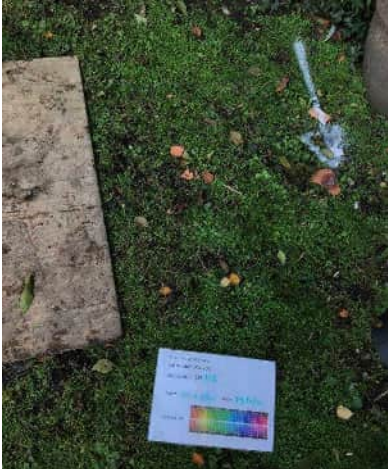
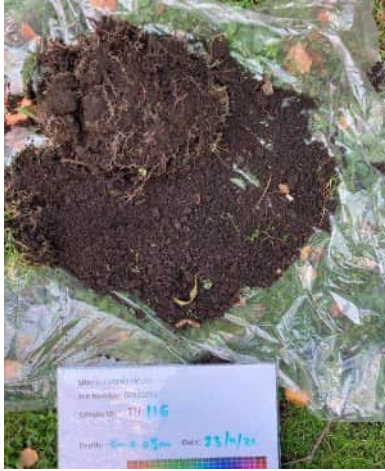
Photo 1: Location prior to sampling	Photo 2: Excavated soil ready for sampling (0–0.05m)

Sample Log:	0 – 0.7m: TOPSOIL. Dark brown slightly sandy, silty CLAY. Rare medium to coarse gravel of brick and concrete. No visual or olfactory evidence of contamination. With rootlets from ground level to 0.1m.
Observed CoPC:	None
Notes:	Turf Testing scheduled: 0-0.05m – Lead and asbestos 0.1-0.2m – Lead & DUP03 for lead 0.3-0.4m – Lead 0.6-0.7m – Lead

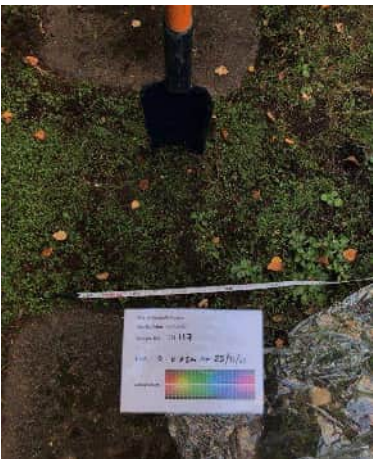
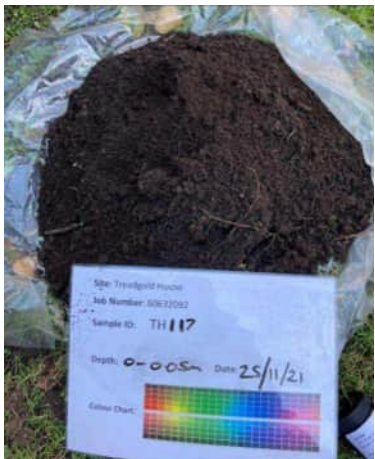
Photo 1: Location prior to sampling	Photo 2: Excavated soil ready for sampling (0-0.05m)

Sample Log:	0 – 0.2m: TOPSOIL. Dark brown loose clayey, sandy SILT. With rootlets and the occasional coarse subangular gravel of concrete. No visual or olfactory evidence of contamination. 0.2 – 0.4m: MADE GROUND. Dark brown loose silty, gravelly SAND. Gravel is medium to coarse, sub angular to rounded of flint, brick, concrete, with the occasional cobble of concrete. No visual or olfactory evidence of contamination.
Observed CoPC:	None
Notes:	Partial turf (weed covered soil) Testing scheduled: 0-0.05m – Lead and asbestos 0.1-0.2m – Lead 0.3-0.4m – Lead

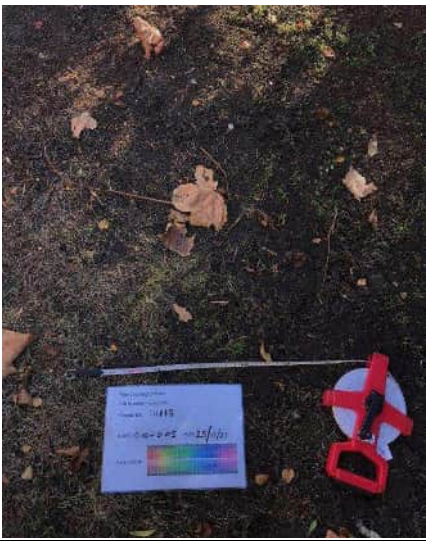
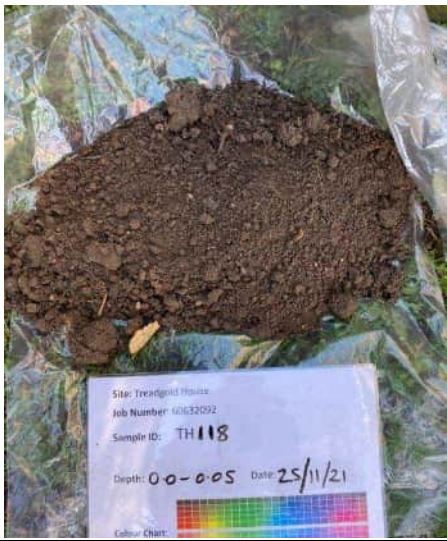
Sample Log:	0 – 0.2m: TOPSOIL. Dark brown loose sandy, gravelly SILT. Gravel is fine to medium, subangular to subrounded of flint. No visual or olfactory evidence of contamination. Piece of ash at 0.1-0.2m. 0.2 – 0.7m: MADE GROUND. Dark brown sandy, gravelly, silty CLAY. Gravel is fine to coarse, subrounded to angular of brick, concrete and flint with infrequent cobbles of concrete, brick and slate. Frequent white tile / ceramic fragments. No visual or olfactory evidence of contamination.
Observed CoPC:	Piece of ash (approximately 1.5 cm) at 0.1-0.2m
Notes:	Bare soil by a tree Testing scheduled: 0-0.05m – 9 metals (including Lead) and asbestos 0.1-0.2m – Lead 0.3-0.4m – Lead 0.6-0.7m – Lead

Photo 1: Undisturbed location	Photo 2: Excavated soil ready for sampling (0-0.05m)

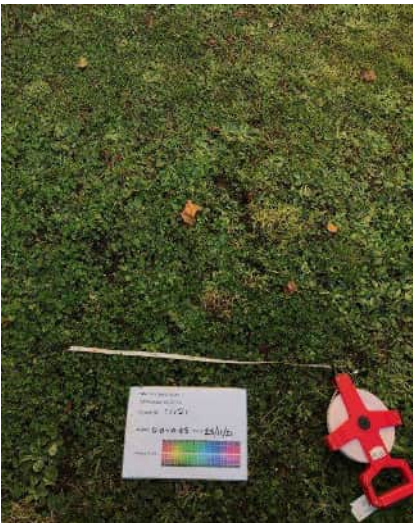
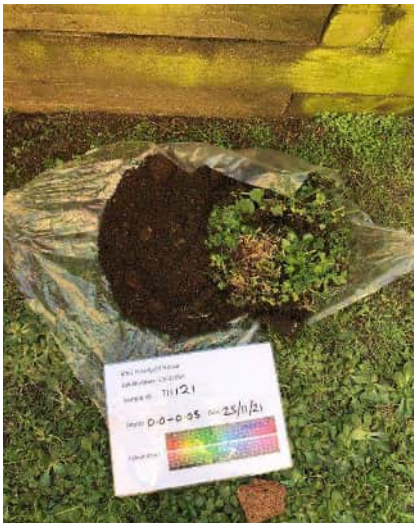
Sample Log:	<p>0 – 0.1m: TOPSOIL. Dark brown, loose sandy clayey SILT. Rootlets and occasional fine gravels of brick and flint are present. Occasional cobbles of concrete and brick.</p> <p>0.1 – 0.7m: MADE GROUND. Greyish brown gravelly, silty SAND. Gravel is mostly fine to medium, sub rounded comprising of concrete, flint and brick with occasional cobbles of brick and concrete.</p> <p>0.6 – 0.7m: As above with an additional rounded clear glass fragment (3 cm).</p>
Observed CoPC:	None
Notes:	<p>Partial turf</p> <p>Testing scheduled:</p> <p>0-0.05m – Asbestos and 9 metals (including Lead)</p> <p>0.1-0.2m – Lead</p> <p>0.3-0.4m – Lead</p> <p>0.6-0.7m - Lead</p>

Photo 1: Location prior to sampling	Photo 2: Excavated soil for sampling (0-0.05m)

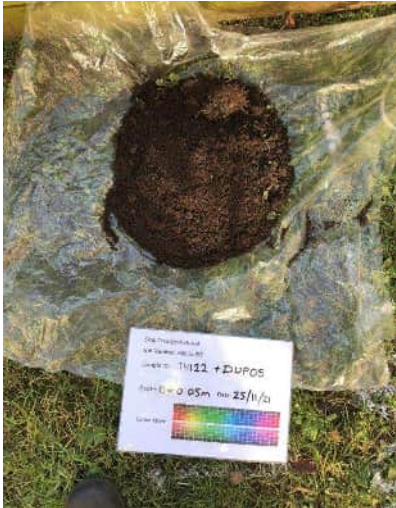
<p>Photo 2: Excavated soil ready for sampling (0-0.05m)</p>

Sample Log:	<p>0– 0.2m: TOPSOIL. Dark brown loose sandy, clayey SILT. With rare fine to medium, subrounded gravel of flint and concrete. Rootlets present. No visual or olfactory evidence of contamination. Rare, rounded glass fragment (old, rounded). At 0.2m: cobble of brick in the side of the pit.</p> <p>0.2 – 0.4m: MADE GROUND. Light brown to dark brown loose gravelly silty SAND. Gravel is fine to coarse, angular to subrounded of concrete, flint, slate and brick. Cobble of concrete present. At 0.4m: 10 cm piece of bent metal.</p>
Observed CoPC:	None
Notes:	<p>Partial turf</p> <p>Testing scheduled:</p> <p>0-0.05m – Asbestos and 9 metals (including Lead) & DUP05 lead</p> <p>0.1-0.2m – Lead</p> <p>0.3-0.4m – Lead</p>

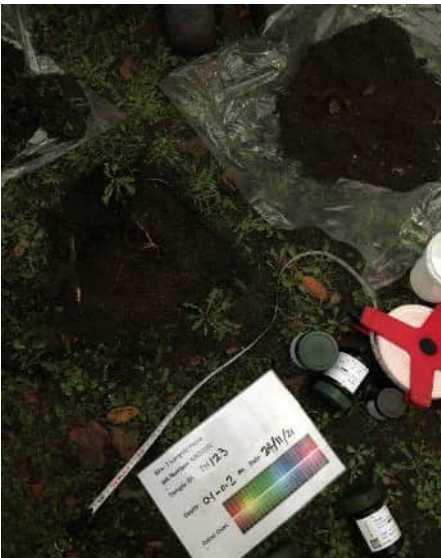
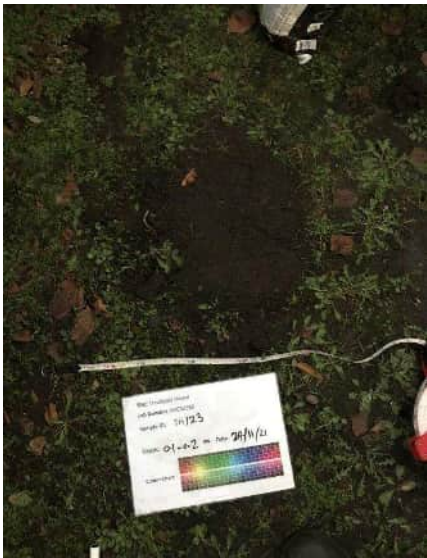
Photo 3: Excavated soil for sampling (0.1-0.2m)	Photo 4: Reinstated location

Sample Log:	<p>0 – 0.1m: TOPSOIL. Dark brown sandy, silty CLAY. With rare sub angular, medium to coarse gravels of brick, flint and concrete. Occasional pieces of slate present and one metal nail. No visual or olfactory evidence of contamination.</p> <p>0.1 – 0.17m: TOPSOIL. Dark brown becoming sandy, gravelly SILT.</p> <p>0.17 – 0.2m: MADE GROUND. Brown, dense gravelly SAND.</p>
Observed CoPC:	None
Notes:	<p>Partial turf (weedy turf)</p> <p>Testing scheduled:</p> <p>0-0.05m – Lead & asbestos</p> <p>0.1-0.2m – Lead</p>

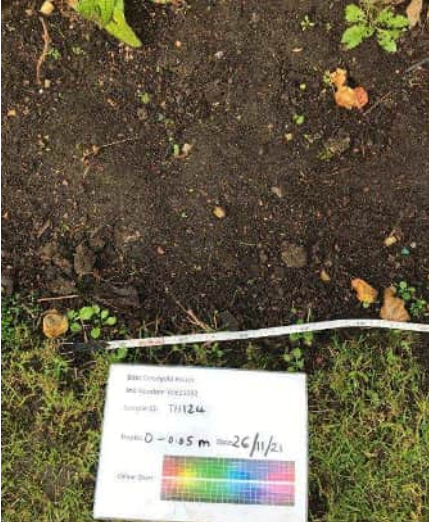
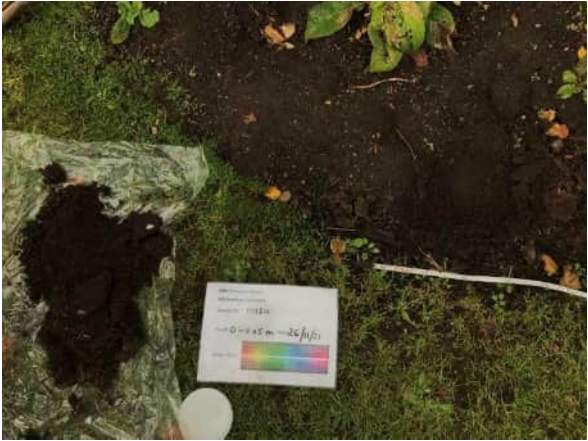
Sample Log:	<p>0 – 0.15m: TOPSOIL. Dark brown, sandy, slightly gravelly SILT. Gravel is fine and subangular of brick and flint. Wood chippings are present at the surface. Two rounded glass fragments are present (<1 cm) and one piece of white tile (2 cm).</p> <p>0.15 – 0.2 cm: MADE GROUND. Orangish brown silty gravelly SAND. Gravel is fine to coarse, subangular to subrounded of concrete and flint. Occasional cobble of concrete.</p>
Observed CoPC:	None
Notes:	<p>Bare soil</p> <p>Testing scheduled:</p> <p>0-0.05m – Lead and asbestos</p> <p>0.1-0.2m – Lead</p>

Photo 1: Location prior to sampling	Photo 2: Excavated soil for sampling (0-0.05m)

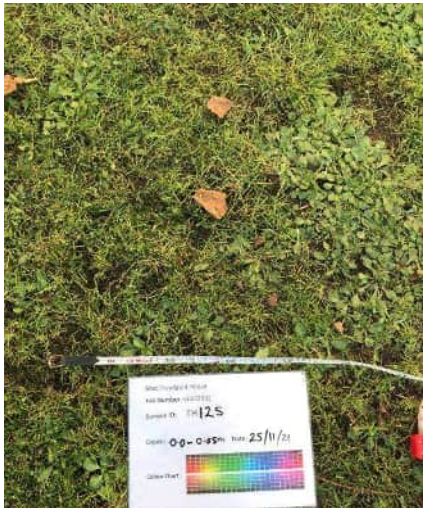
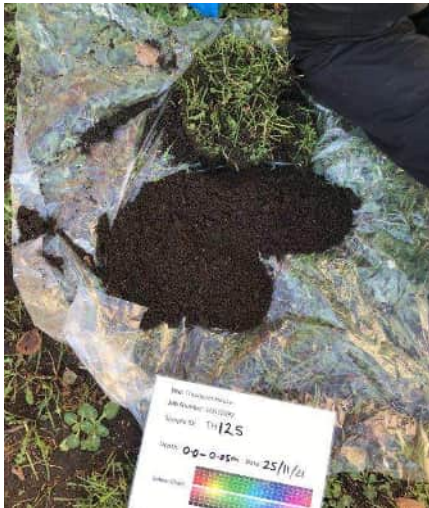
Sample Log:	0 – 0.3m: Dark brown, loose sandy SILT. Containing rootlets and rare fragments of plastic (<0.5 cm). No visual or olfactory evidence of contamination. 0.3 – 0.4m: MADE GROUND. Dark brown loose silty, very gravelly SAND. Gravel is fine to coarse, angular to rounded of flint, brick, and concrete. No visual or olfactory evidence of contamination.
Observed CoPC:	None
Notes:	Turf Testing scheduled: 0-0.05m – Lead & asbestos 0.1-0.2m – Lead 0.3-0.4m – Lead

Photo 1: Location prior to sampling	Photo 2: Excavated soil ready for sampling (0-0.05m)

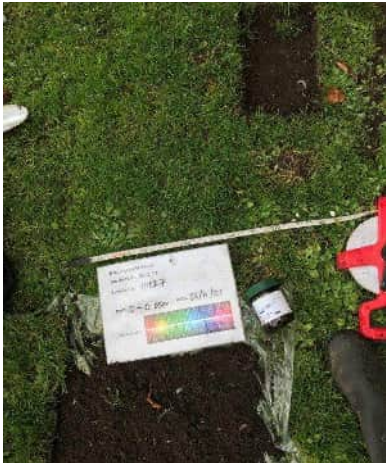
Photo 1: Location prior to sampling	Photo 2: Excavated soil for sampling (0-0.05m)
Photo unavailable

Sample Log:	0 – 0.15m: TOPSOIL. Dark brown sandy, gravelly SILT. Gravel is fine, subangular of concrete, flint and brick. Occasional fragment of green glass. Possible ash (<1 cm) from 0.05-0.2m. No visual or olfactory evidence of contamination 0.15 – 0.2m: MADE GROUND. Light brown, medium dense gravelly SAND. Up to cobble sized fragments of subangular concrete No visual or olfactory evidence of contamination.
Observed CoPC:	Possible ash fragments (2 pieces) from 0.05m – 0.2m
Notes:	Turf Testing scheduled: 0-0.05m – Lead & asbestos 0.1-0.2m – Lead

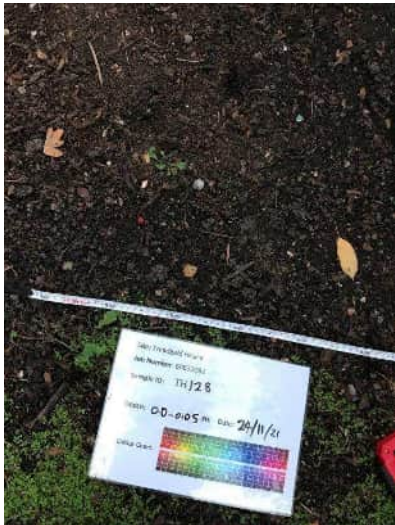
Photo 1: Location prior to sampling	Photo 2: Excavated soil for sampling (0-0.05m)

Sample Log:	0 – 0.1m: TOPSOIL. Dark brown loose sandy, gravelly SILT. Gravel is fine to medium, subangular to rounded of flint and brick. Rare clear glass fragments (old, rounded – <4 cm). 0.1 – 0.2m: TOPSOIL. As above but with the occasional coarse gravel of flint and a cobble of concrete.
Observed CoPC:	None
Notes:	Bare soil Testing scheduled: 0-0.05m – Asbestos & 13 metals (including Lead) 0.1-0.2m – Lead

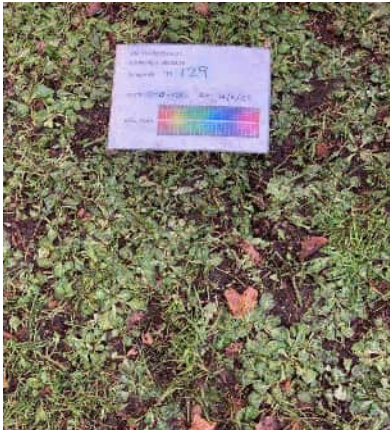
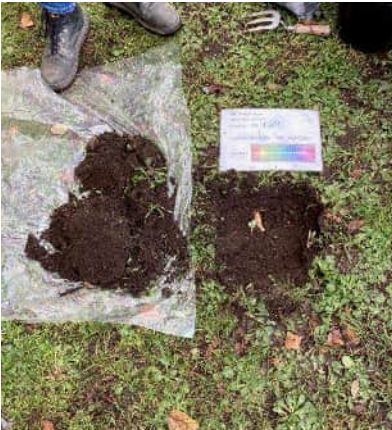
Photo 1: Location prior to sampling	Photo 2: Excavated soil ready for sampling (0-0.05m)

Sample Log:	0 – 0.2m: TOPSOIL. Dark brown SILT. The occasional gravel of red brick and concrete. Organics of rootlets, wood and seed pods.
Observed CoPC:	None
Notes:	Partial turf (weedy grass with patches of bare soil) Testing scheduled: 0-0.05m – Lead & asbestos 0.1-0.2m – Lead

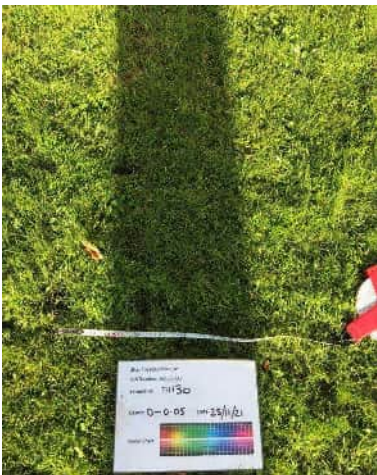
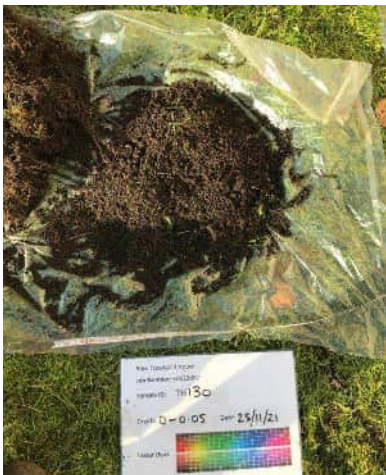
Photo 1: Location prior to sampling	Photo 2: Excavated soil ready for sampling (0-0.05m)

Sample Log:	<p>0 – 0.2m: TOPSOIL. Dark brown loose sandy SILT. Pockets of soft grey clay. No visual or olfactory evidence of contamination. Rootlets.</p> <p>0.2 – 0.5m: MADE GROUND. Dark brown to orangish brown silty, gravelly SAND. Gravel is fine to coarse, angular to rounded of flint. Occasional fragments of clear glass (rounded, old) and rare plastic. A 3 cm piece of patterned white tile is present.</p> <p>0.5 – 0.7m: MADE GROUND. Dark brown silty gravelly SAND. Gravel is fine to coarse, subangular to subrounded of flint and concrete. Large boulders of concrete are present in the hole.</p>
Observed CoPC:	None
Notes:	<p>Turf</p> <p>Testing scheduled:</p> <p>0-0.05m – 9 metals (including Lead)</p> <p>0.1-0.2m – Lead</p> <p>0.3-0.4m – Lead</p> <p>0.6-0.7 – Lead & asbestos</p>

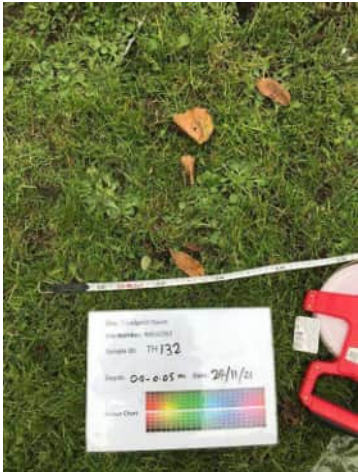
Photo 1: Location prior to sampling	Photo 2: Excavated soil ready for sampling (0-0.05m)

Sample Log:	0 – 0.1m: TOPSOIL. Dark brown loose sandy CLAY. With the occasional rare fine to medium rounded flint gravel. Occasional rootlets. No visual or olfactory evidence of contamination. 0.1 – 0.2m: As above with slightly sandier. Occasional fragments of clear glass (old, rounded < 0.5 cm). No visual or olfactory evidence of contamination.
Observed CoPC:	None
Notes:	Turf Testing scheduled: 0-0.05m – Lead and asbestos 0.1-0.2m – Lead

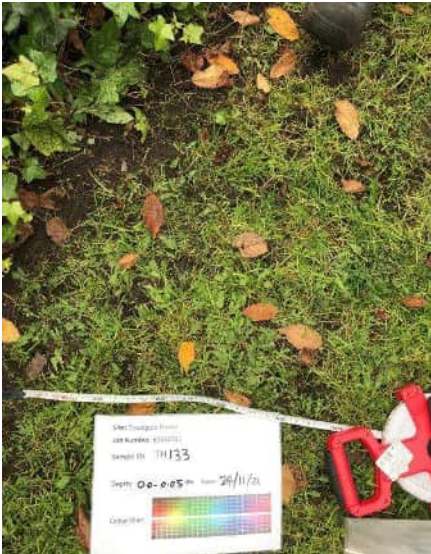
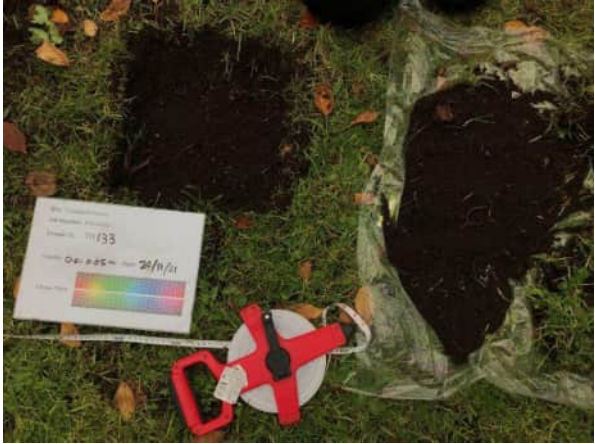
Sample Log:	<p>0 – 0.1m: TOPSOIL. Dark brown loose sandy CLAY. Rare gravel present. Gravel is fine to medium, subangular to subrounded flint. Fragments of red and white plastic are present. No visual or olfactory evidence of contamination.</p> <p>0.1 – 0.2m: As above, with an increased gravel content. Gravel is fine to medium of concrete. More subangular to angular plastic fragments (white, <1 cm) are present). No visual or olfactory evidence of contamination.</p>
Observed CoPC:	None
Notes:	<p>Turf</p> <p>Testing scheduled:</p> <p>0-0.05m – Lead & asbestos</p> <p>0.1-0.2m – Lead</p>

Photo 1: Undisturbed location	Photo 2: Excavated soil ready for sampling (0-0.05m)

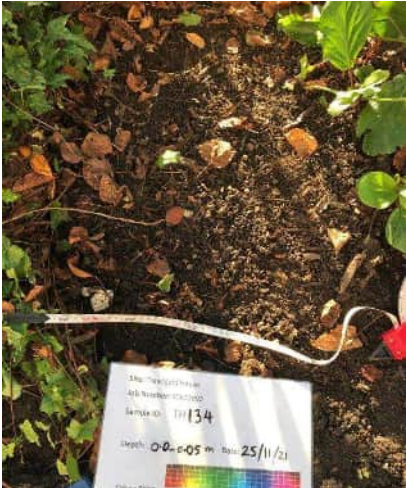
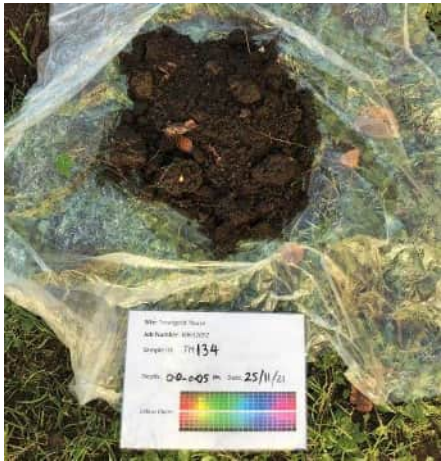
Photo 1: Location prior to sampling	Photo 2: Excavated soil ready for sampling (0-0.05m)

Sample Log:	<p>0 – 0.5m: TOPSOIL. Dark brown loose sandy slightly gravelly, clayey SILT. Gravel is fine to coarse, subangular of brick, flint and concrete. No visual or olfactory evidence of contamination. Roots are present.</p> <p>At 0.05 – 0.2m: Becoming less gravelly. A fragment of red plastic is present.</p> <p>At 0.2 – 0.3m: As above with the occasional cobble of concrete present.</p> <p>0.5 – 0.67m: MADE GROUND. Grey, brown firm sandy gravelly CLAY. Gravel is fine to coarse, angular to subangular of brick and concrete. With frequent angular to subangular cobbles of brick and concrete. Location terminated at 0.67m due to obstruction in ground.</p>
Observed	None
Notes:	<p>Bare soil</p> <p>Testing scheduled:</p> <p>0-0.05m – Lead & asbestos</p> <p>0.1-0.2m – Lead</p> <p>0.3-0.4m – Lead</p> <p>0.6-0.67m – Lead</p>

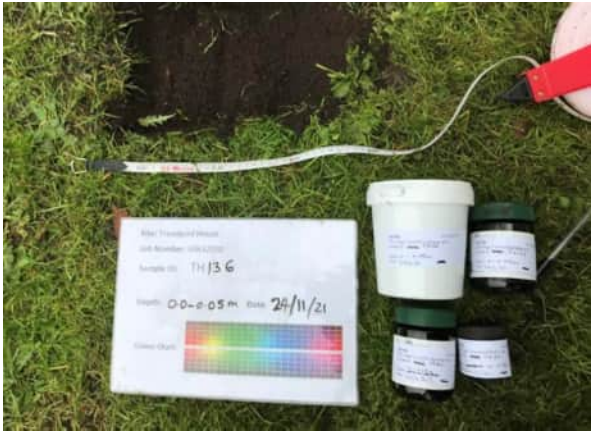
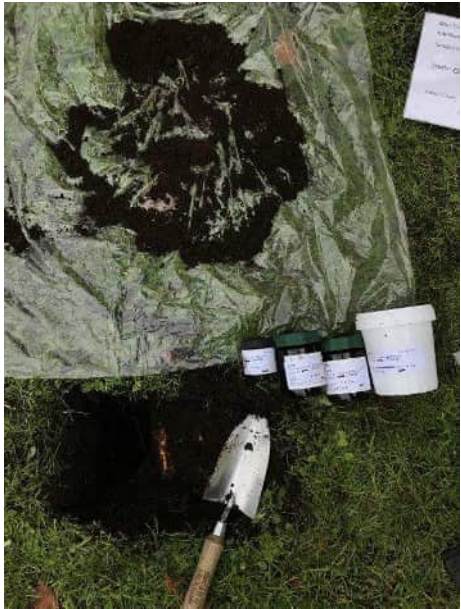
Date / Time	24 November 2021, 14:45	Sampling Area	Treadgold House
Photo 5: Sample collected in containers (0-0.05m)		Photo 6: Sample collected in containers (0.1-0.2m)

Sample Log:	0 – 0.2m: TOPSOIL. Dark brown sandy, slightly gravelly SILT. Gravel is fine, subangular of flint. Rootlets are present. No visual or olfactory evidence of contamination.
Observed CoPC:	None
Notes:	Turf Testing scheduled: 0-0.05m – Lead & asbestos 0.1-0.2m – Lead

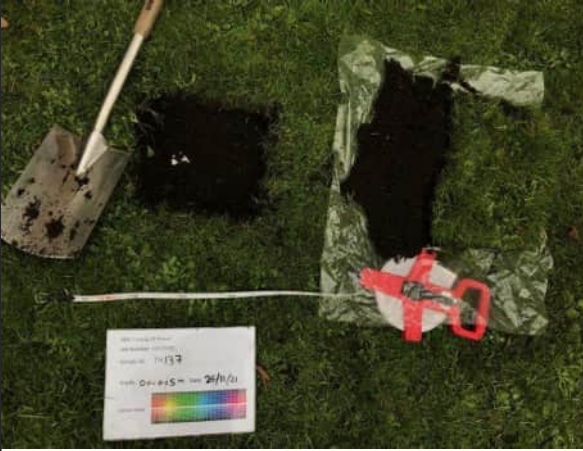
Photo 1: Location prior to sampling	Photo 2: Excavated soil ready for sampling (0-0.05m)

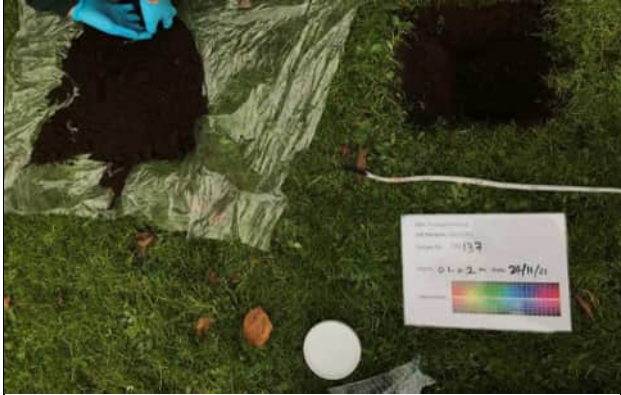
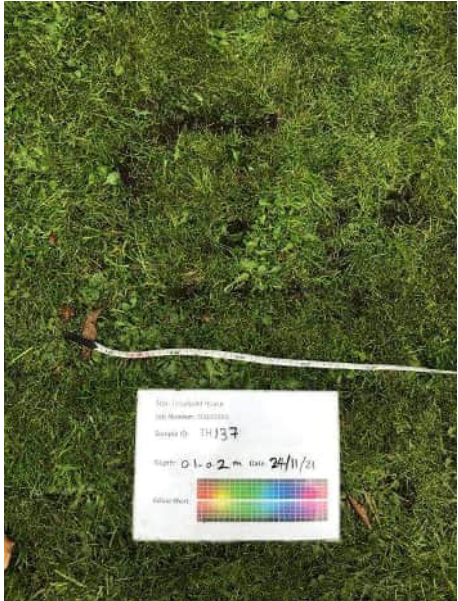
Photo 3: Excavated soil ready for sampling (0.1-0.2m)	Photo 4: Reinstated location

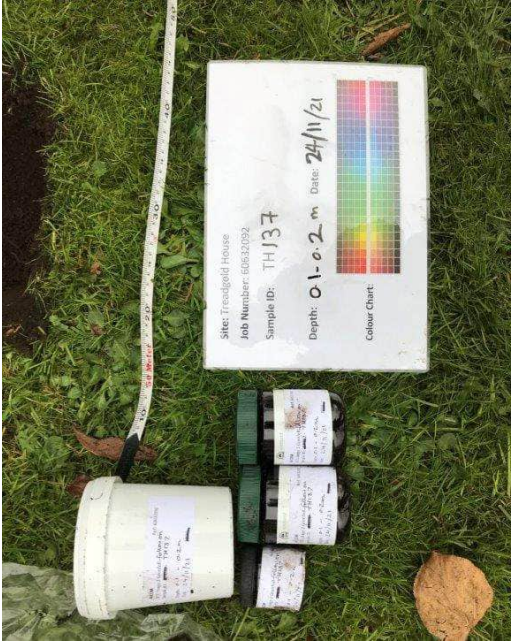
Date / Time	24 November 2021, 14:00	Sampling Area	Treadgold House
Photo 5: Sample collected in containers (0-0.05m)		Photo 6: Sample collected in containers (0.1-0.2m)

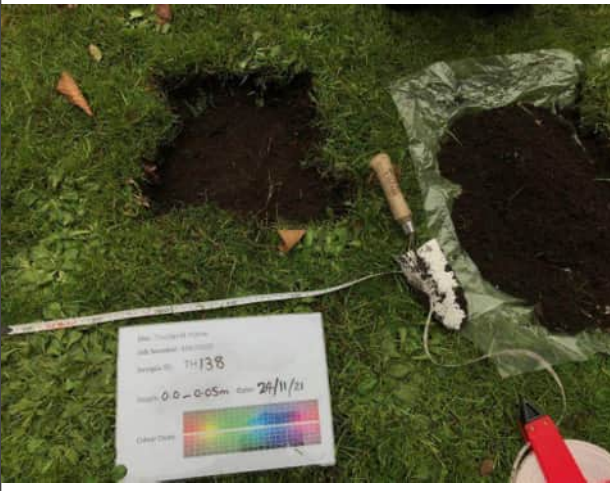
Photo 1: Location prior to sampling	Photo 2: Excavated soil ready for sampling (0-0.05m)

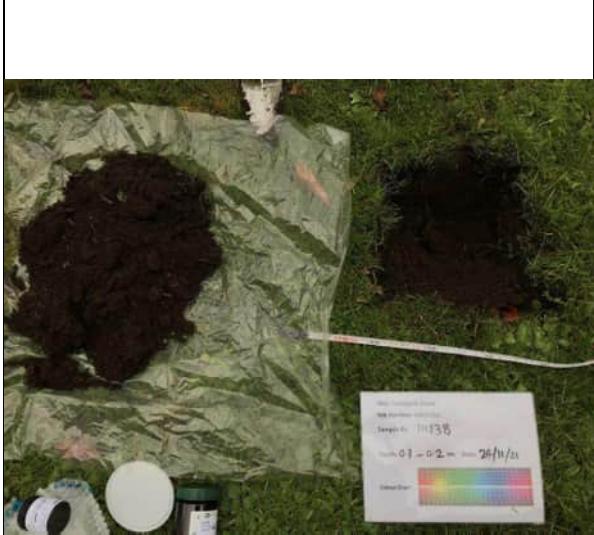
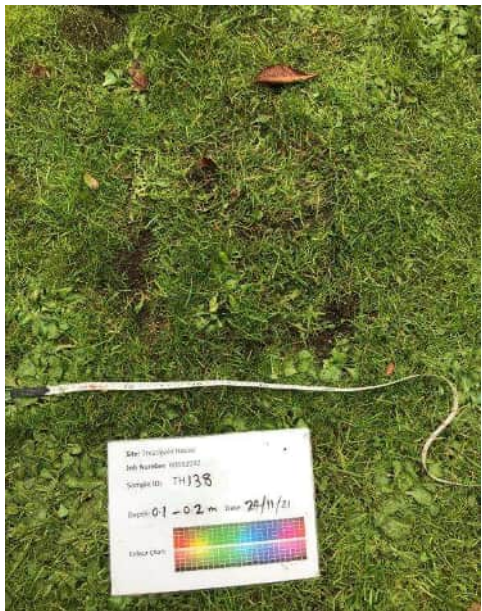
Photo 3: Excavated soil for sampling (0.1-0.2m)	Photo 4: Reinstated location

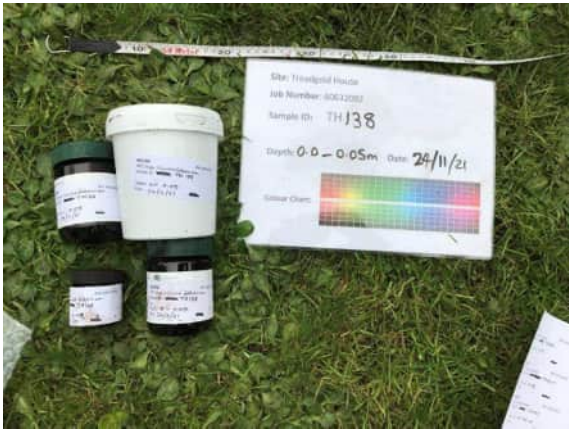
Date / Time	24 November 2021, 12:36	Sampling Area	Treadgold House
Photo 5: Sample collected in containers (0-0.05m)		Photo 6: Sample collected in containers (0.1-0.2m)

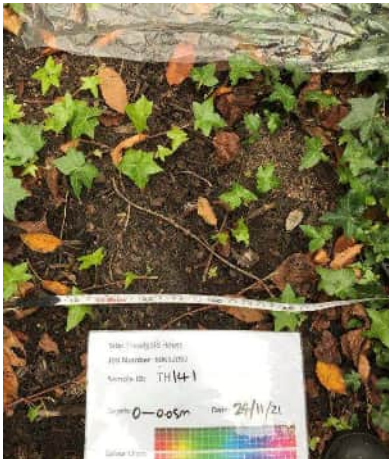
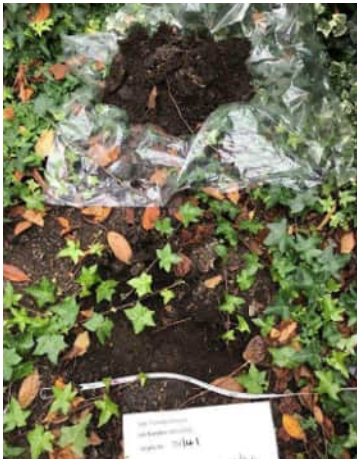
Sample Log:	0 – 0.2m: TOPSOIL. Dark brown loose sandy, gravelly SILT. Gravel is fine to medium, subangular of concrete and flint. Containing wood chips. No visual or olfactory evidence of contamination.
Observed CoPC:	None
Notes:	Bare soil Testing scheduled: 0-0.05m – 13 metals (including Lead) & asbestos 0.1-0.2m – Lead

Photo 1: Location prior to sampling	Photo 2: Excavated soil ready for sampling (0-0.05m)

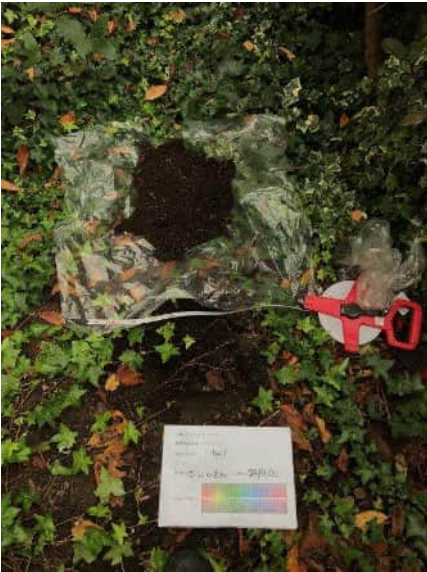
Photo 3: Excavated soil for sampling (0.1-0.2m)	Photo 4: Reinstated location

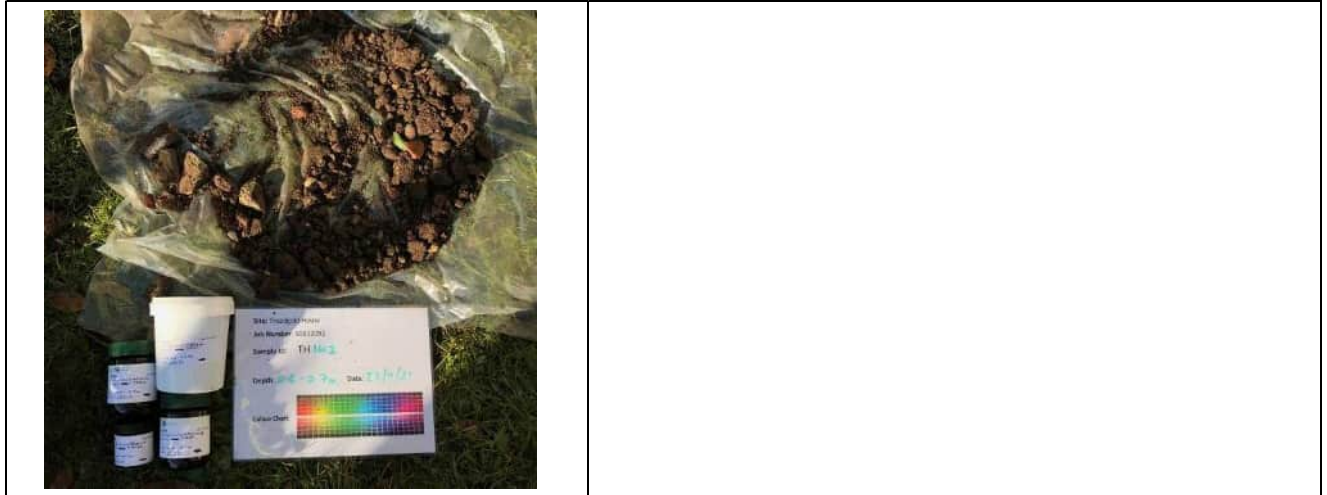
Photo 9: Sample collected in containers (0.6-0.7m)

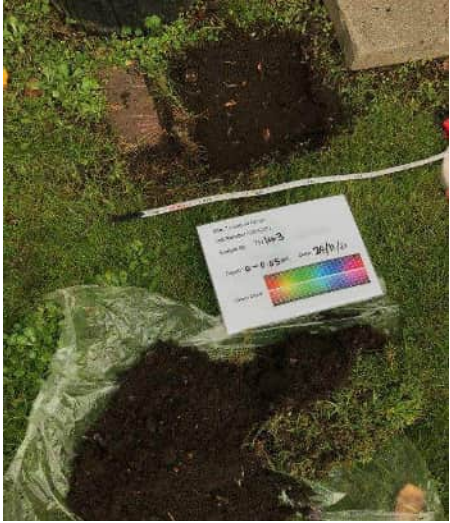
Sample Log:	0 – 0.1m: TOPSOIL. Dark brown loose silty CLAY. Contains rare fine gravel of concrete and flint. Rare ceramic fragments are present. 0.1 – 0.2m: As above but becoming very sandy. Cobbles of concrete are present.
Observed CoPC:	None
Notes:	Turf Testing scheduled: 0-0.05m – Lead & asbestos 0.1-0.2m – Lead

Photo 1: Location prior to sampling	Photo 2: Excavated soil for sampling (0-0.05m)

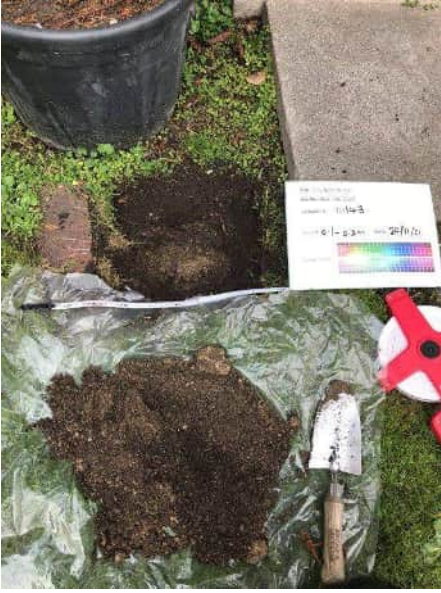
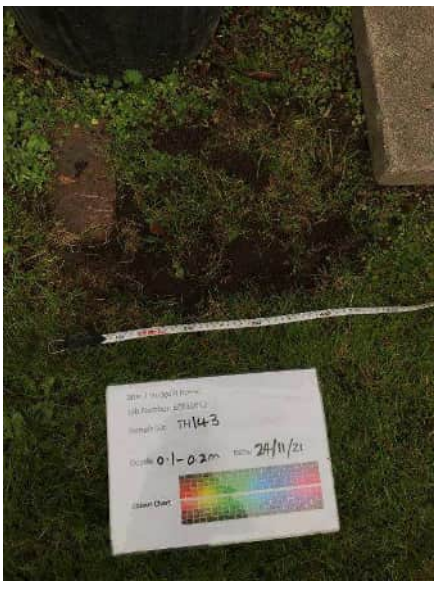
Photo 3: Excavated soil for sampling (0.1-0.2m)	Photo 4: Reinstated location

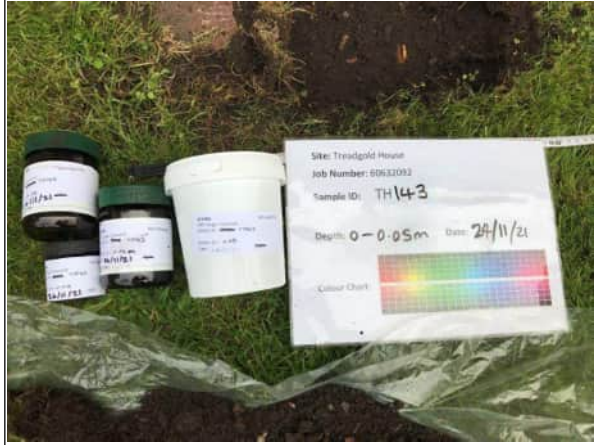
Date / Time	24 November 2021, 09:45	Sampling Area	Treadgold House
Photo 5: Sample collected in containers (0-0.05m)		Photo 6: Sample collected in containers (0.1-0.2m)

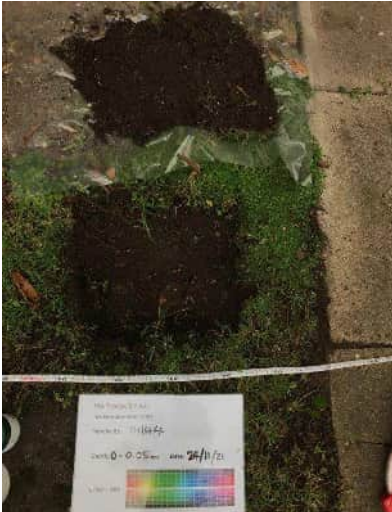
Sample Log:	0 – 0.1m: TOPSOIL. Dark brown sandy, gravelly SILT. Gravel is fine to coarse, subangular to subrounded of flint and concrete. One clear glass fragment was observed (old, rounded) and a 4 cm hard plastic piece. No visual or olfactory evidence of contamination. 0.1 – 0.2m: As above, with an increasing gravel and sand content.
Observed CoPC:	None
Notes:	Turf Testing scheduled: 0-0.05m – Lead & asbestos 0.1-0.2m – Lead

Photo 1: Location prior to sampling	Photo 2: Excavated soil ready for sampling (0-0.05m)

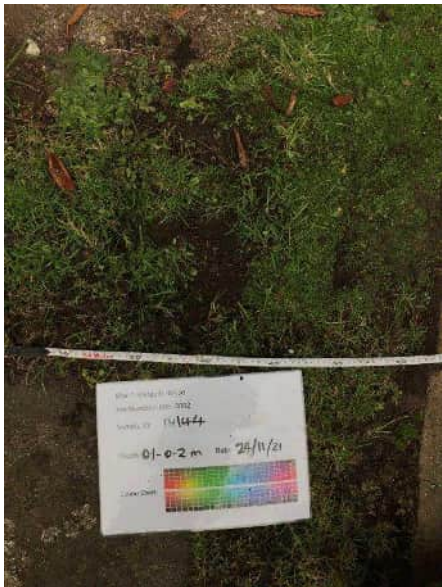
Photo 3: Excavated soil ready for sampling (0.1-0.2m)	Photo 4: Reinstated location

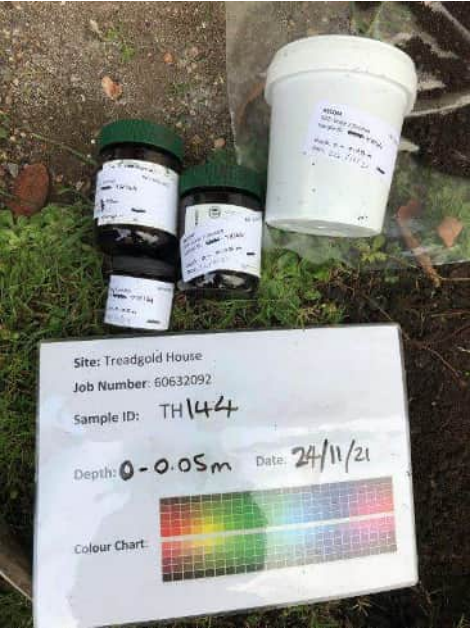
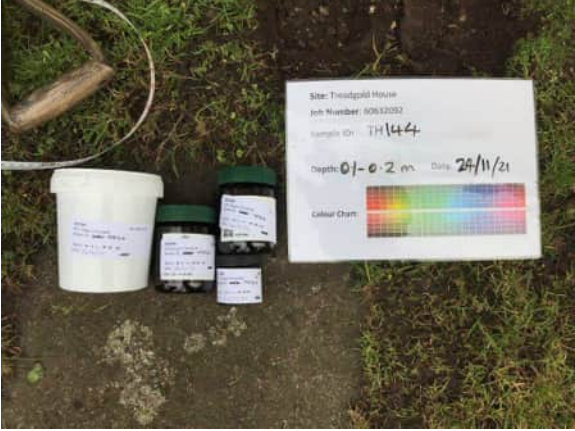
Date / Time	24 November 2021, 09:20	Sampling Area	Treadgold House
Photo 5: Sample collected in containers (0-0.05m)		Photo 6: Sample collected in containers (0.1-0.2m)

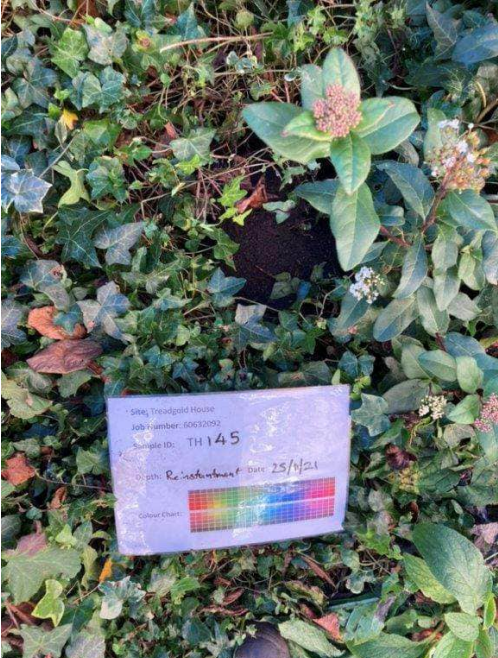
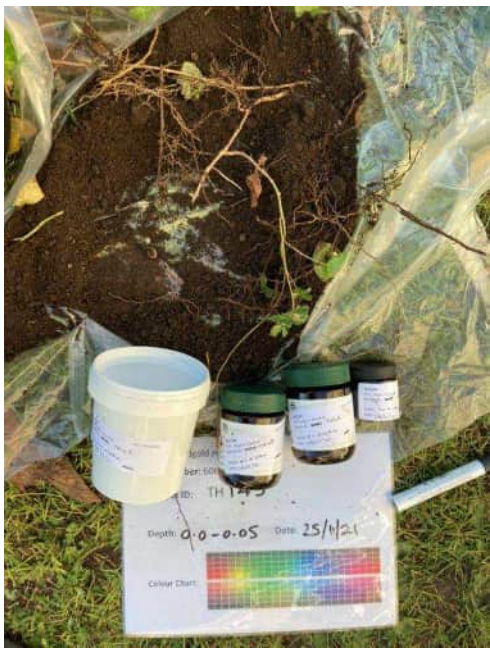
Date / Time	25 November 2021, 09:38	Sampling Area	Treadgold House
Photo 5: Reinstated location		Photo 6: Sample collected in containers (0-0.05m)

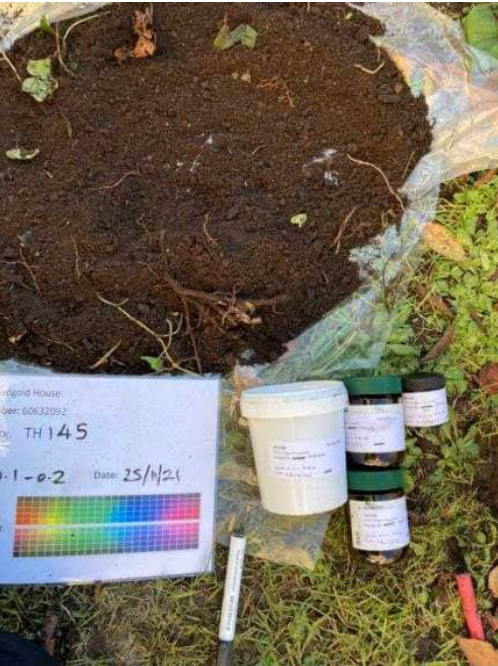
Photo 7: Sample collected in containers (0.1-0.2m)		Photo 8: Sample collected in containers (0.3-0.4m)

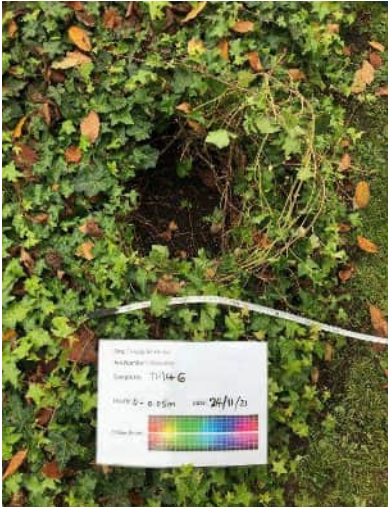
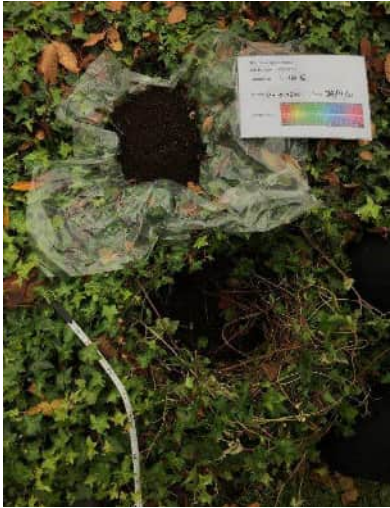
Sample Log:	0 – 0.2m: TOPSOIL. Dark brown loose, gravelly, sandy CLAY. Gravel is fine, subangular of flint. 1 cm plastic fragments are present. Rootlets present. No visual or olfactory evidence of contamination.
Observed CoPC:	None
Notes:	Bare soil under ivy Testing scheduled: 0-0.05m – Lead & asbestos 0.1-0.2m – Lead

Photo 1: Location prior to sampling	Photo 2: Excavated soil ready for sampling (0–0.05m)

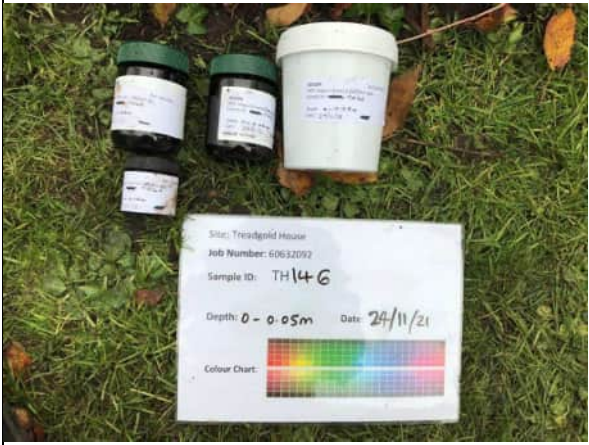
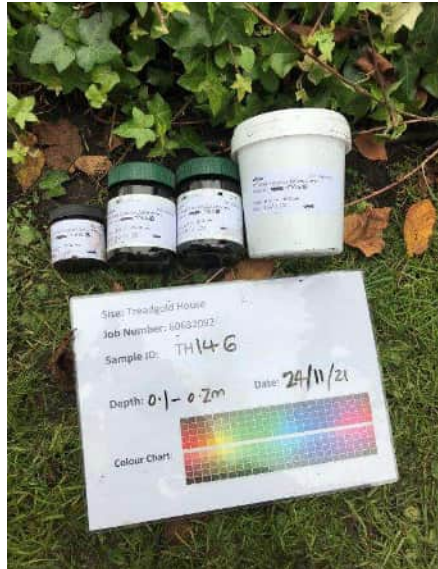
Date / Time	24 November 2021, 10:23	Sampling Area	Treadgold House
Photo 5: Sample collected in containers (0-0.05m)		Photo 6: Sample collected in containers (0.1-0.2m)

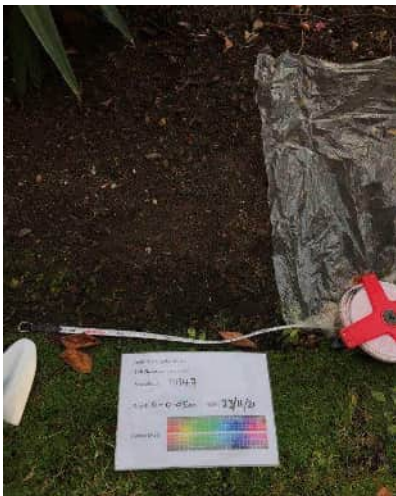
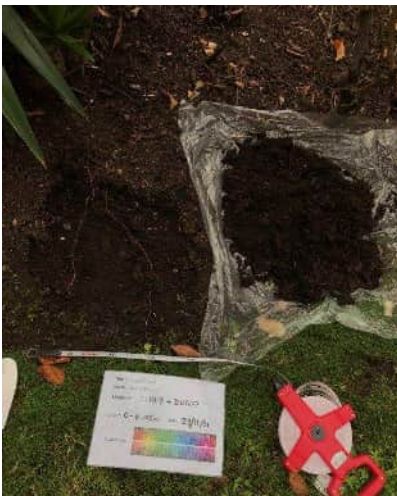
Sample Log:	0 – 0.1m: TOPSOIL. Dark brown, loose, slightly sandy, gravelly SILT. Gravel is fine to medium, angular to subrounded of brick and concrete with the occasional concrete cobble. The occasional glass fragment (old, rounded) was observed. Rootlets were also observed. No visual or olfactory evidence of contamination. Wood chippings present.
Observed CoPC:	None
Notes:	Bare soil Testing scheduled: 0-0.05m – Lead & asbestos 0.1-0.2m – Lead

Photo 1: Location prior to sampling	Photo 2: Excavated soil ready for sampling (0-0.05m)

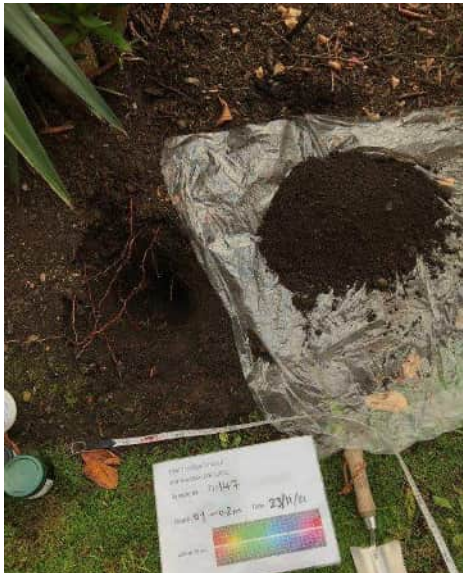
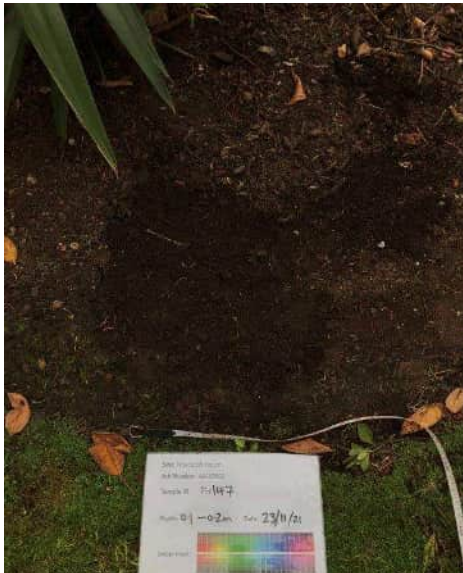
Photo 3: Excavated soil ready for sampling (0.1-0.2m)	Photo 4: Reinstated location

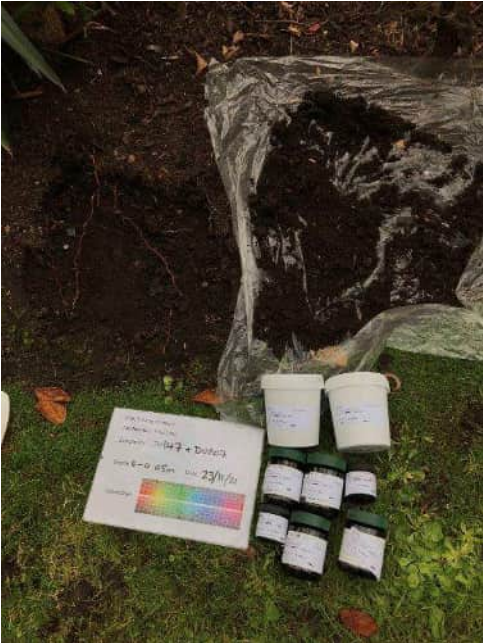
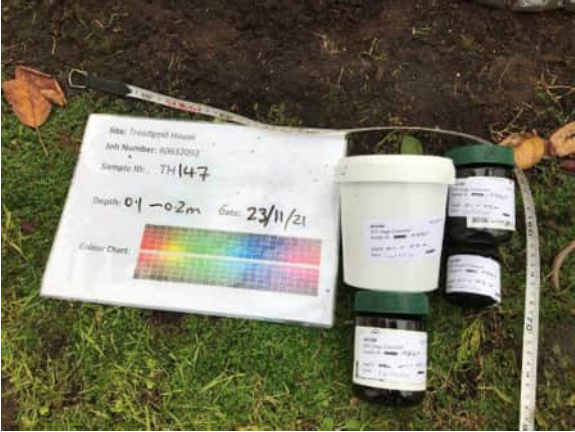
Date / Time	24 November 2021, 09:15	Sampling Area	Treadgold House
Photo 5: Sample collected in containers (0-0.05m)		Photo 6: Sample collected in containers (0.1-0.2m)

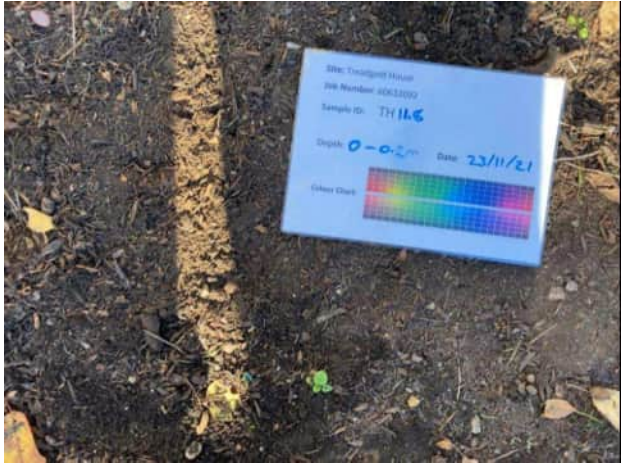
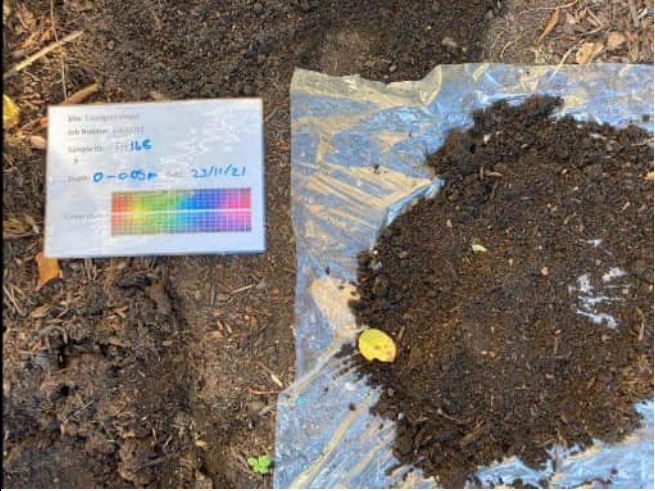
Sample Log:	0 – 0.2m: TOPSOIL. Dark brown loose sandy, SILT. Organic material such as leaves and rootlets was present in the sample.
Observed CoPC:	None
Notes:	Bare soil Testing scheduled: 0-0.05m – Lead & asbestos 0.1-0.2m – Lead

Photo 1: Undisturbed location	Photo 2: Excavated soil ready for sampling (0-0.05m)

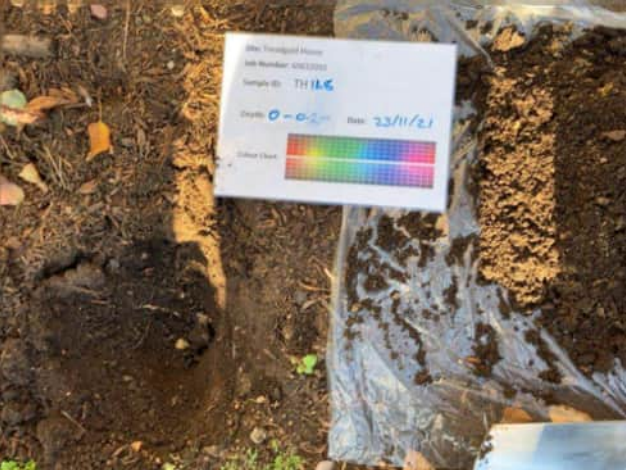
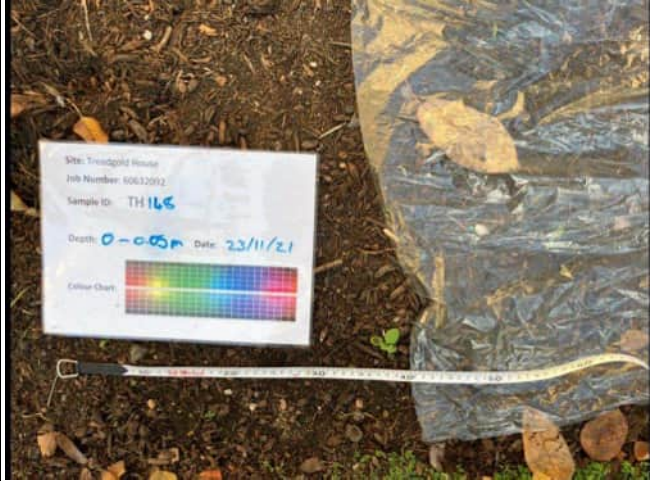
Photo 3: Excavated soil ready for sampling (0.1-0.2m)	Photo 4: Location reinstated

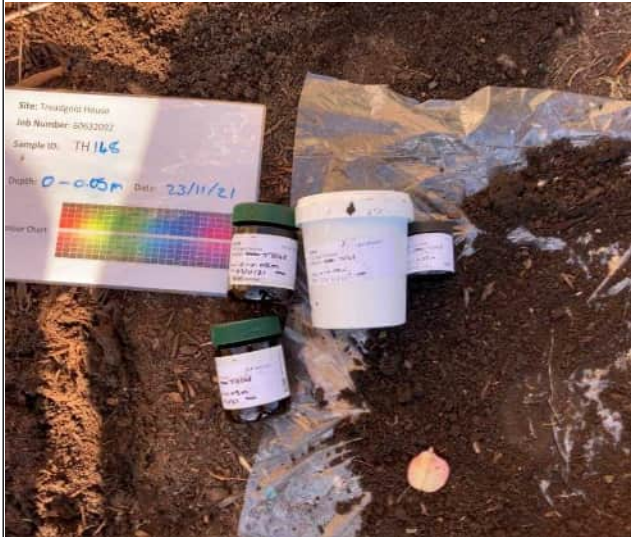
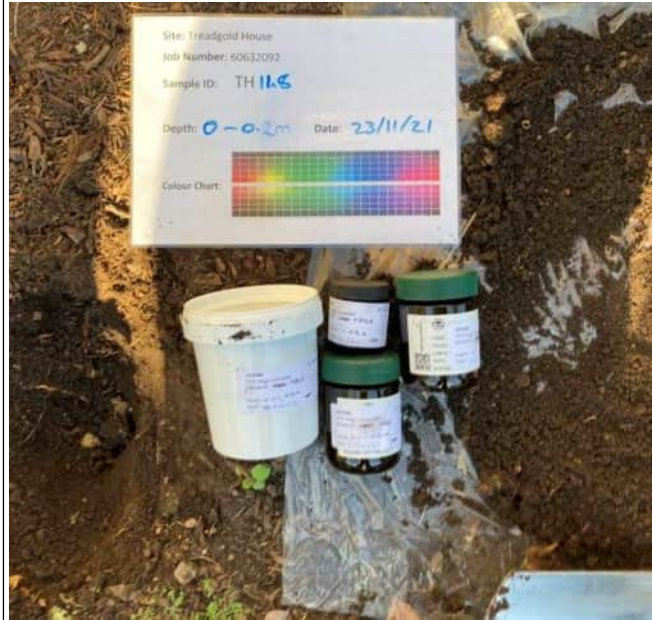
Date / Time	23 November 2021, 09:15	Sampling Area	Treadgold House
Photo 5: Sample collected in containers (0-0.05m)		Photo 6: Sample collected in containers (0.1-0.2m)

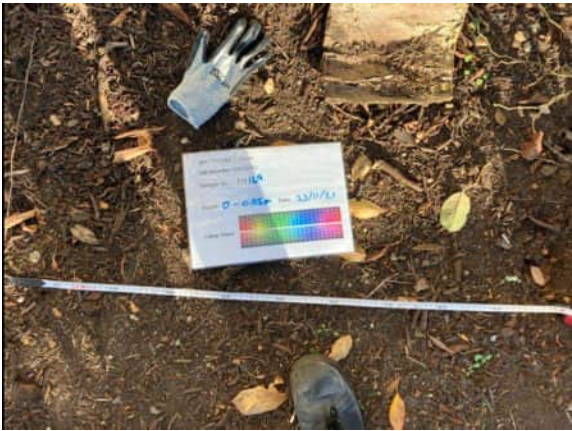
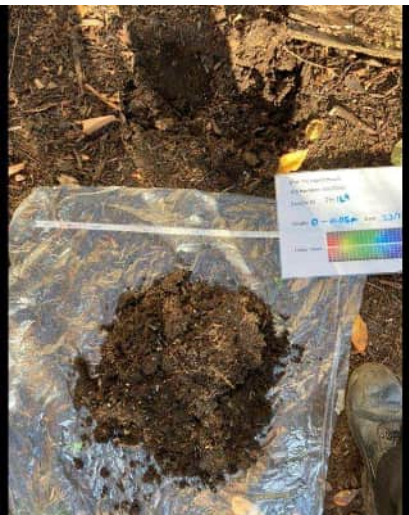
Photo 1: Location prior to sampling	Photo 2: Excavated soil ready for sampling (0-0.05m)

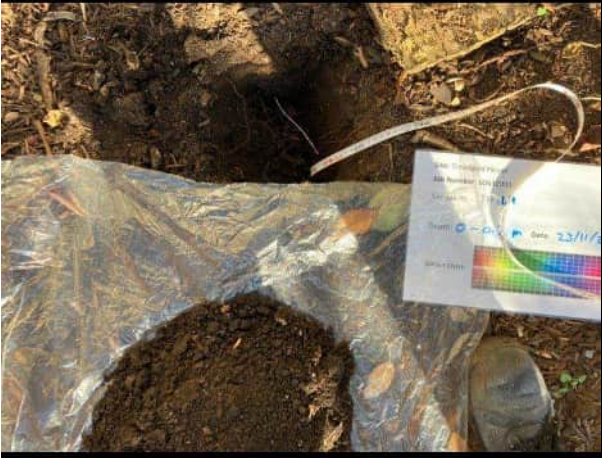
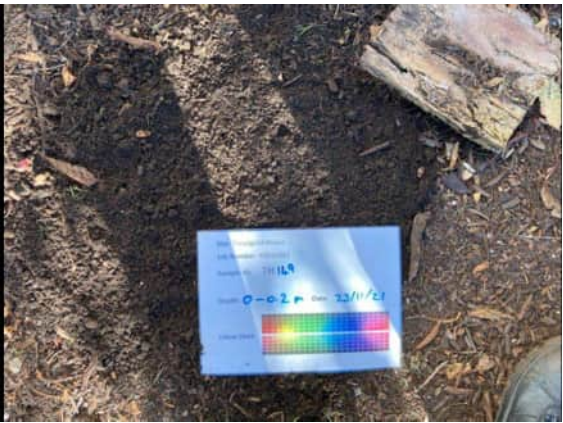
Photo 3: Excavated soil ready for sampling (0.1-0.2m) (depth labelled incorrectly)	Photo 4: Reinstated location

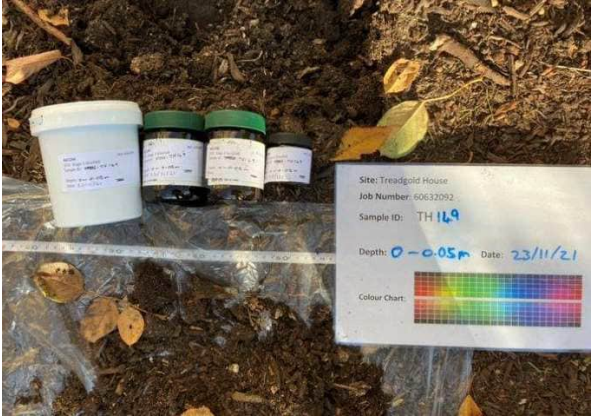
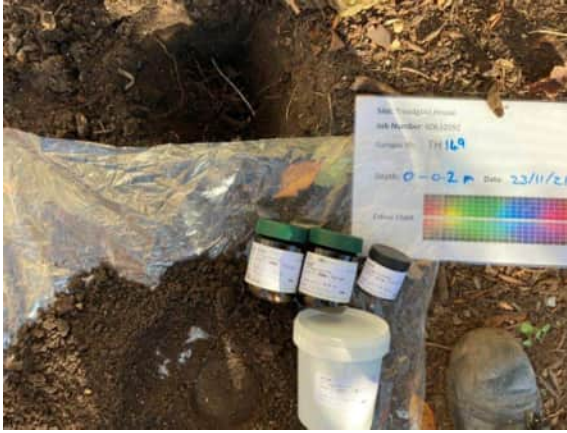
Date / Time	23 November 2021, 11:30	Sampling Area	Treadgold House
<p>Photo 5: Sample collected in containers (0-0.05m)</p>		<p>Photo 6: Sample collected in containers (0.1-0.2m)</p>
