Appendix D Walkover Photolog and Sample Logs & Photos

Treadgold House and Avondale Park
Gardens Walkover Survey

Project No.
60632092

Grenfell Potential Land Contamination: Stage 2 Sampling Notes and Photographic Record

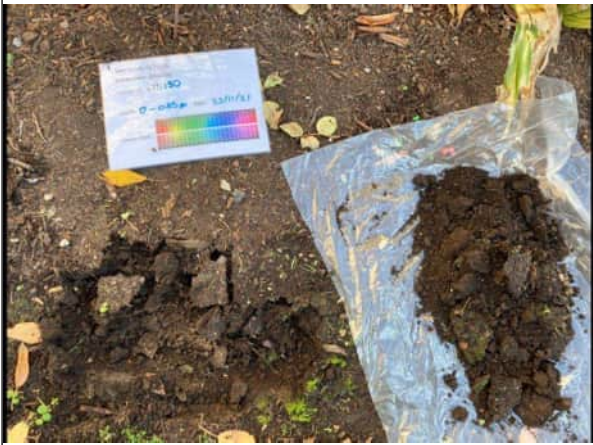
Sample Log:	<p>0 – 0.1m: TOPSOIL. Dark brown sandy, gravelly SILT. Gravel is subangular, fine to medium of concrete and flint. Plastic pieces were observed <1 cm. Wood chips were also present No visual or olfactory evidence of contamination.</p> <p>0.1 – 0.2m: As above with an increased sand content. No visual or olfactory evidence of contamination.</p>
Observed CoPC:	None
Notes:	<p>Bare soil</p> <p>Testing scheduled:</p> <p>0-0.05m – Lead & asbestos</p> <p>0.1-0.2m – Lead</p>

Photo 1: Location prior to sampling	Photo 2: Excavated soil ready for sampling (0-0.05m)

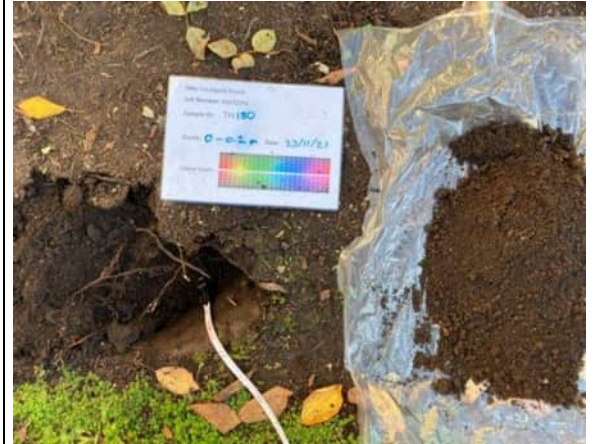
Photo 3: Excavated soil ready for sampling (0.1-0.2m) (error on photo board, sample depth was 0.1-0.2m)	Photo 4: Reinstated location

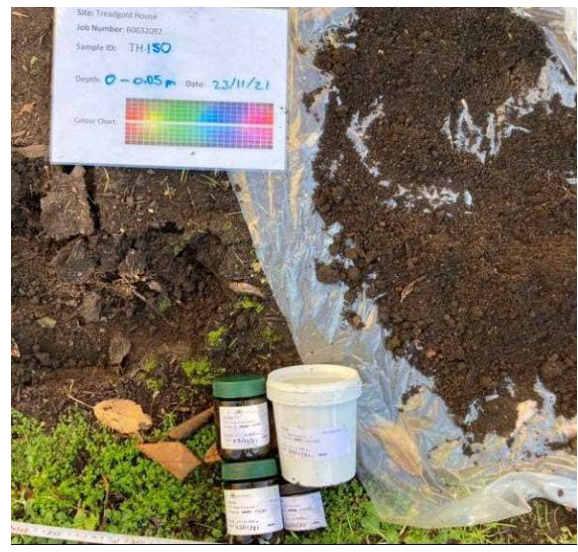
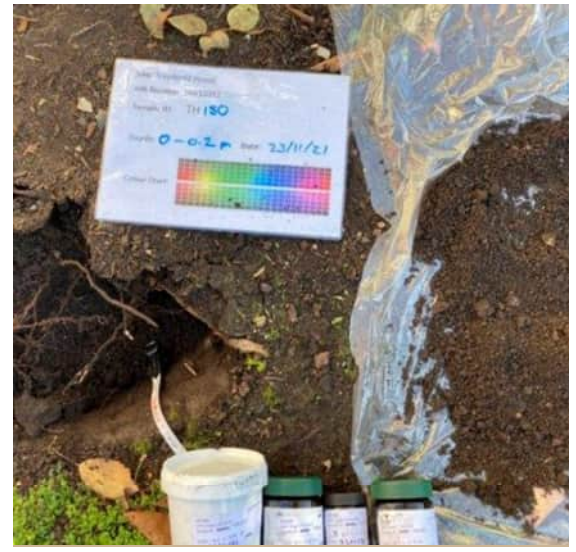
Date / Time	23 November 2021, 10:50	Sampling Area	Treadgold House
Photo 5: Sample collected in containers (0-0.05m)		Photo 6: Sample collected in containers (0.1-0.2m) (error on photo board, sample depth was 0.1-0.2m)

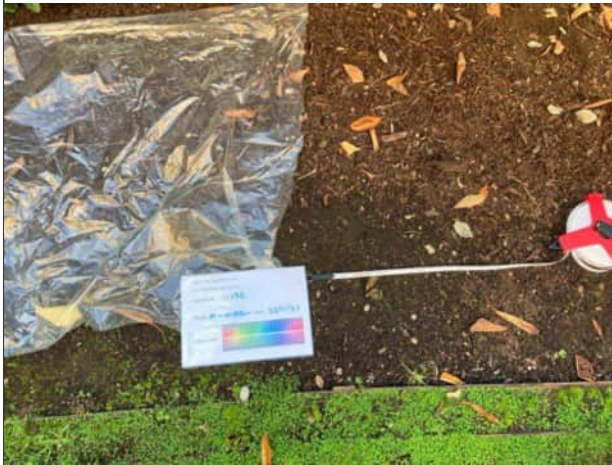
Sample Log:	0 – 0.1m: TOPSOIL. Dark brown sandy, gravelly, silty CLAY. Gravel is fine, subrounded flint. No visual or olfactory evidence of contamination. Leaves and woodchip at surface. 0.1 – 0.2m: As above with the inclusion of ceramic fragments and pockets of loose orange sand. Sand is coarse.
Observed CoPC:	None
Notes:	Turf Testing scheduled: 0-0.05m – Lead & asbestos 0.1-0.2m – Lead

<p>Photo 1: Location prior to sampling</p>

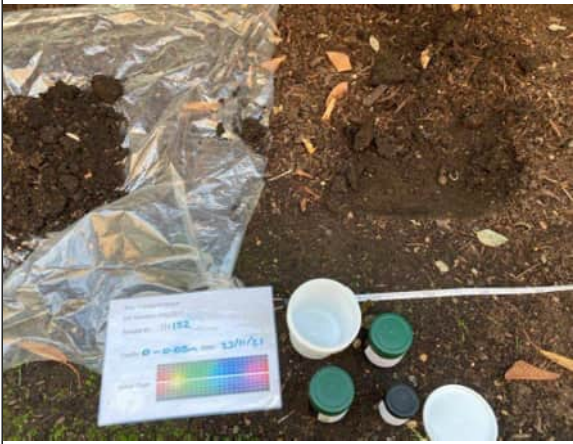
<p>Photo 2: Excavated soil ready for sampling (0-0.05m)</p>

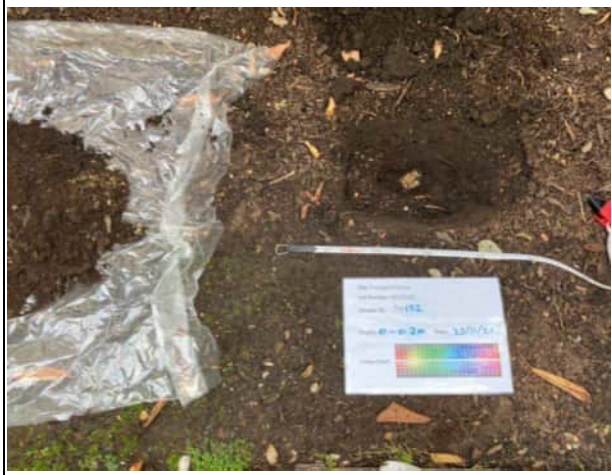
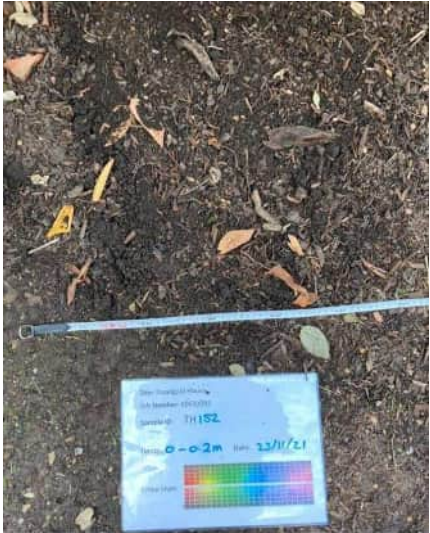
<p>Photo 3: Excavated soil ready for sampling (0.1-0.2m) (error on photo board, sample depth was 0.1-0.2m)</p>	<p>Photo 4: Reinstated location</p>

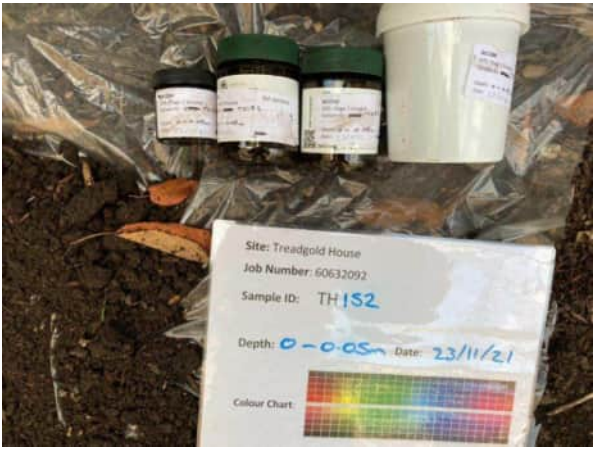
Date / Time	23 November 2021, 08:30	Sampling Area	Treadgold House
<p>Photo 5: Sample collected in containers (0-0.05m)</p>		<p>Photo 6: Sample collected in containers (0.1-0.2m) (error on photo board, sample depth was 0.1-0.2m)</p>

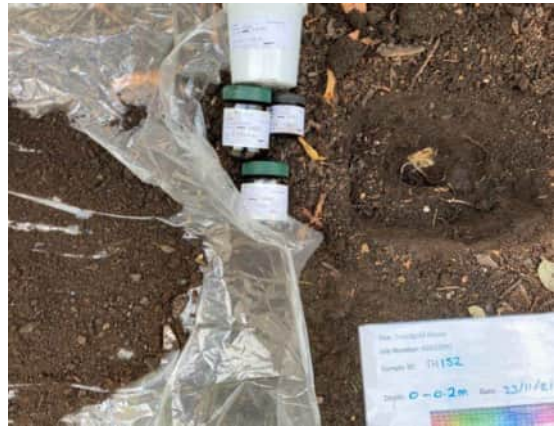
<p>Site: Treadgold House Job Number: 60632092 Sample ID: TH152 Depth: 0-0.05m Date: 23/11/21 Colour Chart</p>

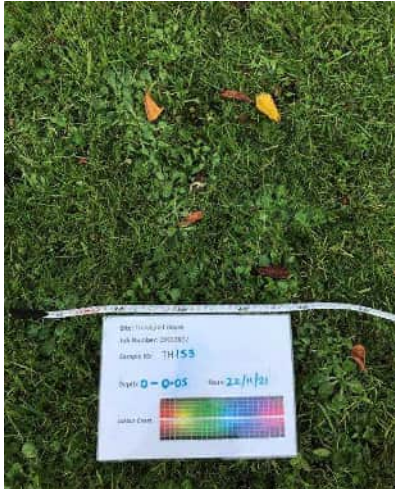
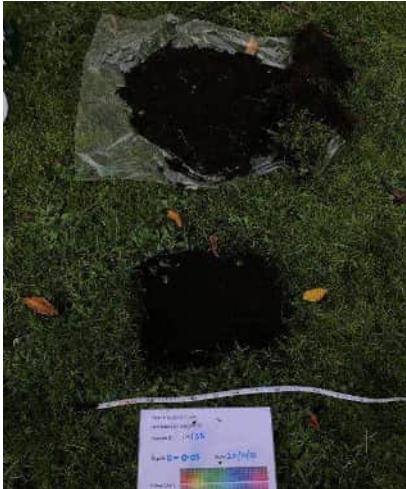
Sample Log:	0 – 0.2m: TOPSOIL. Dark brown slightly sandy, silty CLAY. With occasional fine, subrounded gravel of flint. One piece of plastic was observed (<1 cm). Sample contained abundant rootlets. No visual or olfactory evidence of contamination.
Observed CoPC:	None
Notes:	Turf Testing scheduled: 0-0.05m – Lead & asbestos 0.1-0.2m – Lead

Photo 1: Location prior to sampling	Photo 2: Excavated soil ready for sampling (0-0.05m)

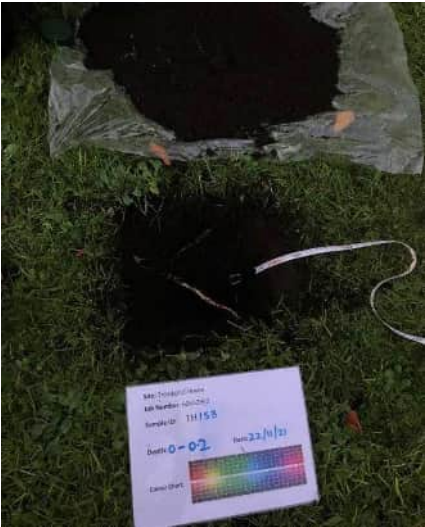
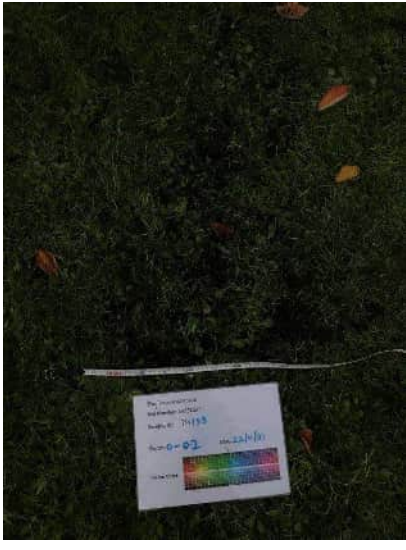
Photo 3: Excavated soil for sampling (0.1-0.2m) (error on photo board, sample depth was 0.1-0.2m)	Photo 4: Reinstated location

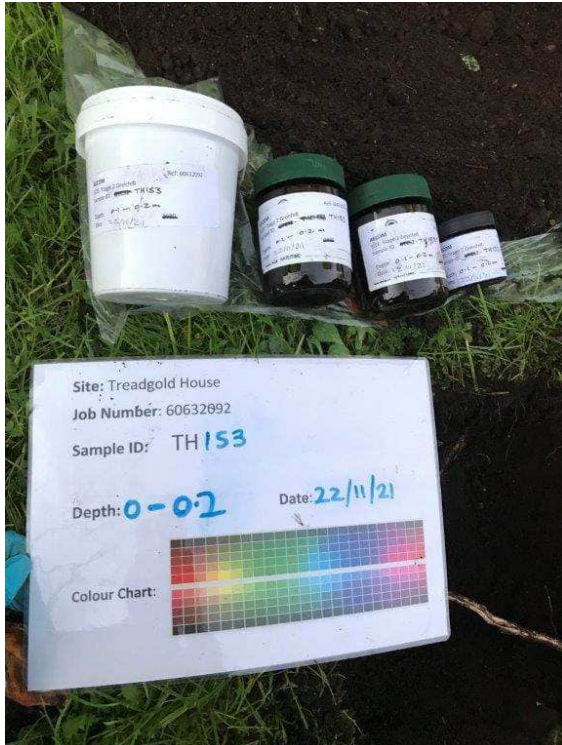
<p>Site: Treadgold House Job Number: 60632092 Sample ID: TH153 Depth: 0-0.05 Date: 22/11/21 Colour Chart:</p>

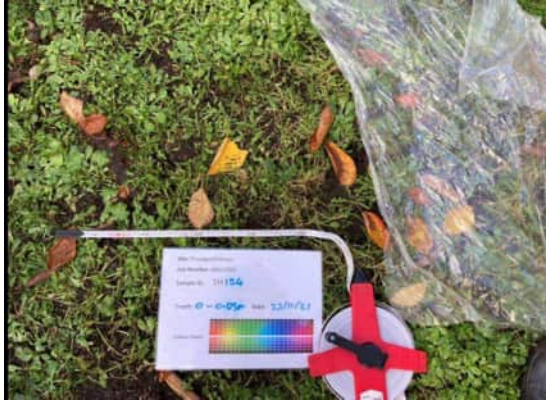
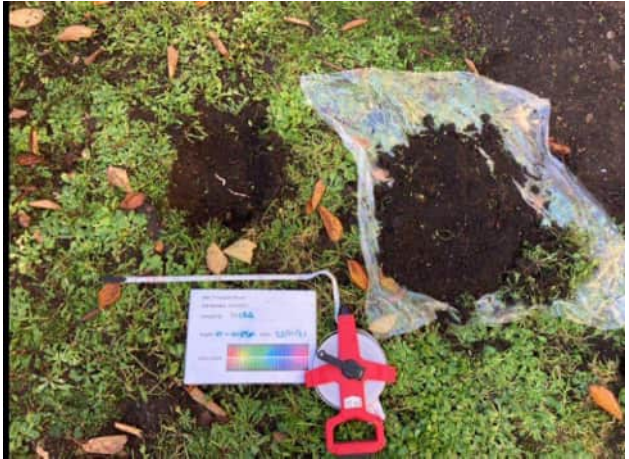
Sample Log:	0 – 0.2m: TOPSOIL. Dark brown, soft slightly sandy, gravelly, clayey SILT. Gravel is fine, subangular to subrounded of brick, sandstone and flint. Rootlets are present. No visual or olfactory evidence of contamination. Below 0.1m: As above with up to medium angular gravel of flint.
Observed CoPC:	None
Notes:	Turf Testing scheduled: 0-0.05m – Lead & asbestos 0.1-0.2m – Lead

Photo 1: Location prior to sampling	Photo 2: Excavated soil for sampling (0-0.05m)

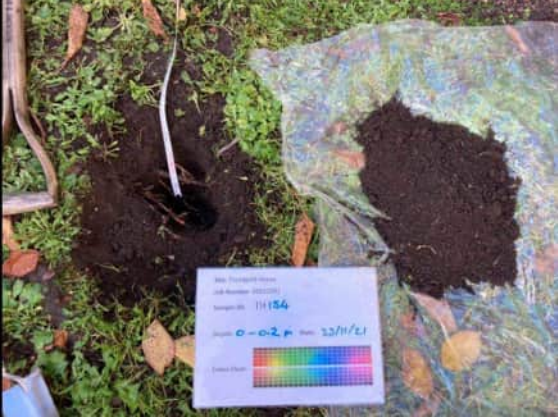
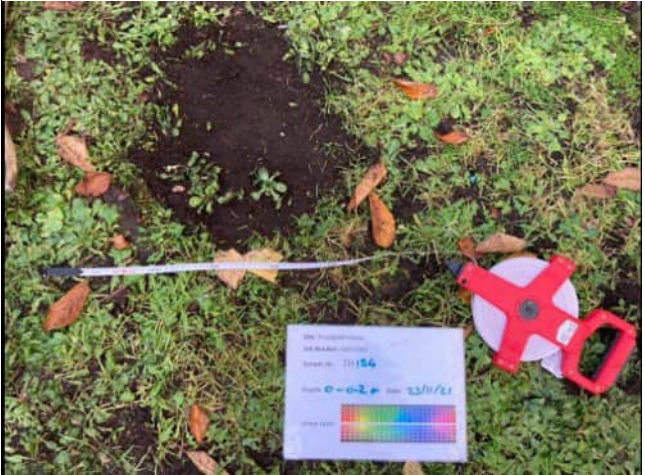
Photo 3: Excavated soil for sampling (0.1-0.2m) (error on photo board, sample depth was 0.1-0.2m)	Photo 4: Reinstated location

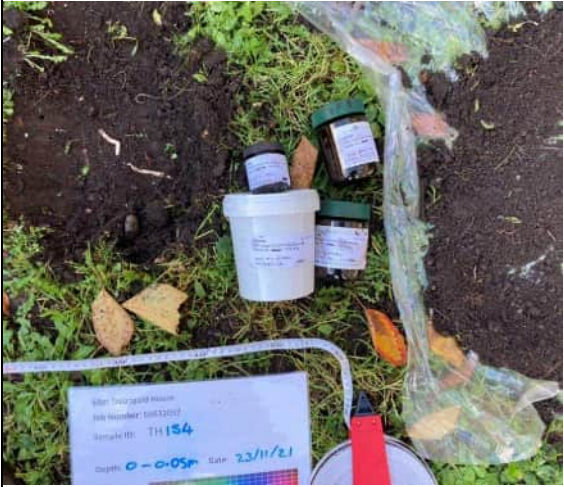
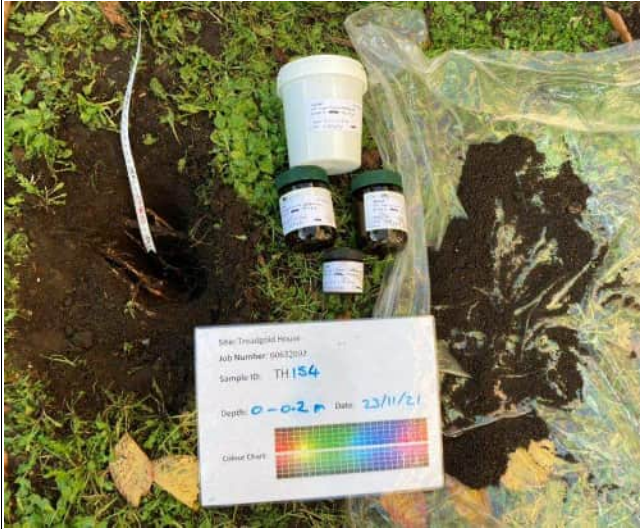
Date / Time	26 November 2021, 09:30	Sampling Area	Treadgold House
Photo 5: Sample collected in containers (0-0.05m)		Photo 6: Sample collected in containers (0.1-0.2m) (error on photo board, sample depth was 0.1-0.2m)

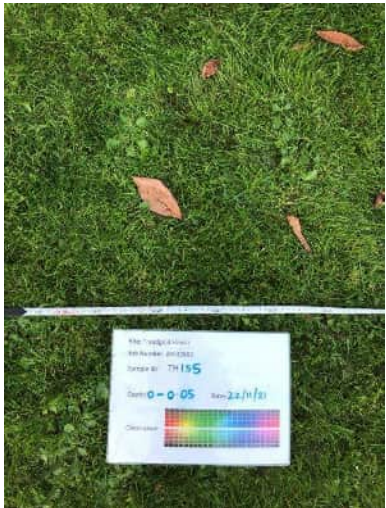
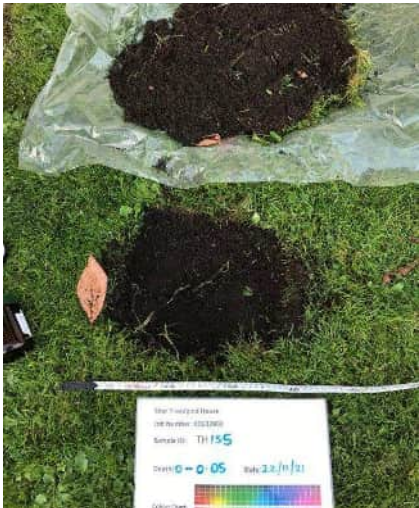
Sample Log:	0 – 0.1m: TOPSOIL. Dark brown firm, slightly sandy, silty CLAY. Occasional medium, rounded to subrounded gravel of concrete and flint. 0.1 – 0.2m: Occasional cobbles of concrete.
Observed CoPC:	None
Notes:	Turf Testing scheduled: 0-0.05m – lead, asbestos & lead bioaccessibility 0.1-0.2m - 13 metals (including lead) & lead bioaccessibility

Photo 1: Location prior to sampling	Photo 2: Excavated soil ready for sampling (0-0.05m)

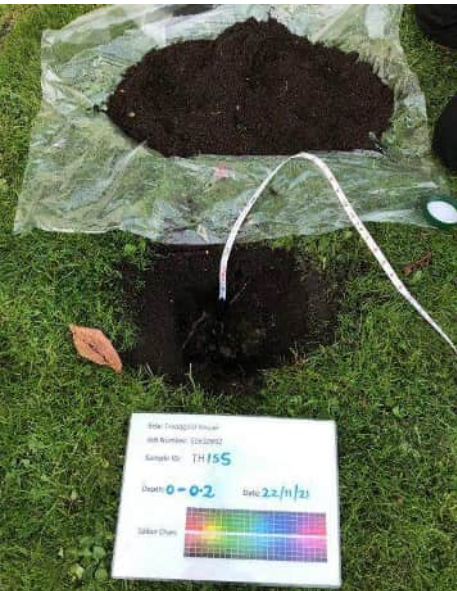
Photo 3: Excavated soil ready for sampling (0.1-0.2m) (error on photo board, sample depth was 0.1-0.2m)	Photo 4: Reinstated location

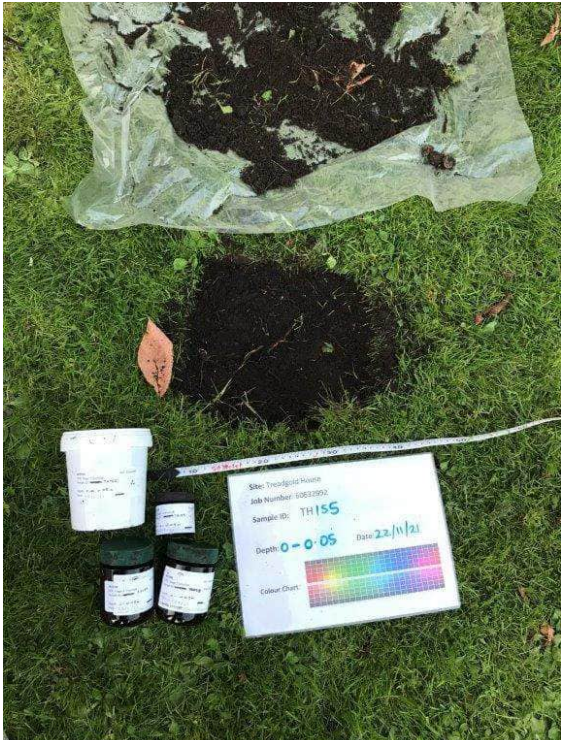
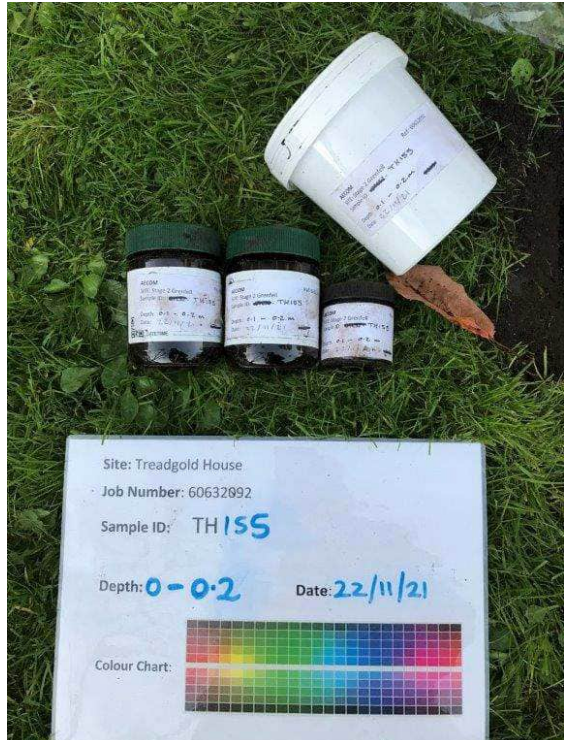
Date / Time	22 November 2021, 15:33	Sampling Area	Treadgold House
Photo 5: Sample collected in containers (0-0.05m)		Photo 6: Sample collected in containers (0.1-0.2m) (error on photo board, sample depth was 0.1-0.2m)

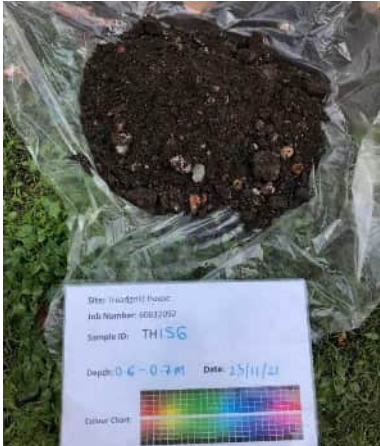
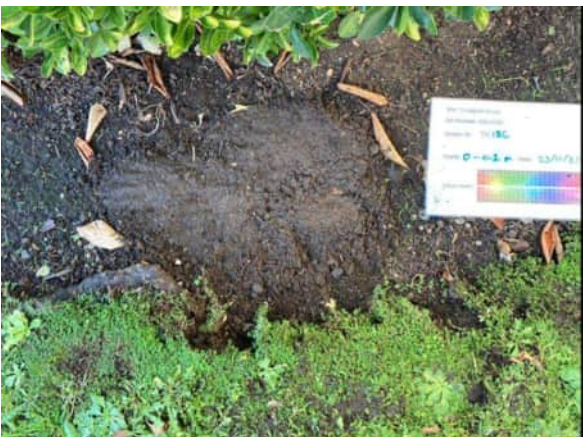
Sample Log:	<p>0 – 0.2m: TOPSOIL. Dark brown gravelly SILT. Gravel is fine to medium, mostly subangular of ceramic, brick, and slate.</p> <p>0.2 – 0.7m: MADE GROUND. Dark brown gravelly, silty CLAY. Gravel is fine to coarse, angular to subrounded, of brick, flint and concrete. Frequent cobbles of marble, brick and concrete. No visual or olfactory evidence of contamination.</p> <p>0.7m – Concrete slab/ blocks reached.</p>
Observed CoPC:	None
Notes:	<p>Bare soil</p> <p>Testing scheduled:</p> <p>0-0.05m – Lead</p> <p>0.1-0.2m – Lead & asbestos</p> <p>0.3-0.4m – Lead</p> <p>0.6-0.7m - Lead</p>

Date / Time	23 November 2021 15:15	Sampling Area	Treadgold House
Photo 5: Excavated soil for sampling (0.6-0.7m)		Photo 6: Reinstated location

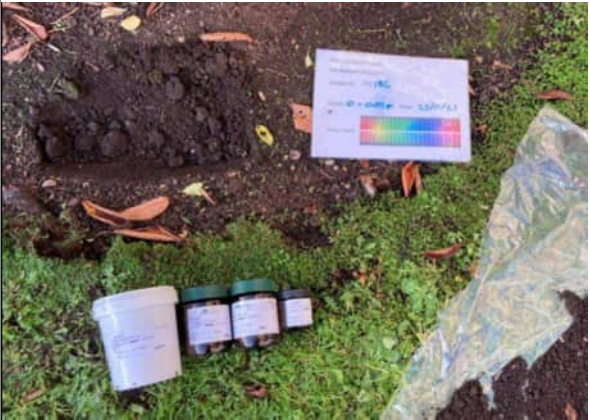
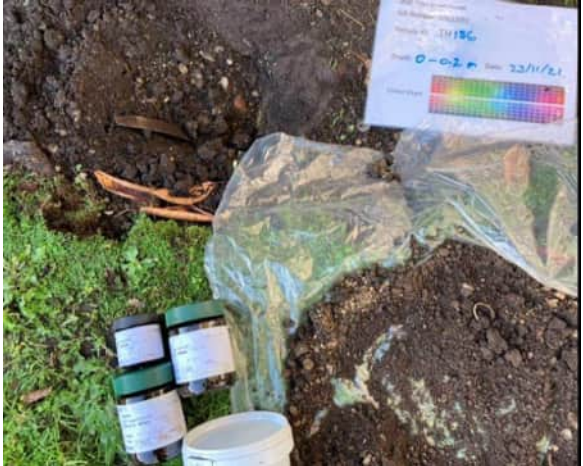
Photo 7: Sample collected in containers (0-0.05m)		Photo 8: Sample collected in containers (0.1-0.2m) (error on photo board, sample depth was 0.1-0.2m)

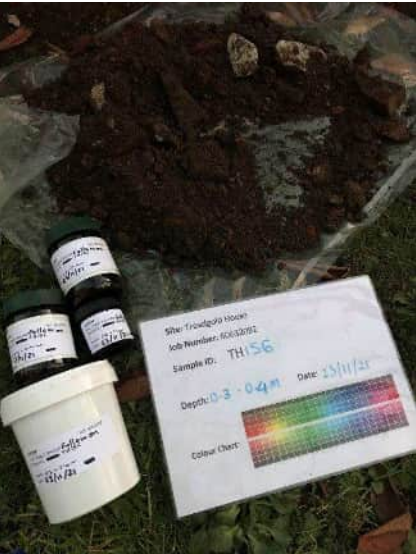
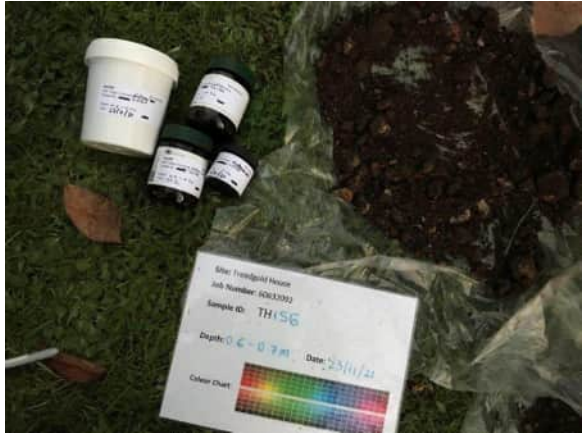
Photo 9: Sample collected in containers (0.3-0.4m)		Photo 10: Sample collected in containers (0.6-0.7m)

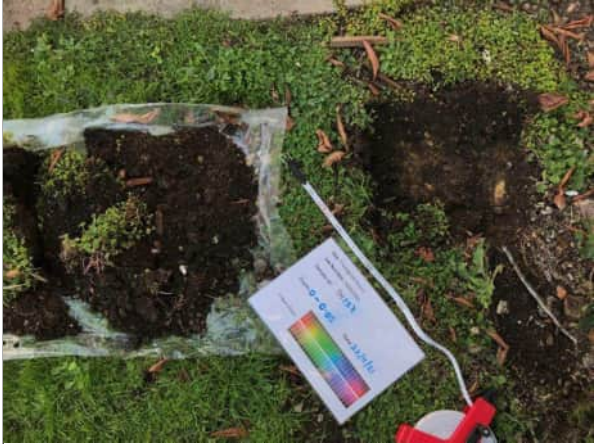
Sample Log:	<p>0 – 0.1m: TOPSOIL. Dark brown loose / soft very sandy, gravelly SILT. Gravel is fine to coarse, subangular of concrete, slate, brick and flint. Half a cable tie was observed.</p> <p>0.1 – 0.2m: TOPSOIL. Dark brown loose, gravelly, silty SAND. Gravel is coarse, subangular to subrounded of concrete, brick and flint. Occasional cobbles of concrete and brick.</p>
Observed CoPC:	None
Notes:	<p>Turf</p> <p>Testing scheduled:</p> <p>0-0.05m – Lead & asbestos</p> <p>0.1-0.2m – Lead</p>

Photo 1: Location prior to sampling	Photo 2: Excavated soil for sampling (0-0.05m)

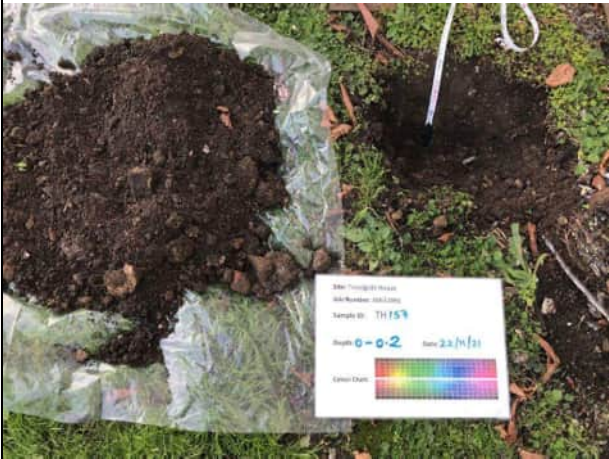
Photo 3: Excavated soil for sampling (0.1-0.2m) (error on photo board, sample depth was 0.1-0.2m)	Photo 4: Reinstated location

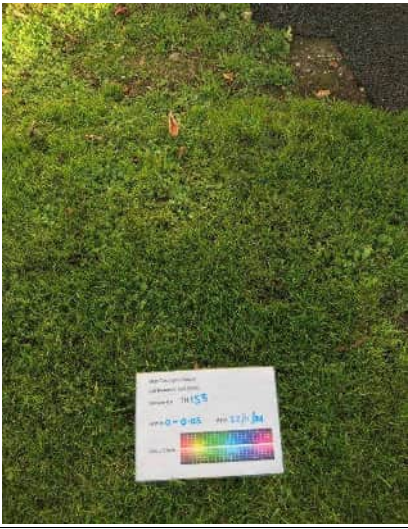
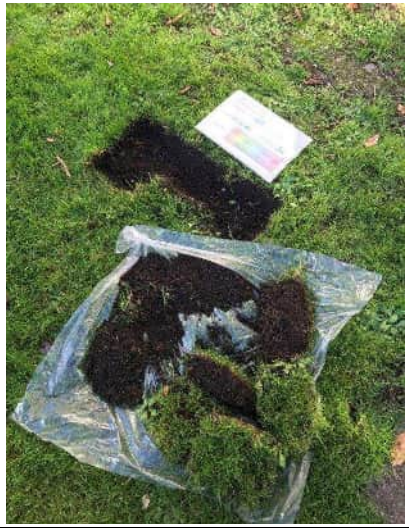
Sample Log:	0 – 0.1m: TOPSOIL. Dark brown loose sandy SILT. Rare gravel is present as fine, subrounded flint and brick. No visual or olfactory evidence of contamination. One fragment of green glass (~1cm). 0.1 – 0.2m: TOPSOIL. As above with fragments of clear glass and 2x 5cm long ceramic fragments.
Observed CoPC:	None
Notes:	Turf Testing scheduled: 0-0.05m – Lead & asbestos 0.1-0.2m – Lead

Photo 1: Location prior to sampling	Photo 2: Excavated soil for sampling (0-0.05m)

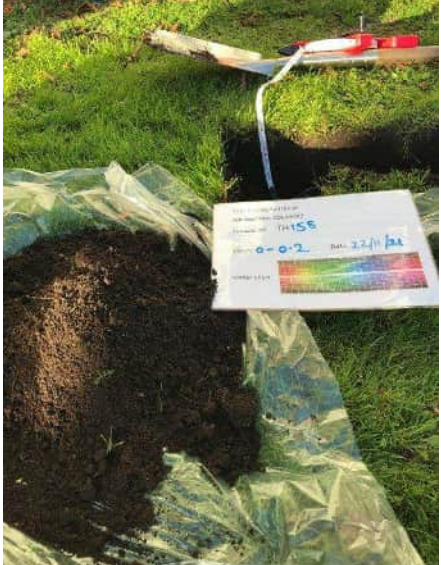
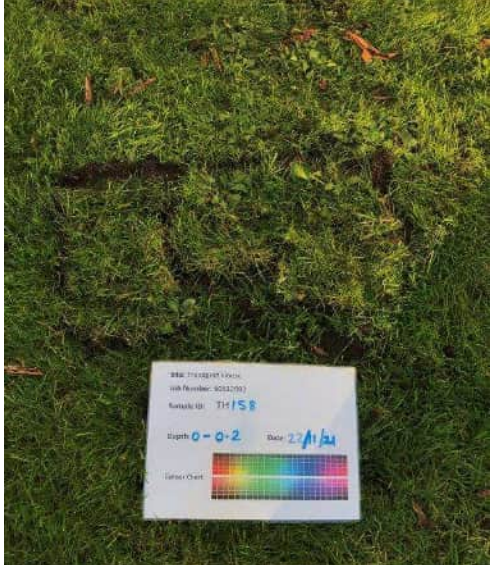
Photo 3: Excavated soil for sampling (0.1-0.2m) (error on photo board, sample depth was 0.1-0.2m)	Photo 4: Reinstated location

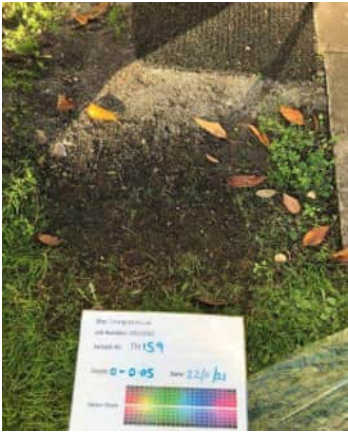
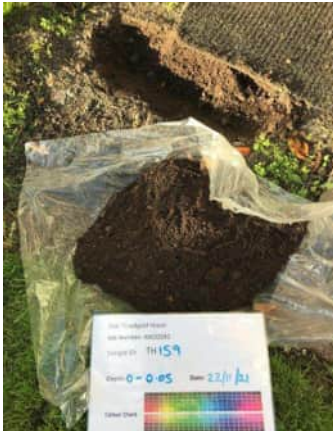
Sample Log:	<p>0 – 0.1m: TOPSOIL. Soft/ loose brown slightly gravelly sandy SILT. Gravel is fine to medium, angular of concrete, brick and. Fragments of clear glass. Occasional rootlets.</p> <p>0.1 – 0.2m: As above with the occasional cobble of concrete and coarse gravel of subrounded flint.</p>
Observed CoPC:	None
Notes:	<p>Partial turf (patchy grass, predominantly weeds)</p> <p>Testing scheduled:</p> <p>0-0.05m – 13 metals (including lead) and asbestos</p> <p>0.1-0.2m – Lead</p>

Photo 1: Location prior to sampling	Photo 2: Excavated soil ready for sampling (0-0.05m)

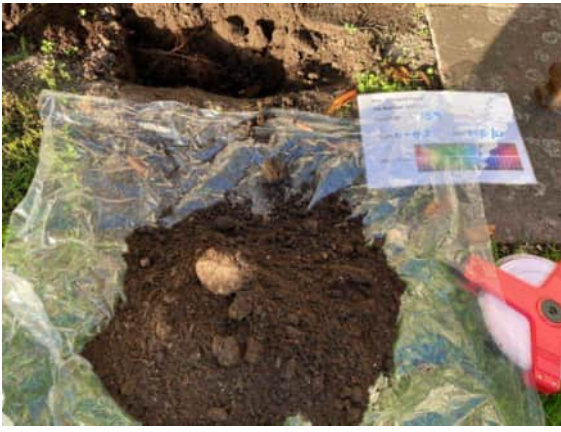
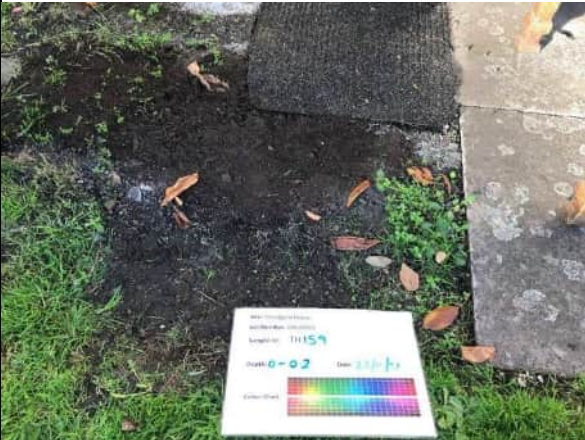
Photo 3: Excavated soil ready for sampling (0.1-0.2m) (error on photo board, sample depth was 0.1-0.2m)	Photo 4: Reinstated location

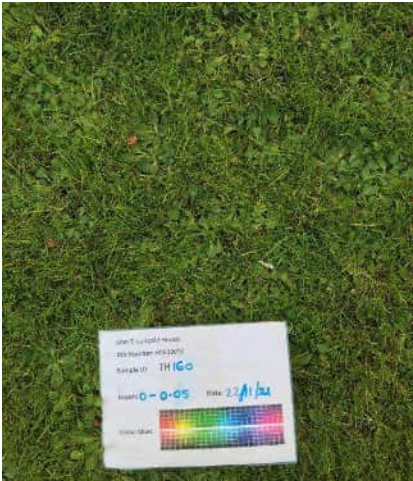
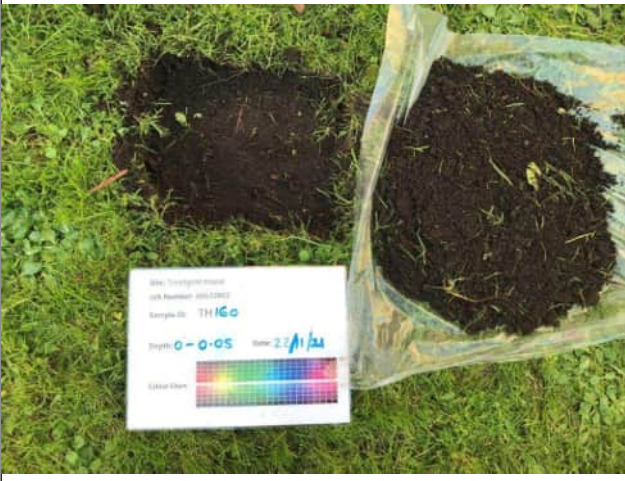
Sample Log:	0 – 0.1m: TOPSOIL. Dark brown soft / loose, sandy silty CLAY. Occasional very fine subangular gravel of brick and flint. No visual or olfactory evidence of contamination. 0.1 – 0.2m: As above with an increased sand content and with rare cobbles of flint.
Observed CoPC:	None
Notes:	Turf Testing scheduled: 0-0.05m – Lead & asbestos 0.1-0.2m – Lead

Photo 1: Location prior to sampling	Photo 2: Excavated soil ready for sampling (0-0.05m)

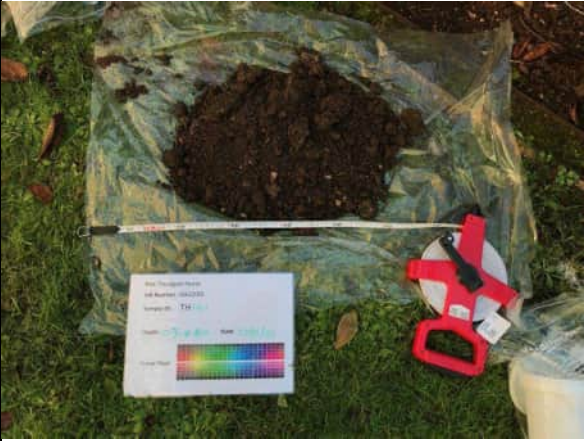
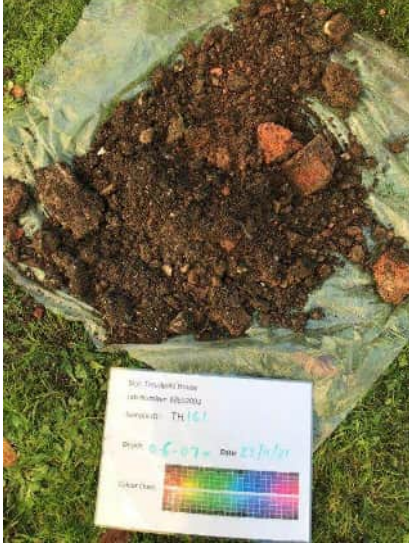
Sample Log:	<p>0 – 0.3m: TOPSOIL. Dark brown sandy, gravelly, clayey SILT. Gravel is fine, subangular of brick and concrete. No visual or olfactory evidence of contamination.</p> <p>0.3 – 0.9m: MADE GROUND. Dark brown sandy, gravelly SILT. Containing pockets of clay (soft to firm). Gravel is medium to coarse of brick and concrete. Cobbles of concrete and brick. No visual or olfactory evidence of contamination.</p> <p>0.9m: Concrete slab met and unable to continue excavation.</p>
Observed CoPC:	None
Notes:	<p>Turf</p> <p>Testing scheduled:</p> <p>0-0.05m – Asbestos, 13 metals (including Lead) & PAHs</p> <p>0.3-0.4m – 13 metals (including Lead) & PAHs. DUP08 for lead</p> <p>0.6-0.7m – 13 metals (including Lead) & PAHs</p>

Photo 3: Excavated soil for sampling (0.3-0.4m)	Photo 4: Excavated soil for sampling (0.6-0.7m)

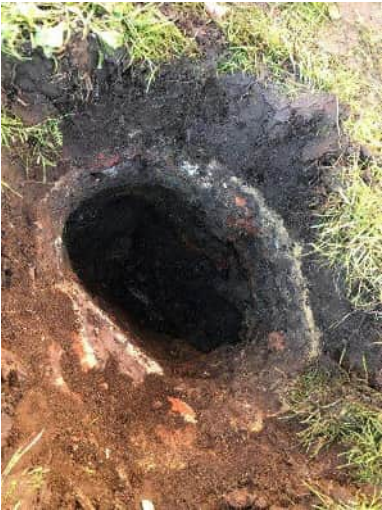
Date / Time	23 November 2021, 09:55	Sampling Area	Treadgold House
<p>Photo 5: Birds eye view of the concrete obstruction preventing further excavation</p>	<p>Photo 6: Reinstated location</p>

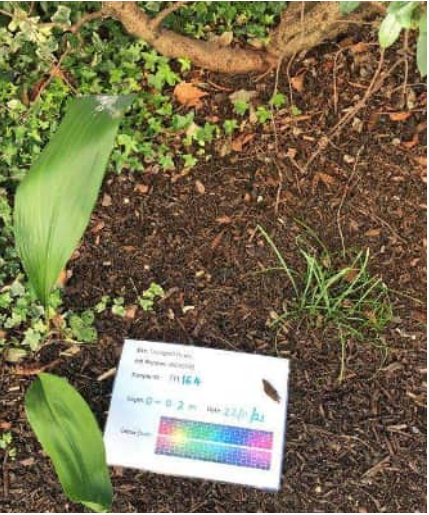
<p>Photo 1: Location prior to sampling</p>

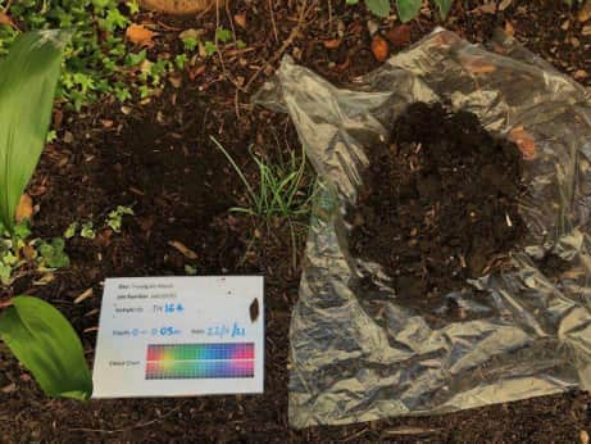
Sample Log:	0 – 0.1m: TOPSOIL. Dark brown slightly sandy, CLAY. Occasional gravel. Gravel is fine to medium, angular to subrounded of flint and brick. Occasional glass fragments (<2 cm – old, rounded). No visual or olfactory evidence of contamination. Fragments of white and black fabric and occasional wood chippings. 0.1 – 0.2m: As above but silty CLAY with the occasional coarse gravel of brick.
Observed CoPC:	None
Notes:	Bare soil Testing scheduled: 0-0.05m – Lead & asbestos 0.1-0.2m – 13 metals (including lead)

<p>Photo 2: Excavated soil ready for sampling (0-0.05m)</p>

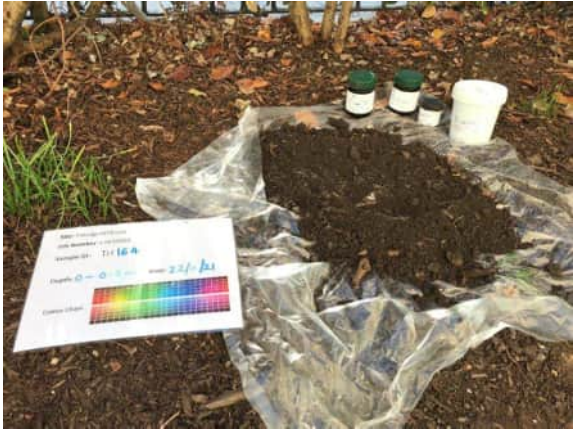
<p>Photo 3: Excavated soil ready for sampling (0.1-0.2m) (error on photo board, sample depth was 0.1-0.2m)</p>

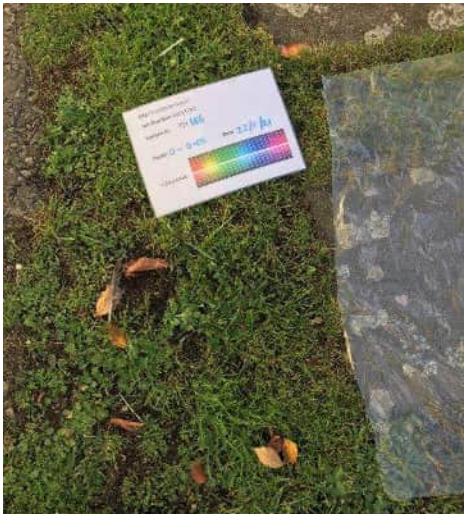
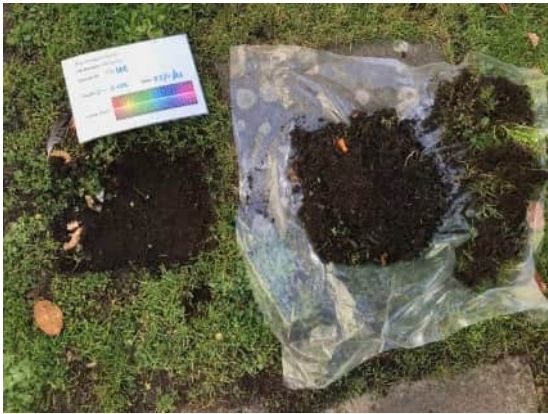
Sample Log:	0 – 0.1m: TOPSOIL. Dark brown slightly sandy CLAY. Rare medium subangular gravel was observed of brick and flint. Ceramic pot fragment present <5 cm and a metal can top. Piece of plastic (<1cm). 0.1 – 0.2m: As above with no gravel.
Observed CoPC:	None
Notes:	Turf Testing scheduled: 0-0.05m – Lead & asbestos 0.1-0.2m – Lead

Photo 1: Location prior to sampling	Photo 2: Excavated soil for sampling (0-0.05m)

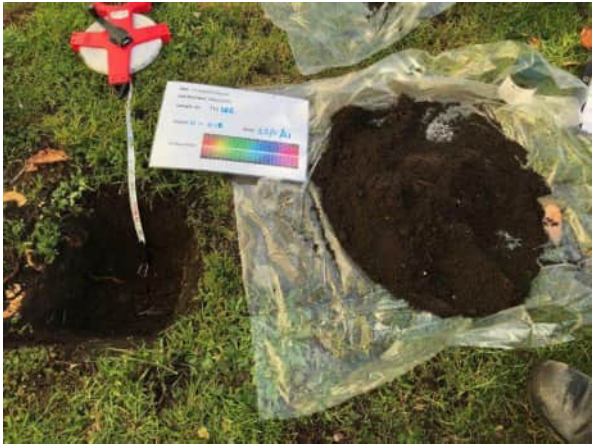
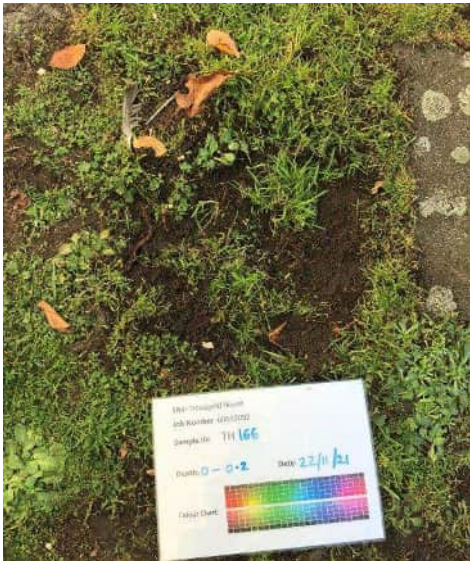
Photo 3: Excavated soil for sampling (0.1-0.2m) (error on photo board, sample depth was 0.1-0.2m)	Photo 4: Reinstated location

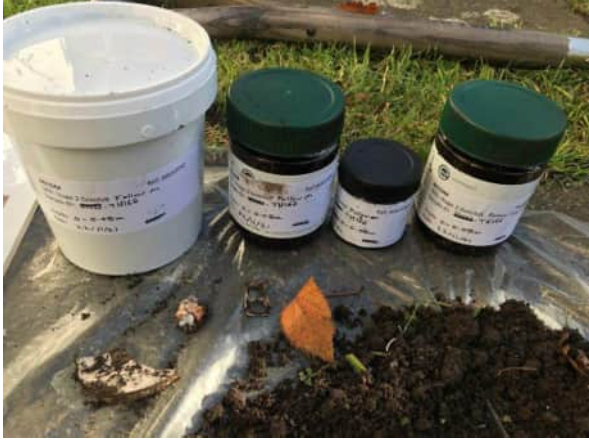
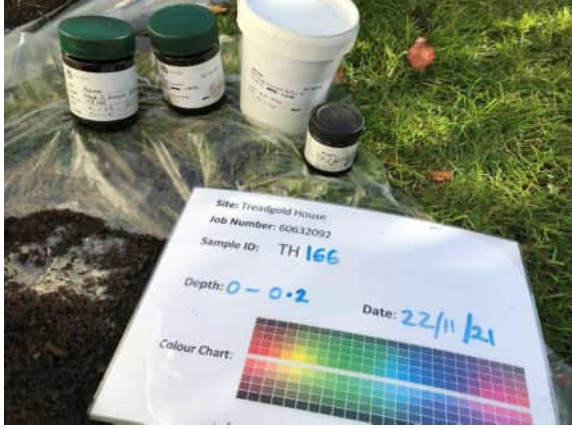
Date / Time	22 November 2021, 10:50	Sampling Area	Treadgold House
Photo 5: Sample collected in containers (0-0.05m)		Photo 6: Sample collected in containers (0.1-0.2m) (error on photo board, sample depth was 0.1-0.2m)

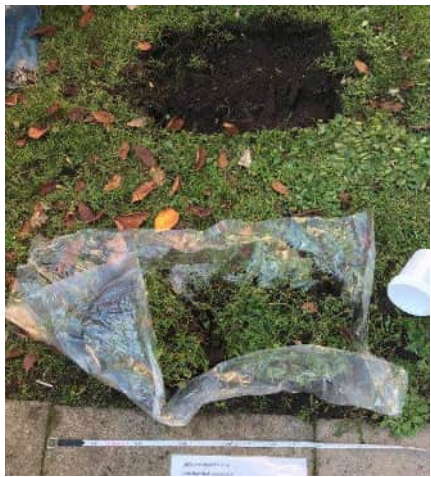
Photo 1: Location prior to sampling	Photo 2: Excavated soil ready for sampling (0-0.05m)
Photo unavailable

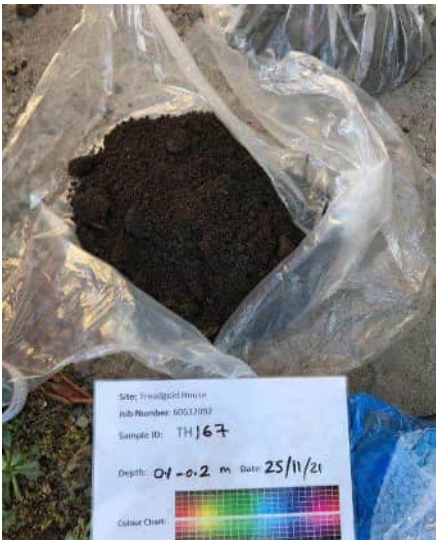
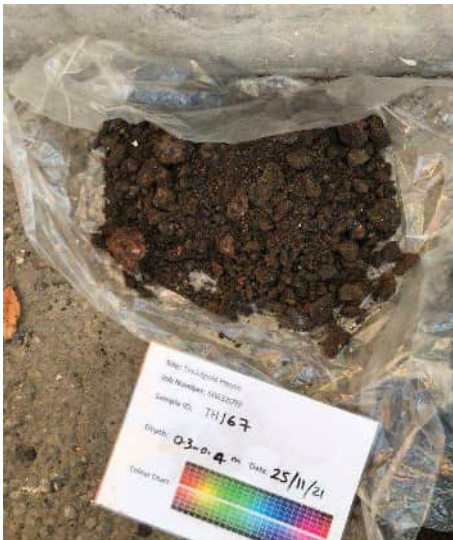
Sample Log:	0 – 0.2m: TOPSOIL. Dark brown loose sandy, clayey SILT. Fragments of plastic and ceramic were observed and occasional fine, subangular gravel of flint. No visual or olfactory evidence of contamination. 0.2 – 0.7m: MADE GROUND. Dark brown sandy gravelly CLAY. Gravel is fine to coarse, angular to subrounded of flint, concrete and brick. Occasional cobbles of brick and concrete are present. Fragment of ceramic (~3cm). Below 0.6m frequent cobbles of brick, concrete and slate are present.
Observed CoPC:	None
Notes:	Turf Testing scheduled: 0-0.05m – 9 metals (including lead) 0.1-0.2m – Lead 0.3-0.4m – Lead 0.6-0.7m – Lead & asbestos

Photo 3: Excavated soil ready for sampling (0.1-0.2m)	Photo 4: Excavated soil ready for sampling (0.3-0.4m)

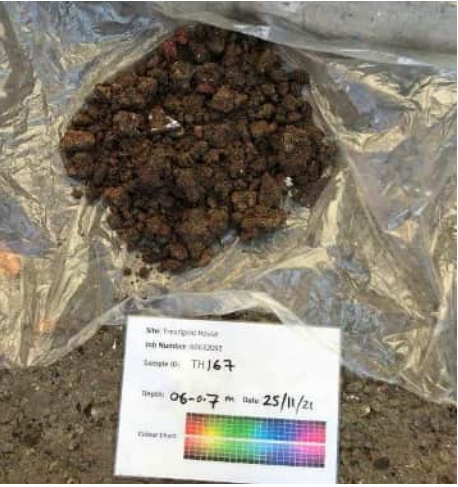
Date / Time	25 November 2021, 09:00	Sampling Area	Treadgold House
Photo 5: Excavated soil for sampling (0.6-0.7m)		Photo 6: Reinstated location

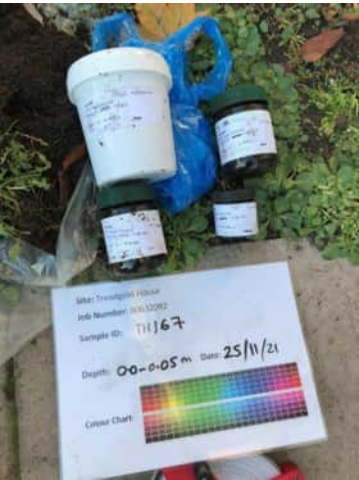
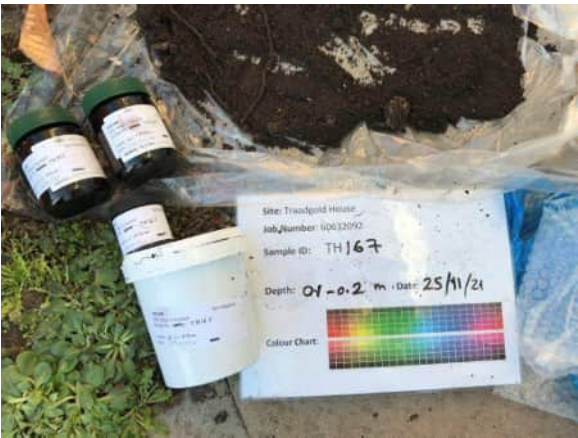
<p style="text-align: center;">Photo unavailable</p>	
Photo 7: Sample collected in containers (0-0.05m)		Photo 8: Sample collected in containers (0.1-0.2m)

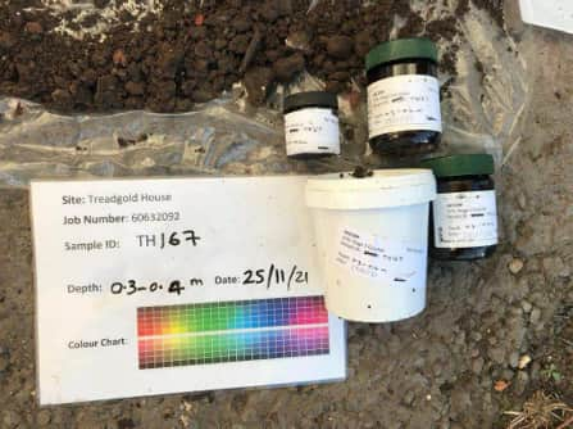
Photo 9: Sample collected in containers (0.3-0.4m)		Photo 10: Sample collected in containers (0.6-0.7m)

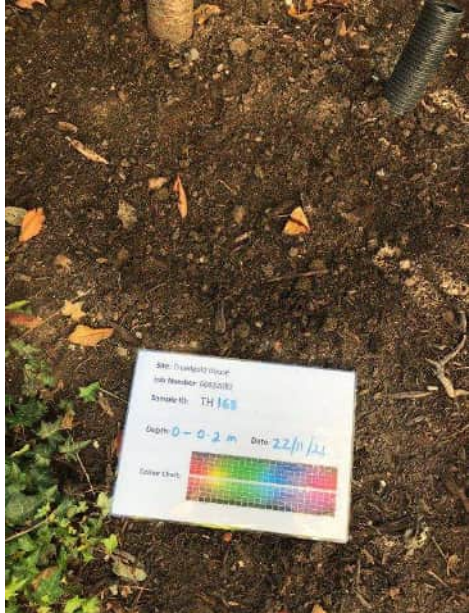
Photo 3: Excavated soil for sampling (0.1-0.2m) (error on photo board – sample depth is 0.1-0.2m)	Photo 4: Reinstated location

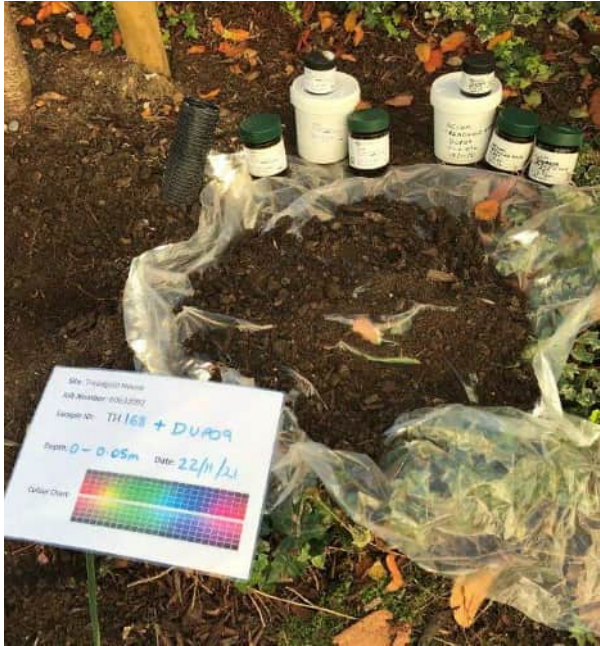
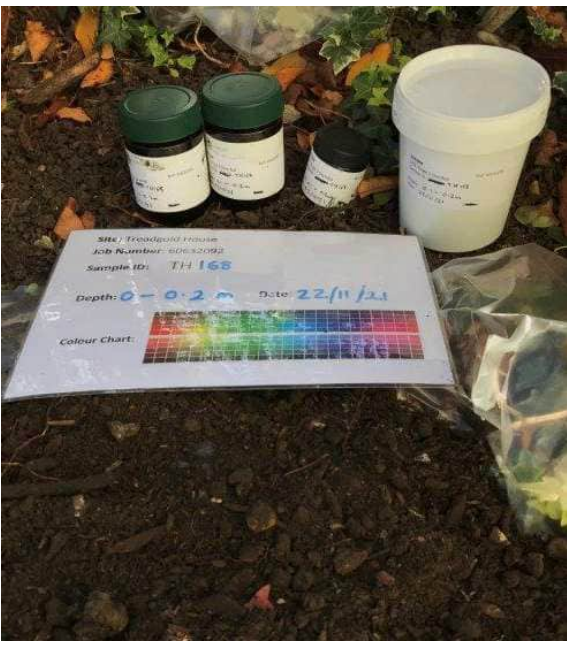
Date / Time	22 November 2021, 09:37	Sampling Area	Treadgold House
Photo 5: Sample collected in containers (0-0.05m + DUP09)		Photo 6: Sample collected in containers (0.1-0.2m) (error on photo board – sample depth is 0.1-0.2m)

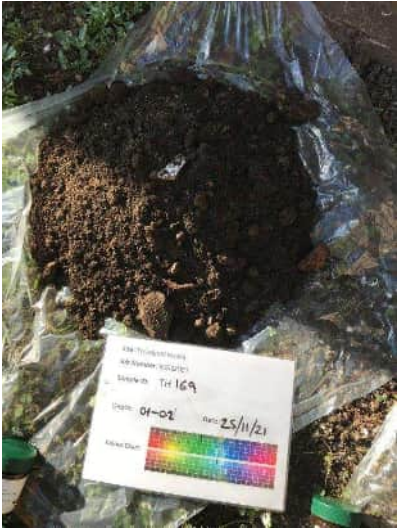
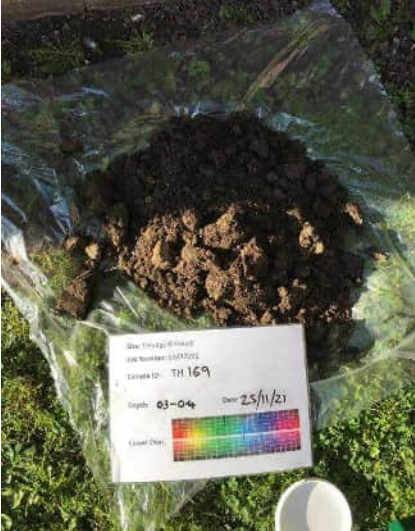
Sample Log:	0 – 0.3m: TOPSOIL. Dark brown clayey, sandy SILT with rare gravel. The gravel is subangular and coarse of flint. Occasional cobbles of concrete and brick. No visual or olfactory evidence of contamination. Pieces of white tile. 0.3 – 0.4m MADE GROUND. Light brown to dark brown silty gravelly SAND. With pockets of firm grey clay, with organic material observed within the clay. Gravel is fine to coarse, subangular of brick and flint.
Observed CoPC:	None
Notes:	Partial turf Testing scheduled: 0-0.05m – 9 metals (including lead) and lead bioaccessibility 0.1-0.2m – Lead 0.3-0.4m – Lead & asbestos

Photo 3: Excavated soil for sampling (0.1-0.2m)	Photo 4: Excavated soil for sampling (0.3-0.4m)

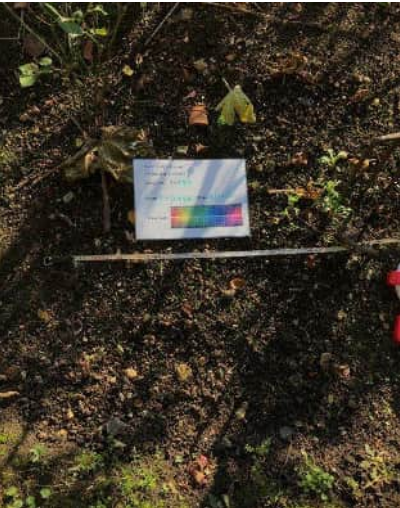
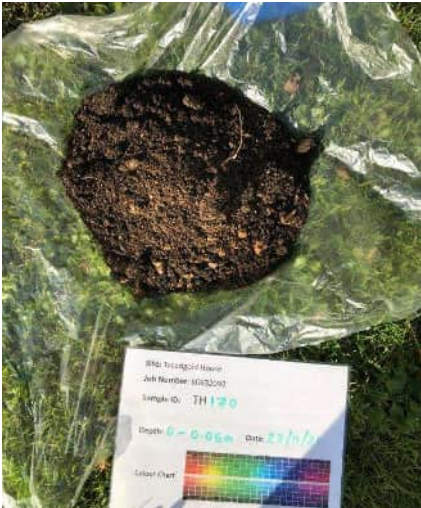
Sample Log:	<p>0 – 0.1m: TOPSOIL. Dark brown sandy gravelly SILT. Rounded gravel. Glass fragments <4 cm. Ceramic fragments. No visual or olfactory evidence of contamination.</p> <p>0.1 – 0.6m: MADE GROUND. Dark brown medium dense sandy, gravelly SILT. Gravel is fine to coarse of brick. No visual or olfactory evidence of contamination. At 0.3-0.4m: more brick encountered. Also glass fragments (<4cm).</p> <p>0.6 – 1.07m: MADE GROUND. Dark brown sandy, gravelly CLAY, glass fragments (~3 cm). Brick cobbles, rounded flint cobbles and coarse sandstone gravel <5 cm. At 1.0m: possible tarmac.</p> <p>1.07m: Encountered concrete obstruction. Excavation terminated.</p>
Observed CoPC:	None
Notes:	<p>Bare soil</p> <p>Testing scheduled:</p> <p>0-0.05m – Asbestos, 13 metals (including lead) & PAHs</p> <p>0.3-0.4m – 13 metals (including lead) & PAHs</p> <p>0.6-0.7m- 13 metals (including lead) & PAHs</p>

Photo 1: Location prior to sampling	Photo 2: Excavated soil ready for sampling (0-0.05m)

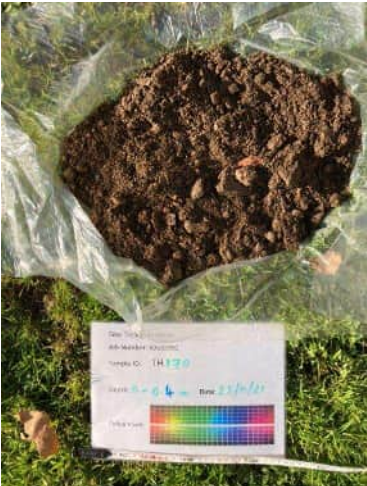
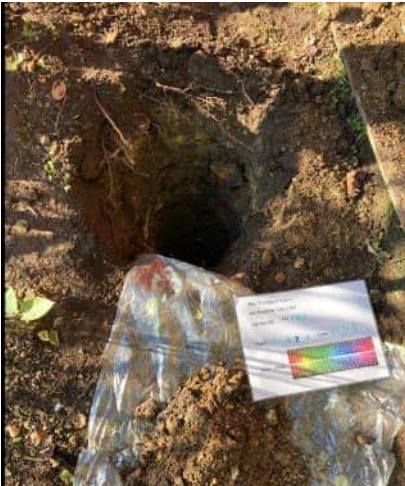
Photo 3: Excavated soil ready for sampling (0.3-0.4m) (error on photo board, sample depth was 0.3-0.4m)	Photo 4: Excavated soil ready for sampling (0.6-0.7m) (error on photo board, sample depth was 0.6-0.7m)

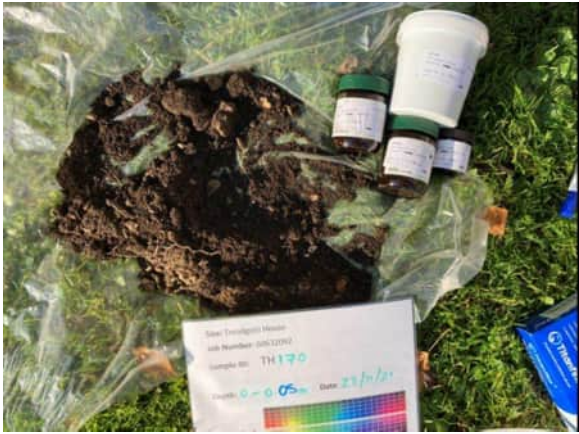
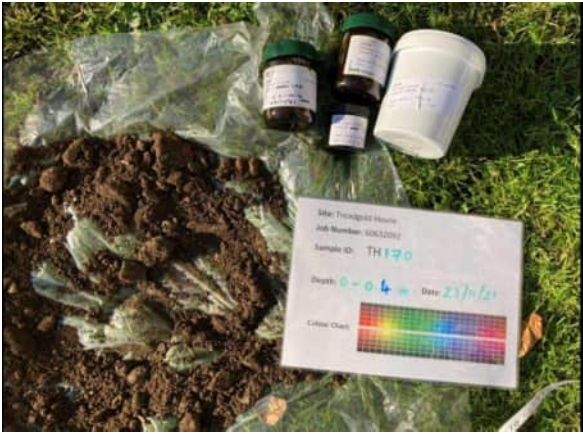
<p>Photo unavailable</p>		
<p>Photo 7: Sample collected in containers (0-0.05m)</p>	<p>Photo 8: Sample collected in containers (0.3-0.4m) (error on photo board – sample depth is 0.3-0.4m)</p>

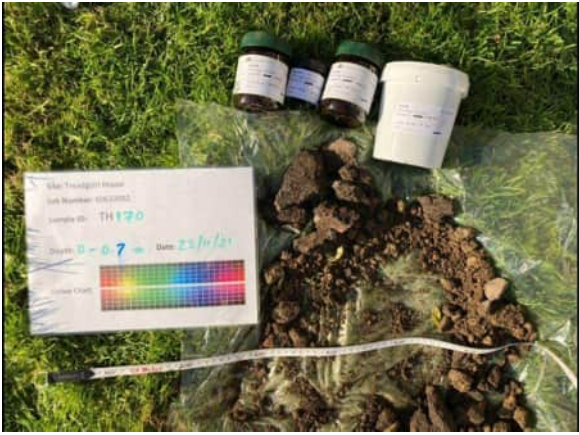
<p>Photo 9: Sample collected in containers (0.6-0.7m) (error on photo board – sample depth is 0.6-0.7m)</p>
