Appendix D Walkover Photolog and Sample Logs & Photos

Treadgold House and Avondale Park
Gardens Walkover Survey

Project No.
60632092

Grenfell Potential Land Contamination: Stage 2 Sampling Notes and Photographic Record

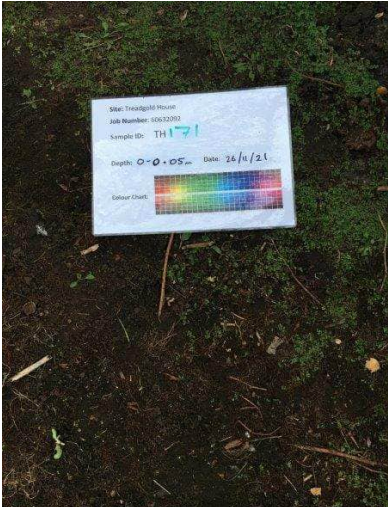
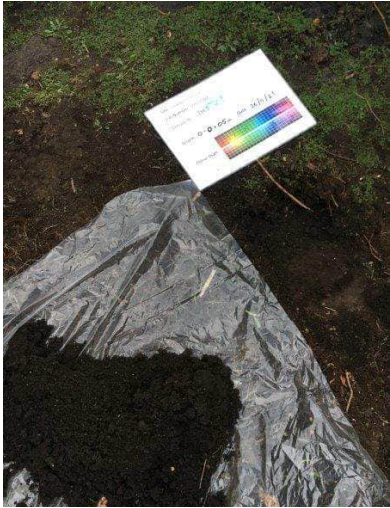
Sample Log:	0 – 0.05m: TOPSOIL. Dark brown SILT with occasional gravel. Rootlets and other organic matter present (twigs, seed pods).
Observed CoPC:	None
Notes:	Bare soil with a light weed cover Testing scheduled: 0-0.05m – Lead

Photo 1: Location prior to sampling	Photo 2: Excavated soil ready for sampling (0–0.05m)

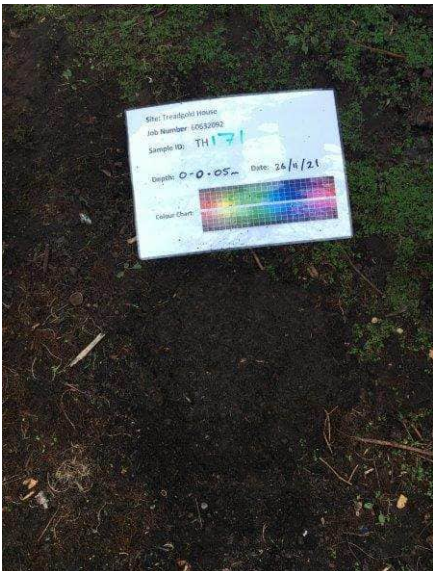
Photo 3: Excavated soil in sampling jars (0-0.05m)	Photo 4: Reinstated location

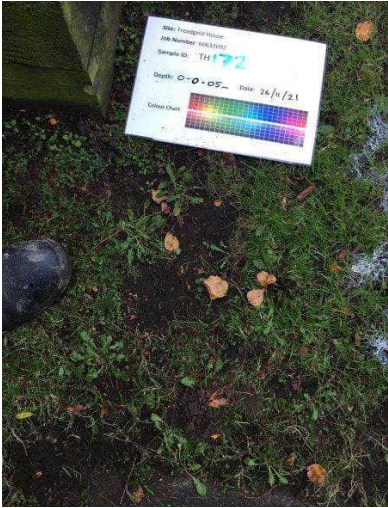
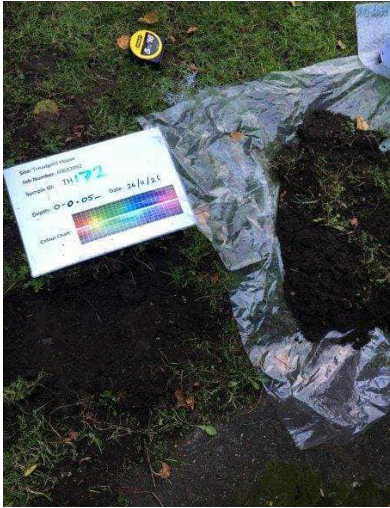
Sample Log:	0 – 0.05m: TOPSOIL. Dark brown SILT with rootlets and a small amount of gravel (<1%). Other organic matter (twigs and seed pods).
Observed CoPC:	None
Notes:	Turf with weeds Testing scheduled: 0-0.05m – Lead

Photo 1: Location prior to sampling	Photo 2: Excavated soil ready for sampling (0–0.05m)

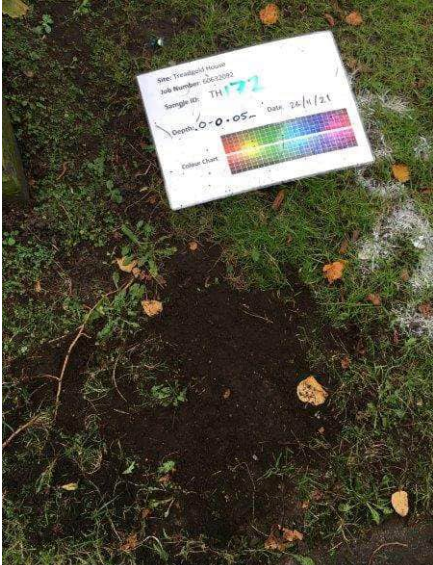
Photo 3: Excavated soil in sampling jars (0-0.05m)	Photo 4: Reinstated location

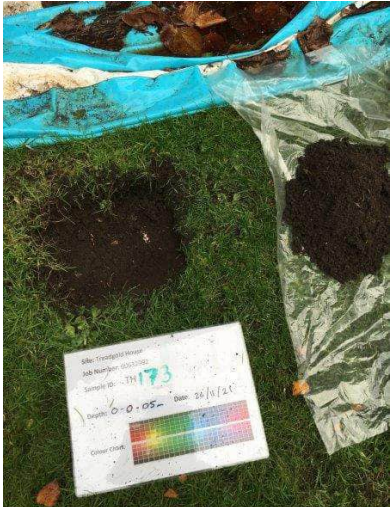
Sample Log:	0 – 0.05m: TOPSOIL. Dark brown SILT with rootlets and occasional gravel. Occasional glass and plastic fragments are present.
Observed CoPC:	None
Notes:	Turf Testing scheduled: 0-0.05m – Lead

Photo 1: Location prior to sampling	Photo 2: Excavated soil ready for sampling (0–0.05m)

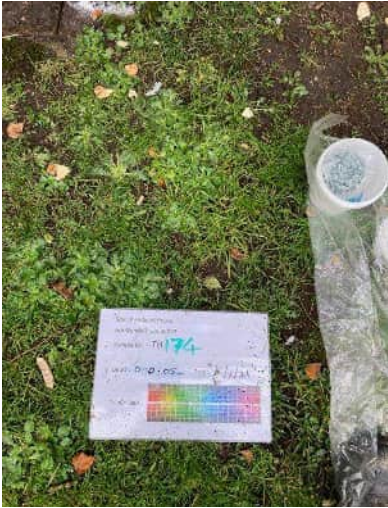
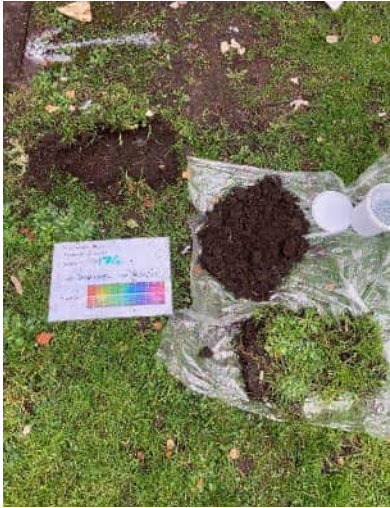
Sample Log:	0 – 0.05m: TOPSOIL. Dark brown SILT with the occasional red brick fragment and rootlets. Organic matter is also present.
Observed CoPC:	None
Notes:	Partial turf Testing scheduled: 0-0.05m – Lead

Photo 1: Location prior to sampling	Photo 2: Excavated soil ready for sampling (0–0.05m)

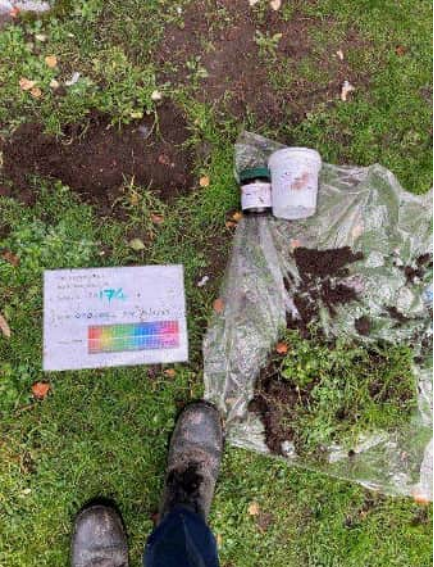
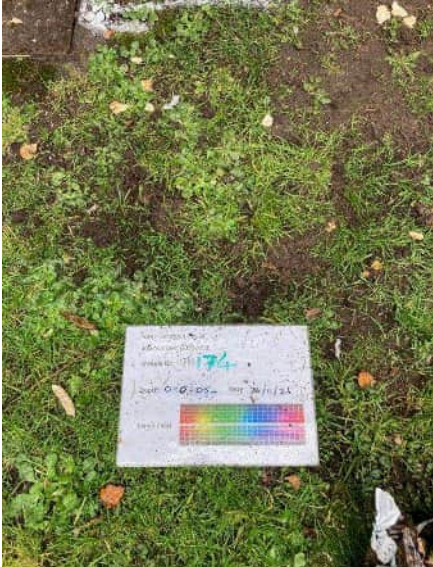
Photo 3: Excavated soil in sampling jars (0-0.05m)	Photo 4: Reinstated location

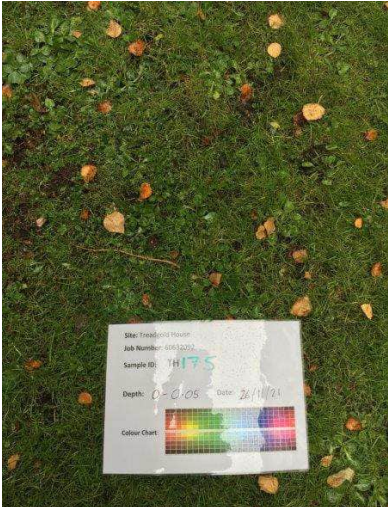
Sample Log:	0 – 0.05m: TOPSOIL. Dark brown SILT, with the occasional rootlet and other organic matter (seed pods and twigs). Occasional rare small brick red fragment is present (<1 cm) and flint gravel fragment (<3 cm).
Observed CoPC:	None
Notes:	Turf Testing scheduled: 0-0.05m – Lead

Photo 1: Location prior to sampling	Photo 2: Excavated soil ready for sampling (0–0.05m)

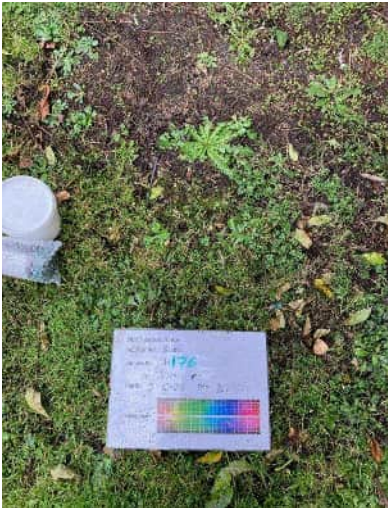
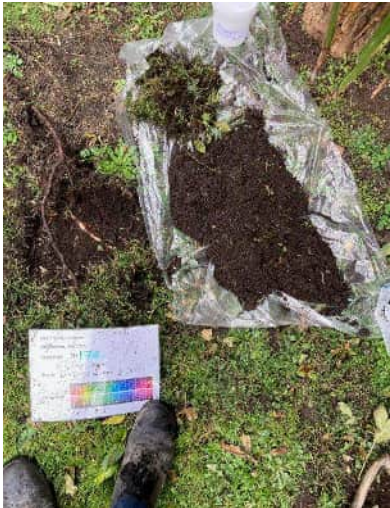
Sample Log:	0 – 0.05m: TOPSOIL. Dark brown SILT. With roots, rootlets and fragments of plastic (cable tie and wire sheath), glass, tile, cigarette butt and red brick.
Observed CoPC:	None
Notes:	Partial turf Testing scheduled: 0-0.05m – Lead

Photo 1: Location prior to sampling	Photo 2: Excavated soil ready for sampling (0–0.05m)

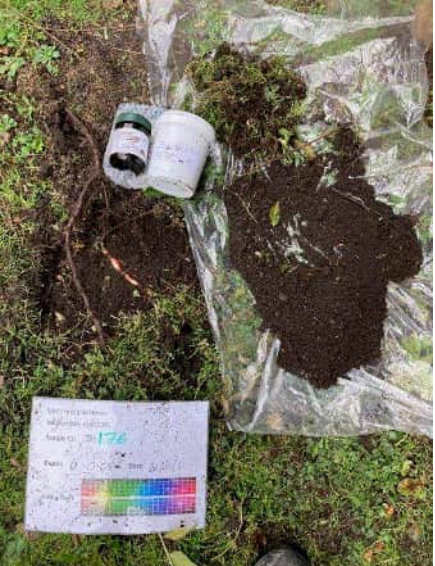
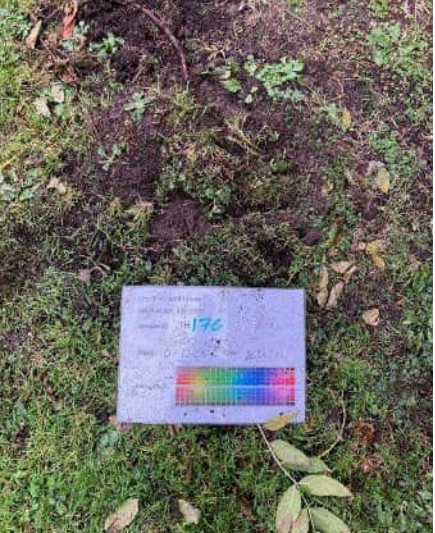
Photo 3: Excavated soil in sampling jars (0-0.05m)	Photo 4: Reinstated location

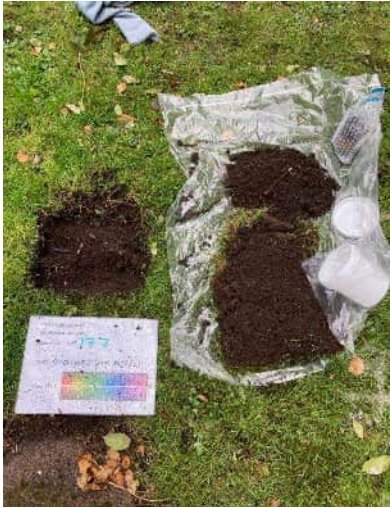
Sample Log:	0 – 0.05m: TOPSOIL. Dark brown SILT with fragments of glass (<0.5cm), plastic (including a pen), concrete, metal fragment (5-10cm), red brick fragments and organic matter (rootlets, twigs).
Observed CoPC:	None
Notes:	Turf Testing scheduled: 0-0.05m – Lead

Photo 1: Location prior to sampling	Photo 2: Excavated soil ready for sampling (0–0.05m)

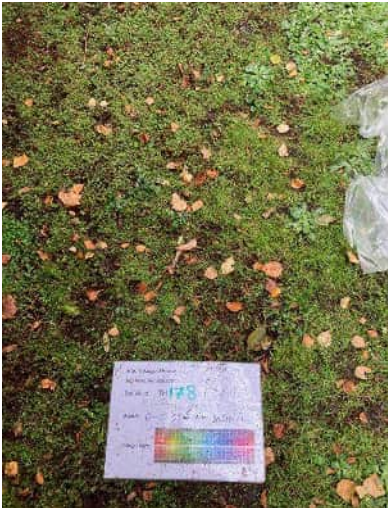
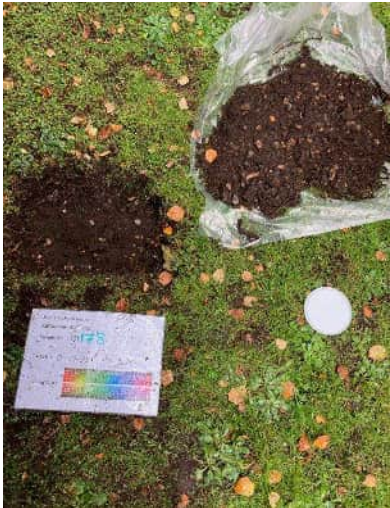
Sample Log:	0 – 0.05m: TOPSOIL. Dark brown SILT. With frequent fine to coarse subangular to rounded gravel of flint. The sample contains rare metal (wire fragment) and red brick fragments (~5mm).
Observed CoPC:	None
Notes:	Turf with some weeds Testing scheduled: 0-0.05m – Lead

Photo 1: Location prior to sampling	Photo 2: Excavated soil ready for sampling (0–0.05m)

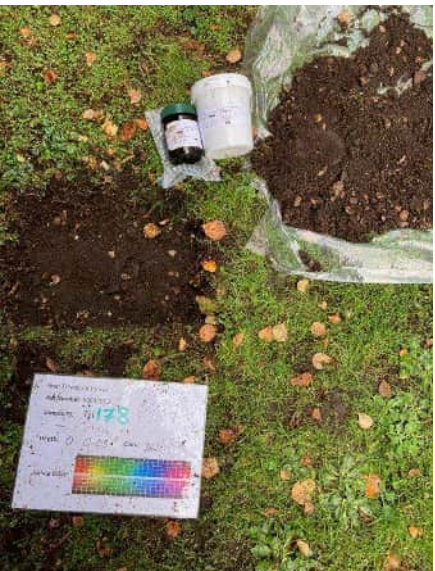
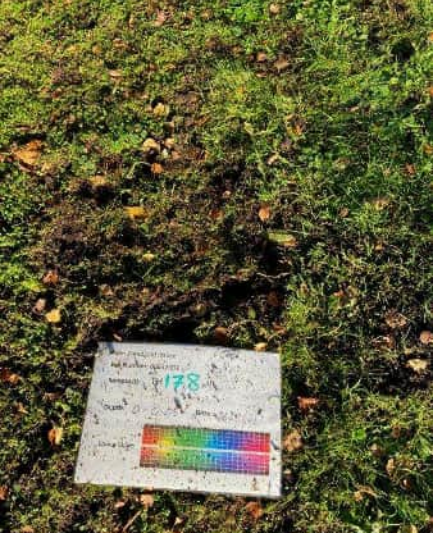
Photo 3: Excavated soil in sampling jars (0-0.05m)	Photo 4: Reinstated location

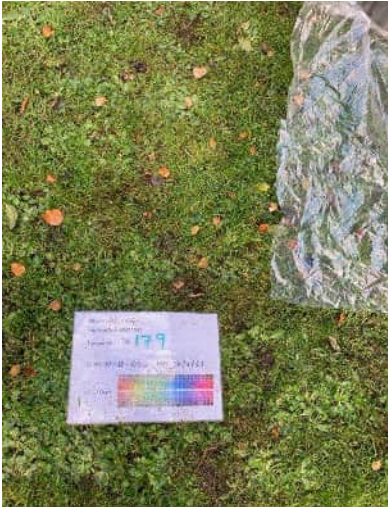
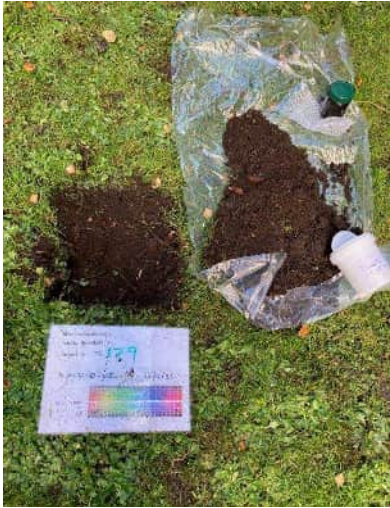
Sample Log:	0 – 0.05 m: TOPSOIL. Dark brown SILT with fragments of red pottery (1-2 cm), glass (1cm), red brick (1 cm), white rubbery/ silicon sealant piece and organic matter (red roots, rootlets and wood chippings).
Observed CoPC:	None
Notes:	Turf with weeds Testing scheduled: 0-0.05m – Lead

Photo 1: Location prior to sampling	Photo 2: Excavated soil ready for sampling (0–0.05m)

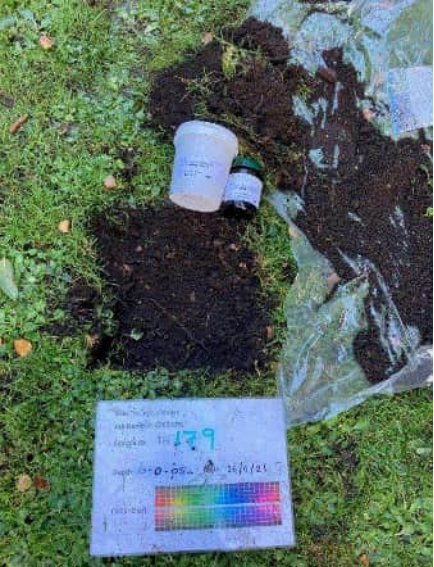
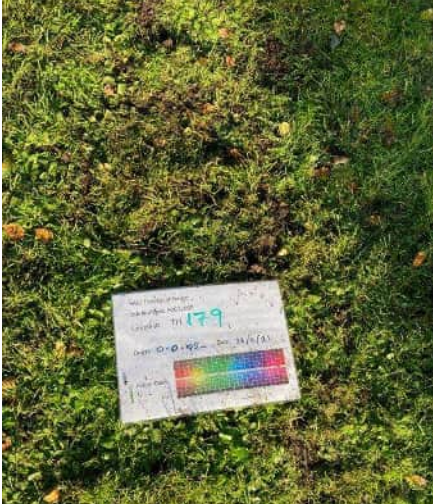
Photo 3: Excavated soil in sampling jars (0-0.05m)	Photo 4: Reinstated location

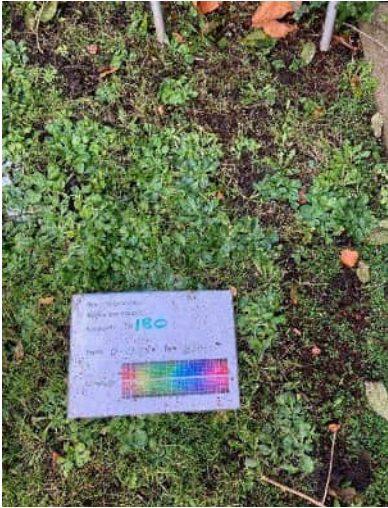
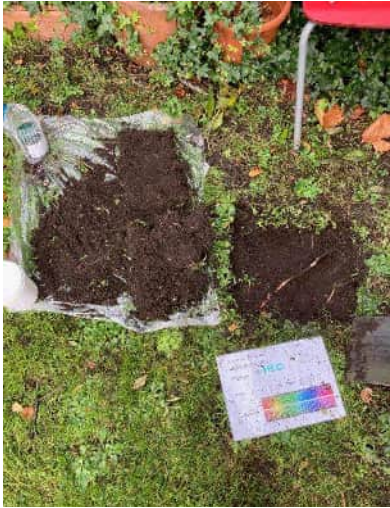
Sample Log:	0 – 0.05m: TOPSOIL. Dark brown SILT. Containing roots and rootlets. Occasional coarse subrounded flint gravel with pieces of rubber and cardboard.
Observed CoPC:	None
Notes:	Partial turf (sparse cover of grass and other vegetation) Testing scheduled: 0-0.05m – Lead

Photo 1: Location prior to sampling	Photo 2: Excavated soil ready for sampling (0–0.05m)

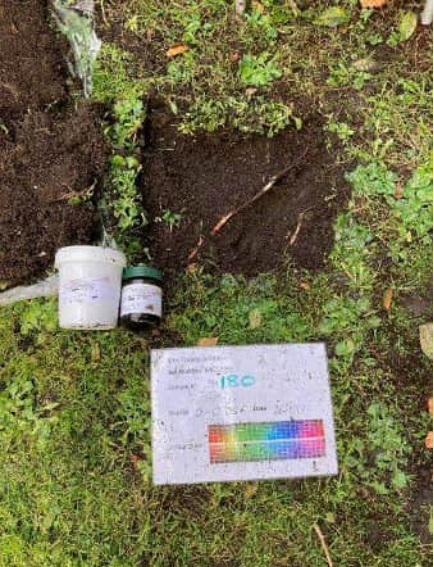
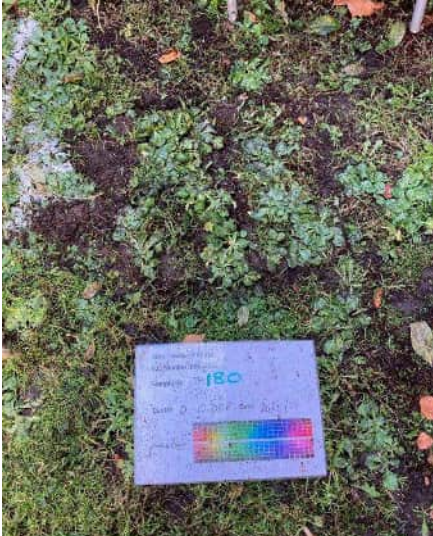
Photo 3: Excavated soil in sampling jars (0-0.05m)	Photo 4: Reinstated location

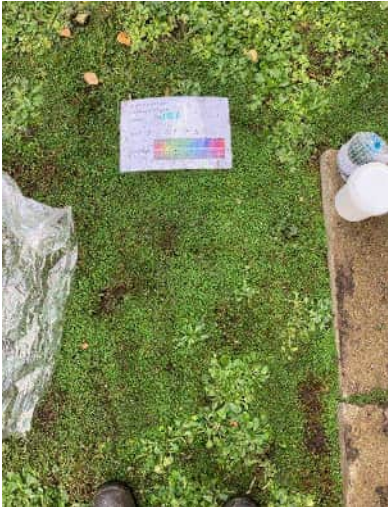
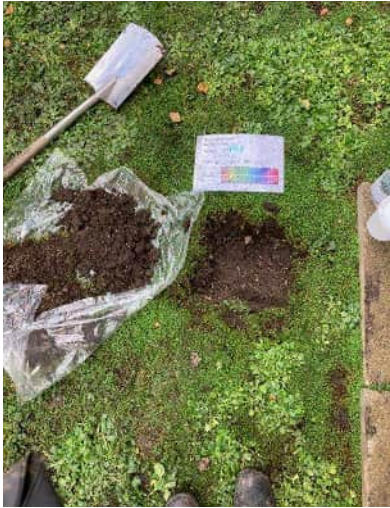
Sample Log:	0 – 0.05m: TOPSOIL. Dark brown silty, gravelly CLAY. Gravel is of concrete and flint. Fragments of red brick, slate, ceramic and plastic were also observed. Organic matter such as rootlets were present.
Observed CoPC:	None
Notes:	Partial turf (weed covered soil) Testing scheduled: 0-0.05m – Lead

Photo 1: Location prior to sampling	Photo 2: Excavated soil ready for sampling (0–0.05m)

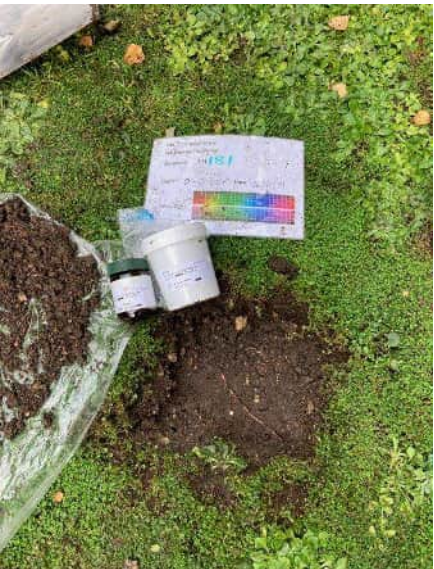
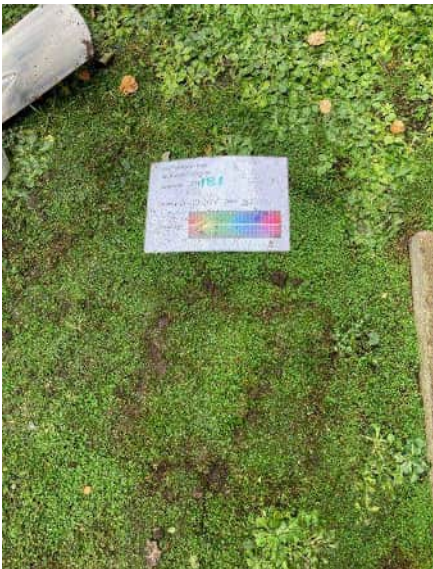
Photo 3: Excavated soil in sampling jars (0-0.05m)	Photo 4: Reinstated location

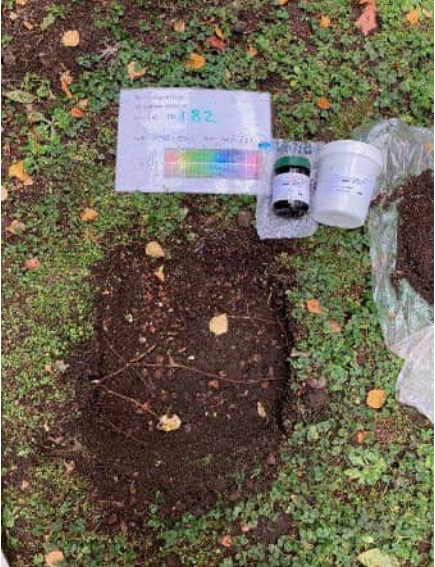
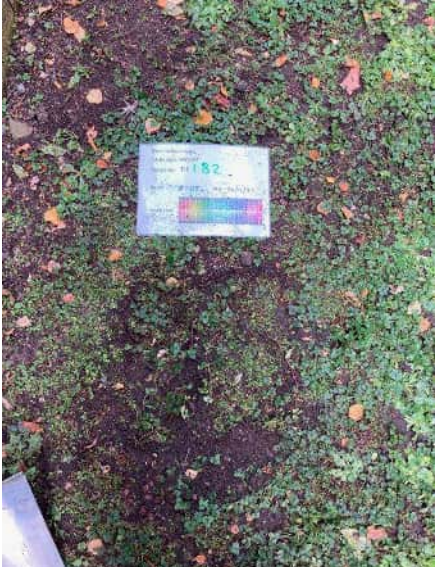
Photo 3: Excavated soil in sampling jars (0-0.05m)	Photo 4: Reinstated location

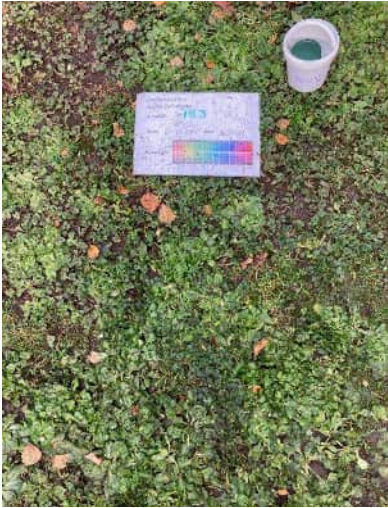
Sample Log:	0 – 0.05m: TOPSOIL. Dark brown SILT. With medium angular to subangular red gravel, flint, concrete (1-2cm) and bits of white tile. Organic material (rootlets, twigs).
Observed CoPC:	None
Notes:	Partial turf (weed covered soil) Testing scheduled: 0-0.05m – Lead

Photo 1: Location prior to sampling	Photo 2: Excavated soil ready for sampling (0–0.05m)

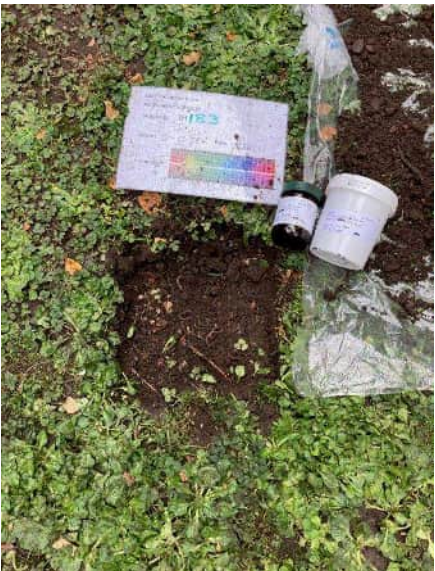
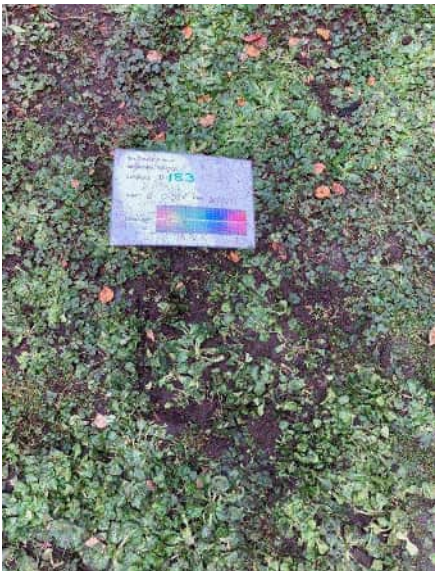
Photo 3: Excavated soil in sampling jars (0-0.05m)	Photo 4: Reinstated location

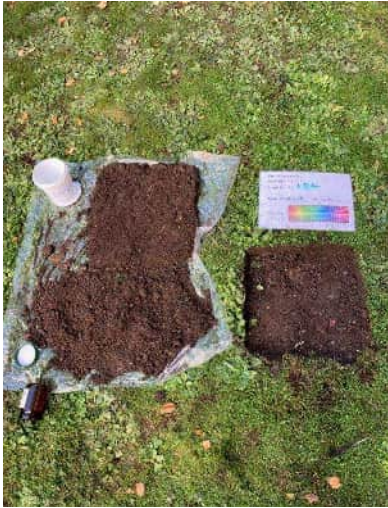
Sample Log:	0 – 0.05m: TOPSOIL. Dark brown SILT with occasional fragments of angular red brick (1-5 cm), decorative coloured gravel, plastic, glass (1-5 cm) and twigs.
Observed CoPC:	None
Notes:	Partial turg (thin weedy vegetation) Testing scheduled: 0-0.05m – Lead

Photo 1: Location prior to sampling	Photo 2: Excavated soil ready for sampling (0–0.05m)
Photo unavailable

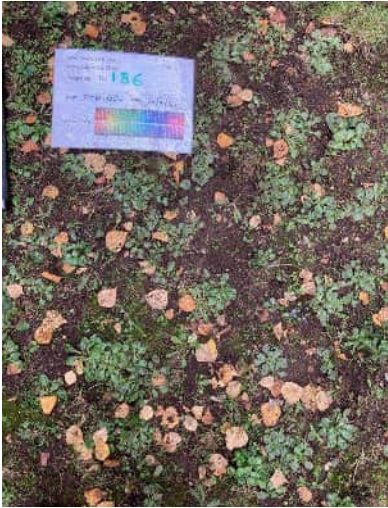
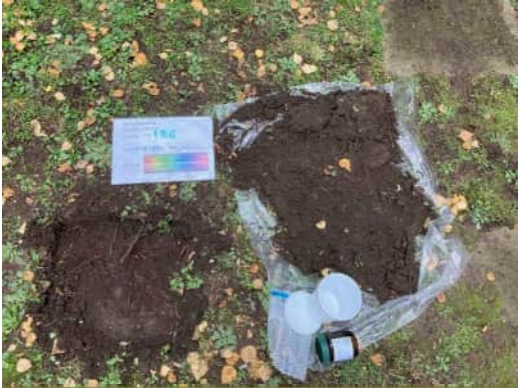
Sample Log:	0 – 0.05m: TOPSOIL. Dark brown SILT. With frequent twigs and rootlets. Rare, rounded gravel with fragments of glass (2-5 mm) and white ceramics.
Observed CoPC:	None
Notes:	Partial turf (sparse weedy vegetation) Testing scheduled: 0-0.05m – Lead

Photo 1: Location prior to sampling	Photo 2: Excavated soil ready for sampling (0–0.05m)

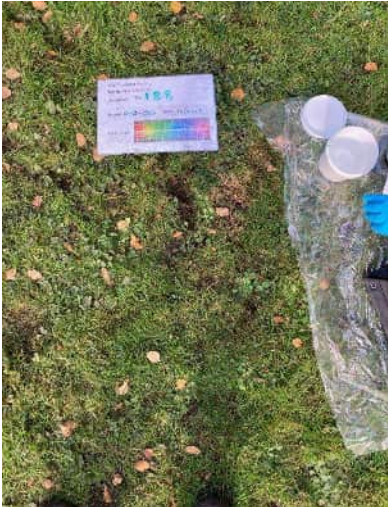
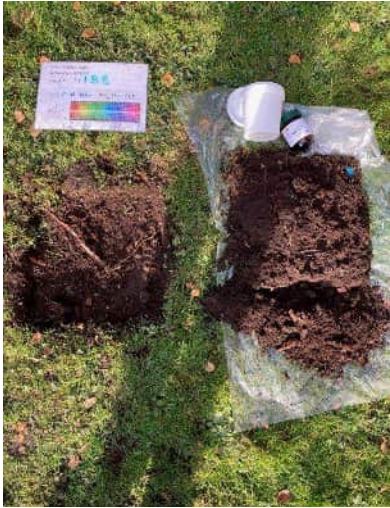
Sample Log:	0 – 0.05m: TOPSOIL. Dark brown, SILT with wood fragments and occasional plastic and rare gravel of flint.
Observed CoPC:	None
Notes:	Turf Testing scheduled: 0-0.05m – Lead

Photo 1: Location prior to sampling	Photo 2: Excavated soil ready for sampling (0–0.05m)

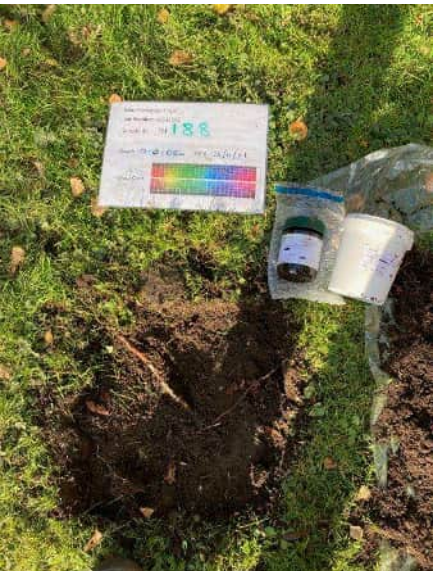
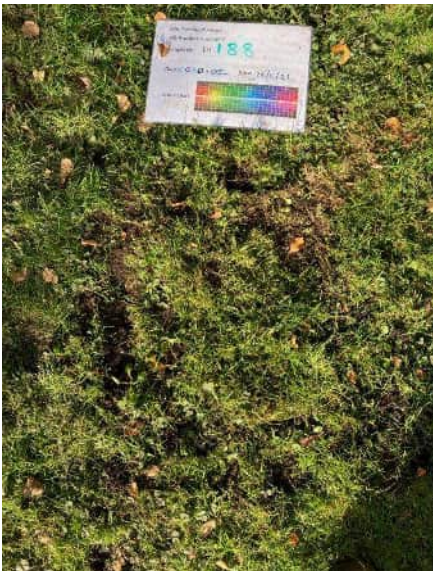
Photo 3: Excavated soil in sampling jars (0-0.05m)	Photo 4: Reinstated location

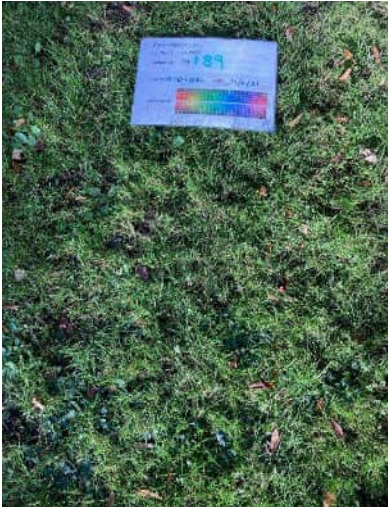
Sample Log:	0 – 0.05m: TOPSOIL. Dark grey SILT. Containing wood fragments, glass fragments (<1 cm) and rare fine to medium gravel. Organic matter of wood fragments, bone (0.5 cm by 4 cm long) and rootlets.
Observed CoPC:	None
Notes:	Turf Testing scheduled: 0-0.05m – Lead

Photo 1: Location prior to sampling	Photo 2: Excavated soil ready for sampling (0–0.05m)

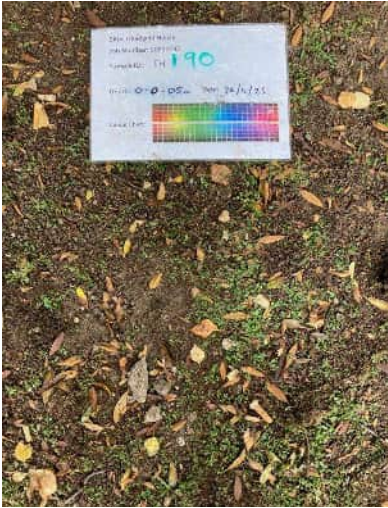
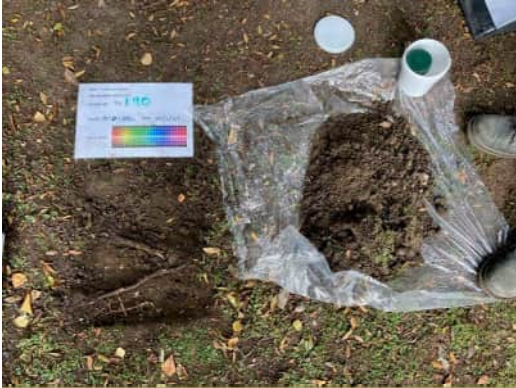
Sample Log:	0 – 0.05m: TOPSOIL. Medium/ dark brown sandy, SILT with the occasional gravel of flint, concrete, and red brick.
Observed CoPC:	None
Notes:	Bare soil with a sparse weed and vegetation covering Testing scheduled: 0-0.05m – Lead

Photo 1: Location prior to sampling	Photo 2: Excavated soil ready for sampling (0–0.05m)

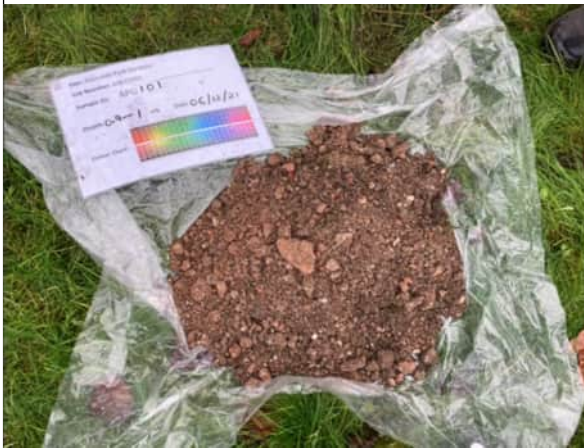
Photo 5: Excavated soil for sampling (0.9-1.0m)

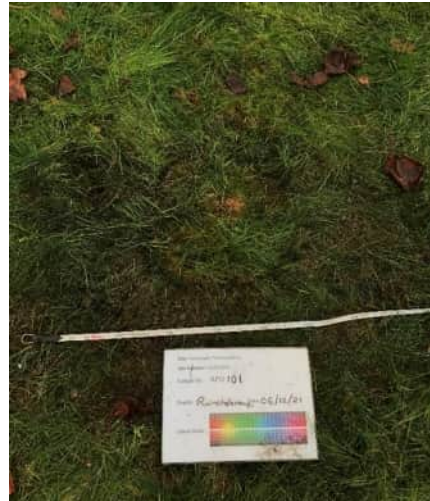
Photo 6: Reinstated location

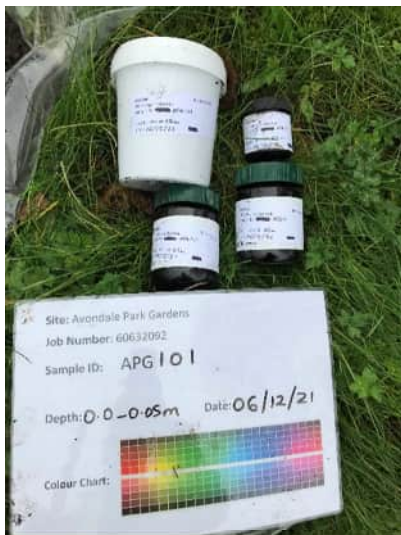
Photo 7: Sample collected in containers (0-0.05m)

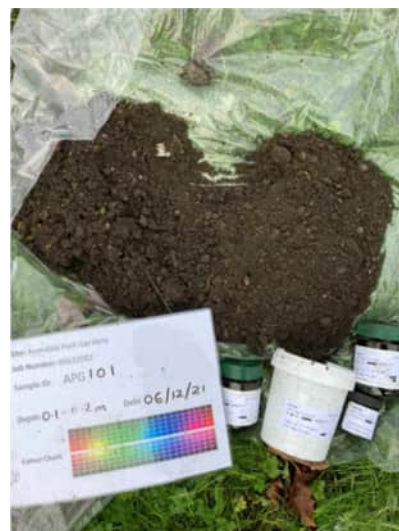
Photo 8: Sample collected in containers (0.1-0.2m)

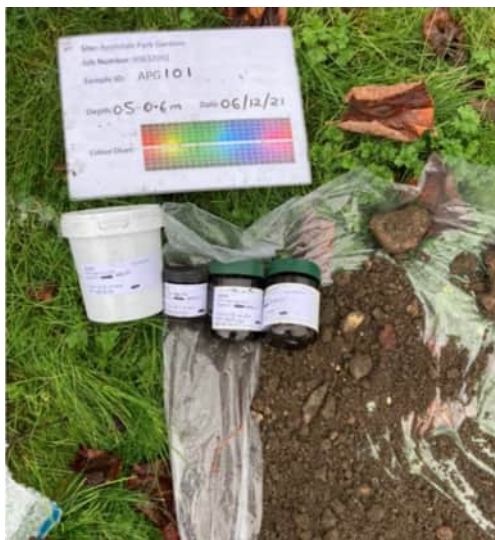
Photo 9: Sample collected in containers (0.5-0.6m)

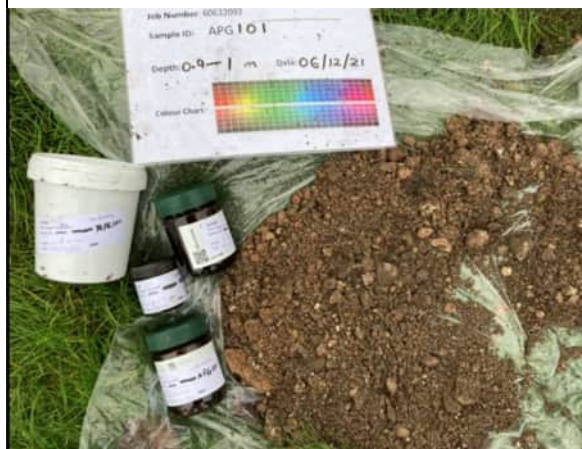
Photo 10: Sample collected in containers (0.9-1.0m)

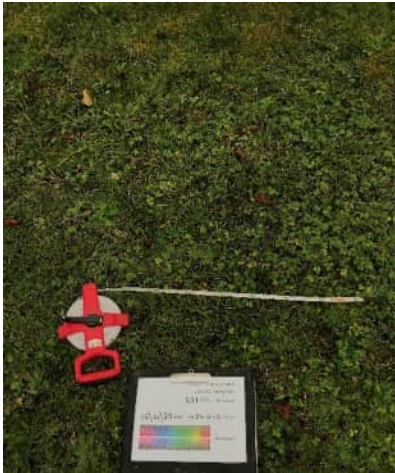
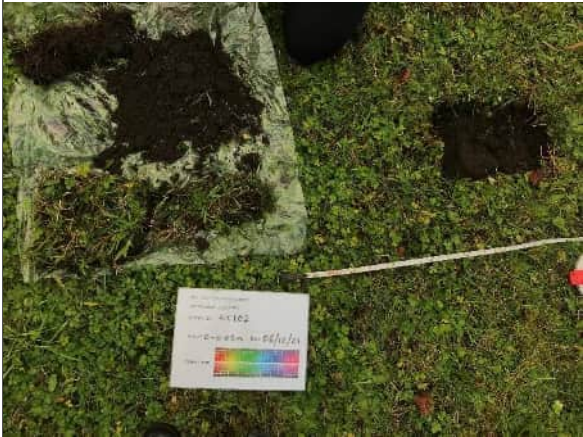
Photo 1: Location prior to sampling	Photo 2: Excavated soil ready for sampling (0-0.05m)

Sample Log:	0 – 0.1m: TOPSOIL. Dark brown loose sandy, clayey SILT. No visual or olfactory evidence of contamination. Below 0.1m: Becoming slightly more clayey with gravel. Gravel is medium to coarse, subrounded of flint, brick, and concrete. No visual or olfactory evidence of contamination.
Observed CoPC:	None
Notes:	Turf Testing scheduled: 0-0.05m – Asbestos, 13 metals (including Lead) & PAHs 0.1-0.2m – Lead

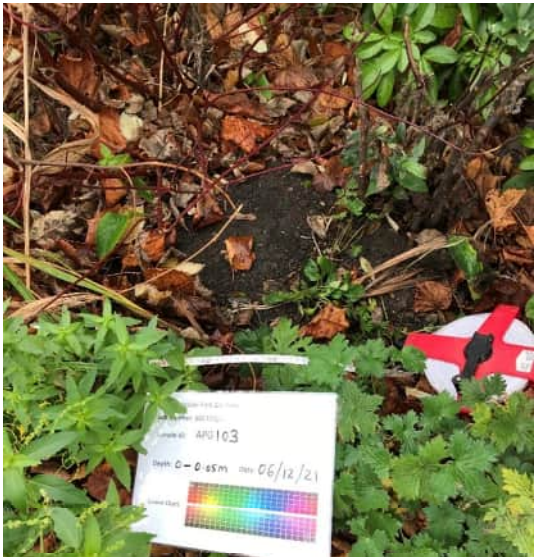
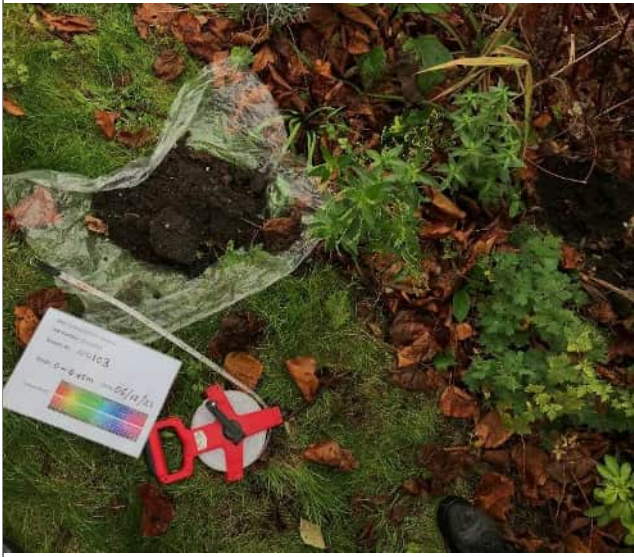
Photo 1: Undisturbed location	Photo 2: Excavated soil ready for sampling (0-0.05m)

Sample Log:	<p>0 – 0.2m: TOPSOIL. Dark brown loose sandy gravelly SILT. Gravel is coarse, subangular of concrete, flint and brick. Occasional rootlets are present, rare slate fragment and one piece of plastic (2 cm long). No visual or olfactory evidence of contamination.</p> <p>Below 0.05m: As above but becoming very sandy and changing colour to brown to dark brown. One piece of green glass was present in the sample. No visual or olfactory evidence of contamination.</p>
Observed CoPC:	None
Notes:	<p>Bare soil</p> <p>Testing scheduled:</p> <p>0-0.05m – Lead</p> <p>0.1-0.2m – Asbestos, 13 metals (including Lead) & PAHs plus DUP10 – Asbestos, 13 metals (including Lead) and PAHs</p>

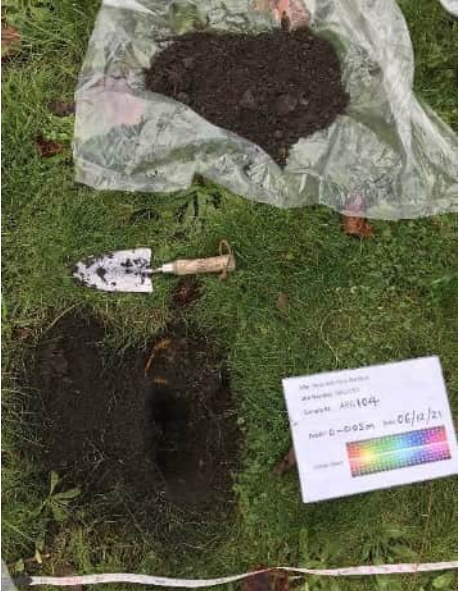
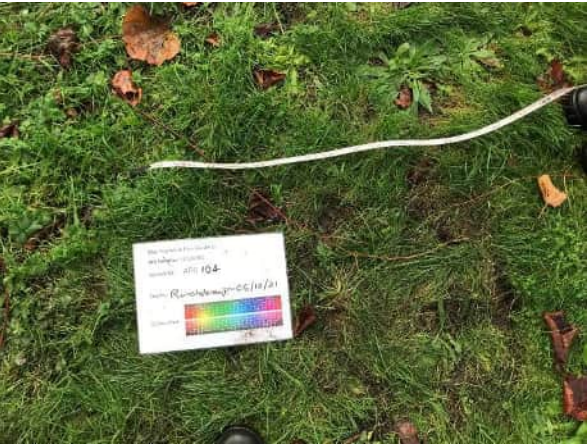
Photo 3: Excavated soil ready for sampling (0.1-0.2m) (photoboard states 0-0.05m – labelling error)	Photo 4: Reinstated location

Sample Log:	0 – 0.2m: TOPSOIL. Dark brown sandy, clayey SILT with the occasional fine, subangular gravel of flint with rare coarse gravel of concrete. No visual or olfactory evidence of contamination. 0.1 – 0.2m. As above with the occasional coarse gravel of brick and concrete. No visual or olfactory evidence of contamination.
Observed CoPC:	None
Notes:	Turf Testing scheduled: 0-0.05m – Lead 0.1-0.2m – Lead

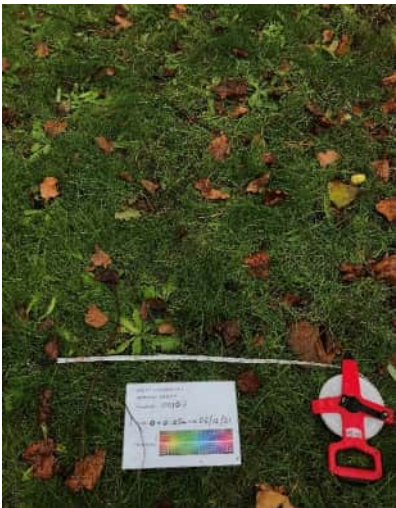
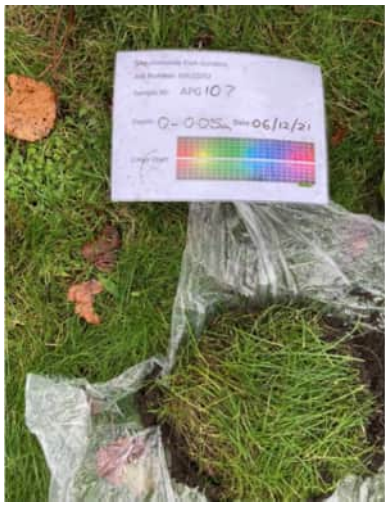
Photo 1: Location prior to sampling	Photo 2: Turf cut for sampling (0-0.05m)

Sample Log:	0 – 0.1m: TOPSOIL. Dark brown slightly sandy, silty CLAY. 0.1 – 0.2m: As above but with the occasional fine to coarse, subangular gravel of flint, slate, coal, and rare ceramic fragments. One piece of clear soft plastic was observed (2 cm) and one piece of rounded, clear glass (1 cm).
Observed CoPC:	Coal at 0.1-0.2m.
Notes:	Turf Testing scheduled: 0-0.05m – Lead 0.1-0.2m – Lead

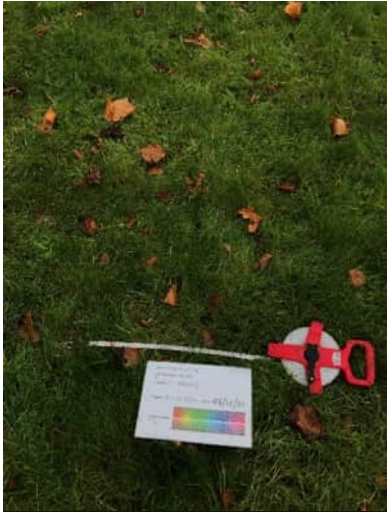
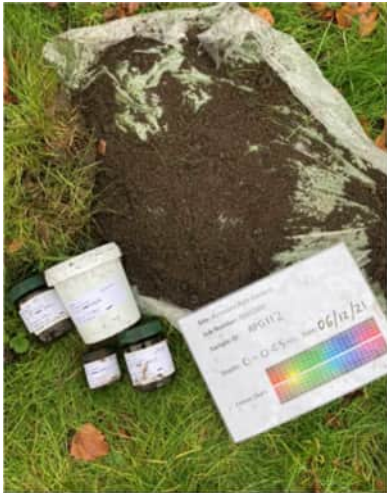
Photo 1: Location prior to sampling	Photo 2: Excavated soil in sampling jars (0-0.05m)

Sample Log:	0 – 0.1m: TOPSOIL. Dark brown, loose sandy SILT. No visual or olfactory evidence of contamination. 0.1 – 0.2m: As above but becomes gravelly and clayey. Gravel is fine to coarse, subangular of flint, brick, and concrete. A small piece of ash was present and a fragment of clear glass (rounded, old). No visual or olfactory evidence of contamination.
Observed CoPC:	An approximately 0.5cm piece of ash at 0.1-0.2m
Notes:	Turf Testing scheduled: 0-0.05m – Asbestos, 13 metals (including Lead) & PAHs 0.1-0.2m – Lead

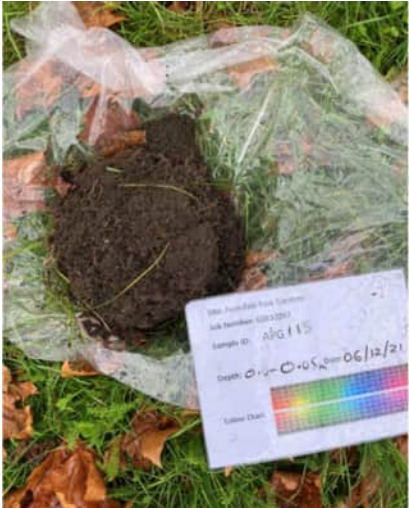
Sample Log:	0 – 0.1m: TOPSOIL. Dark brown, loose slightly sandy, silty CLAY. Occasional medium, subangular gravel of flint and concrete is present with rare cobbles of flint. No visual or olfactory evidence of contamination. 0.1 – 0.2m: As above but with increased amounts of sand and silt. Also with cobbles of flint, brick, and concrete. No visual or olfactory evidence of contamination.
Observed CoPC:	None
Notes:	Turf Testing scheduled: 0.0-0.05m – Lead 0.1-0.2m – Lead

Photo 1: Location prior to sampling	Photo 2: Excavated soil ready for sampling (0-0.05m)
Photo unavailable

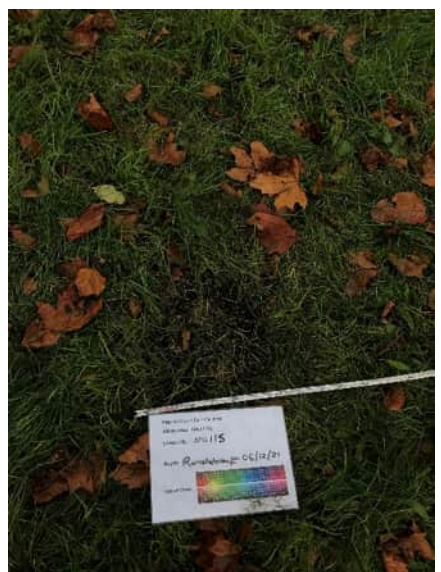
Photo 3: Excavated soil ready for sampling (0.1-0.2m)	Photo 4: Reinstated location

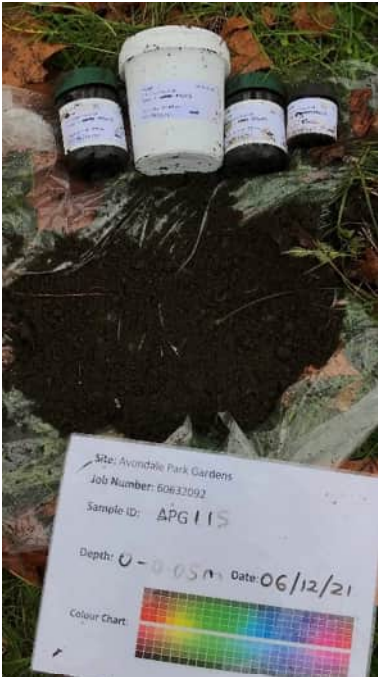
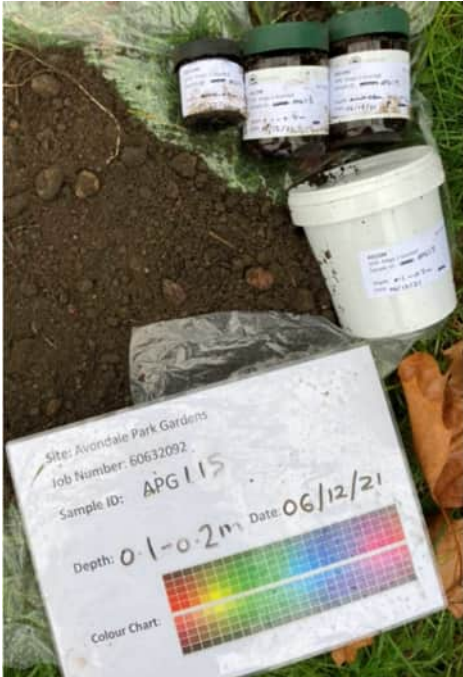
Date / Time	06 December 2021 12:35	Sampling Area	Avondale Park Gardens
Photo 5: Sample collected in containers (0-0.05m)		Photo 6: Sample collected in containers (0.1-0.2m)

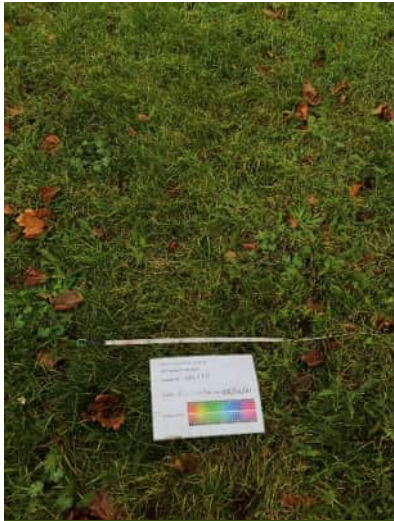
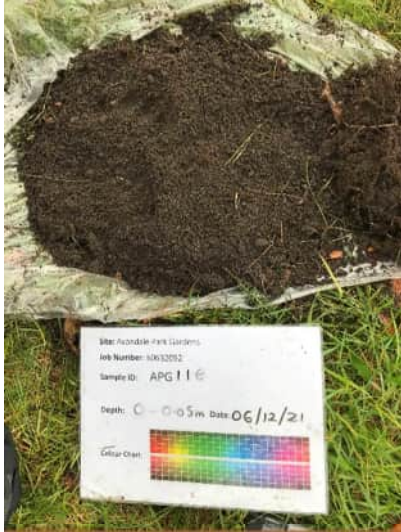
Sample Log:	0 – 0.2m: TOPSOIL. Dark brown, slightly sandy, silty CLAY. Organic material such as rootlets are present and rare ceramic fragments. Occasional medium subangular gravel of brick. Occasional cobbles of concrete and flint below 0.1m.
Observed CoPC:	None
Notes:	Turf Testing scheduled: 0-0.05m – Lead 0.1-0.2m – Asbestos, 13 metals (including Lead) & PAHs

Photo 1: Location prior to sampling	Photo 2: Excavated soil ready for sampling (0-0.05m)

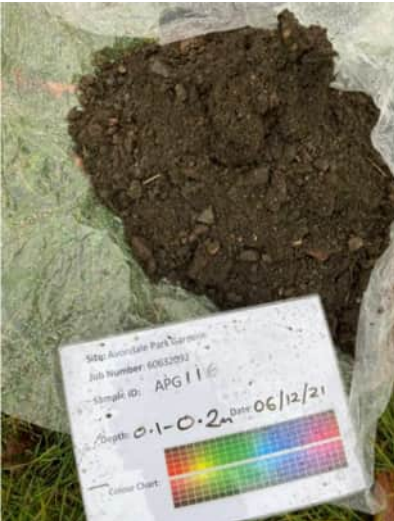
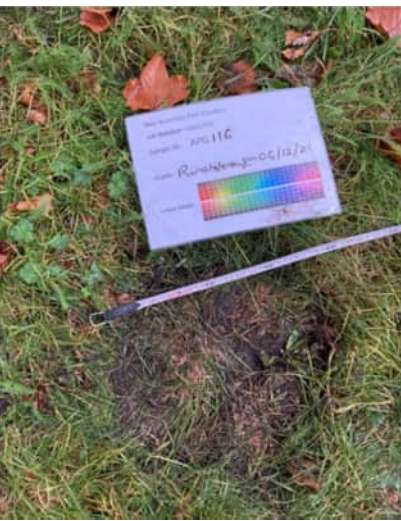
Photo 3: Excavated soil ready for sampling (0.1-0.2m)	Photo 4: Reinstated location

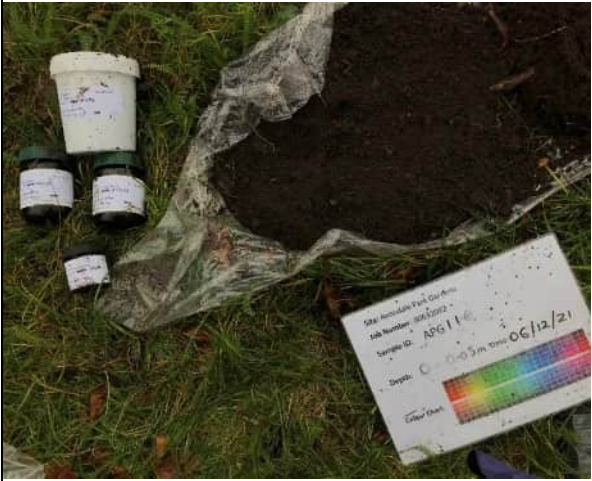
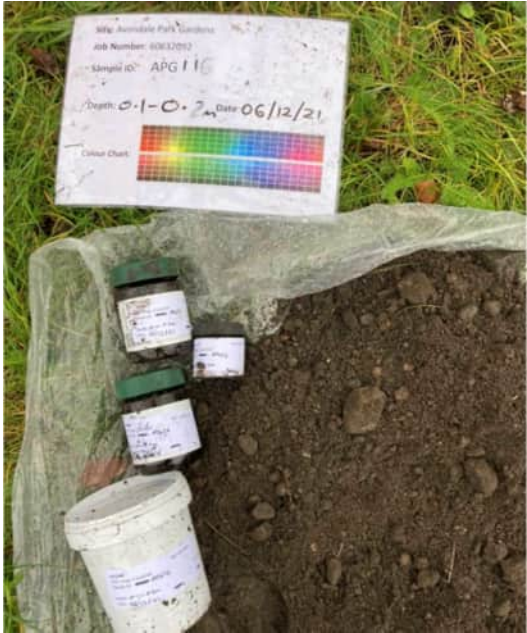
Date / Time	06 December 2021 12:15	Sampling Area	Avondale Park Gardens
Photo 5: Sample collected in containers (0-0.05m)		Photo 6: Sample collected in containers (0.1-0.2m)

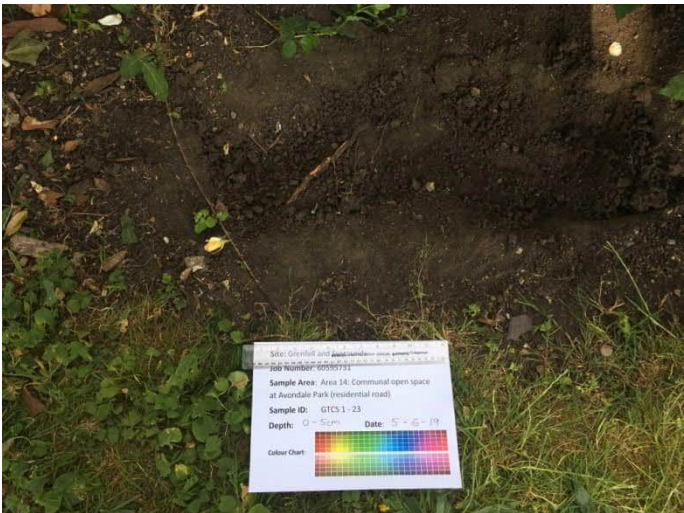
Project Reference: 60595731		
Date: 05 / 06 / 19	Time Start: 08:50	Time complete 09:50
Weather Conditions:	Cloudy, dry	
Sample Area:	Area 14: Communal space at Avondale Park (residential road) (1st sample)	
Primary Sample	GTCS 1 - 23 a	
Duplicate (y/n)	Yes	
Photos Taken:	Photographer name (camera ID if different)	J Storey
	1 st down hole & turf

Field team:	K Bruce, J Storey, J Craggs
Sample Log:	Loose brown slightly gravelly sandy clay. Gravel is angular to sub-rounded fine to coarse of brick and flint. Occasional fragments of metal, glass and plastic. Rare fragments of coal. Rootlets frequent throughout (Made Ground / Topsoil).
Observed CoPC: (note of any ash etc.)	Coal fragments
AOB:	n/a

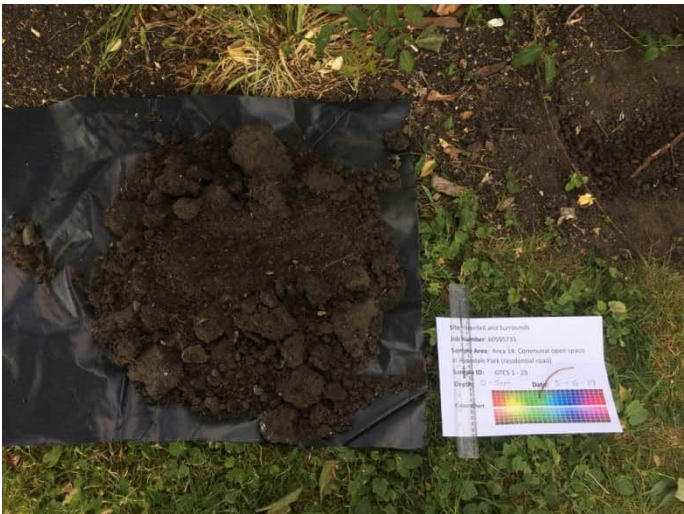
2 nd plastic sheet of soil

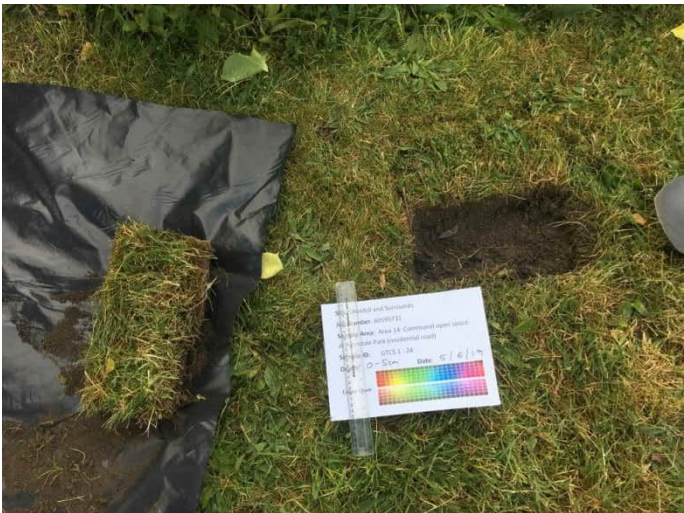
Project Reference: 60595731		
Date: 05 / 06 / 19	Time Start: 09:50	Time complete 10:25
Weather Conditions:	Cloudy, dry	
Sample Area:	Area 14: Communal space at Avondale Park (residential road) (2nd sample)	
Primary Sample	GTCS 1 - 24 a	
Duplicate (y/n)	No	
Photos Taken:	Photographer name (camera ID if different)	J Storey
	1 st down hole & turf

Field team:	K Bruce, J Storey, J Craggs
Sample Log:	Loose brown sandy clay with rare gravels. Gravel is fine angular to sub-angular brick and flint. Glass, bone and metal (bottle cap) fragments at base. Rootlets very frequent (Made Ground / Topsoil).
Observed CoPC: (note of any ash etc.)	No
AOB:	n/a

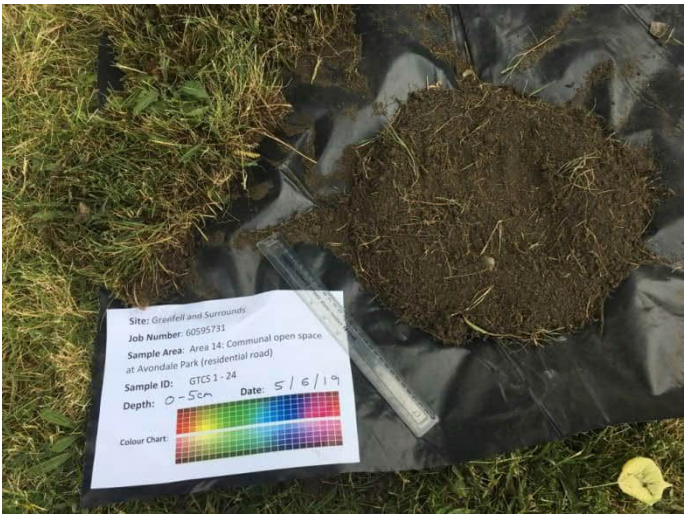
2 nd plastic sheet of soil

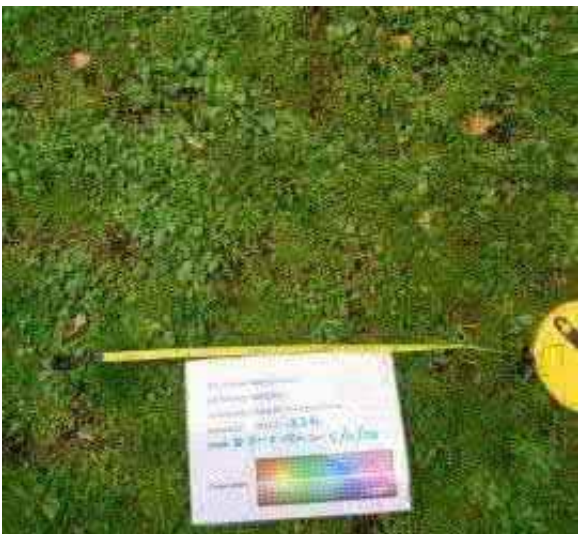
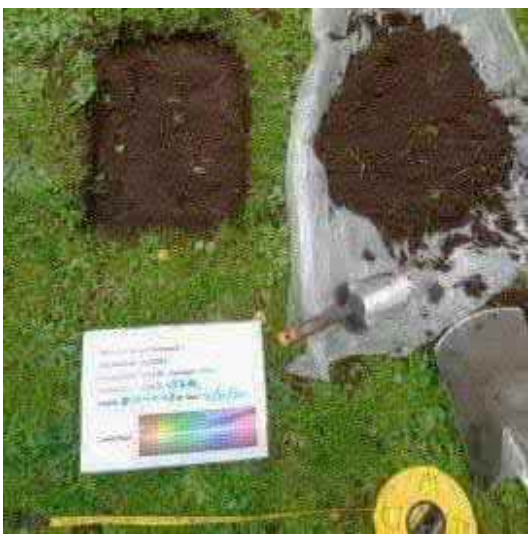
Sample Log:	Turf overlying topsoil composed of loose dark brown slightly sandy silt with pockets of soft grey clay and a single fragment of coarse gravel (sub-rounded) of brick. Presence of rootlets.
Observed CoPC:	None
Notes:	Turf

<p>Photo 1: Location prior to sampling</p>	<p>Photo 2: Excavated soil ready for sampling</p>
