Appendix D Walkover Photolog and Sample Logs & Photos

Treadgold House and Avondale Park
Gardens Walkover Survey

Project No.
60632092

Grenfell Potential Land Contamination: Stage 2 Sampling Notes and Photographic Record

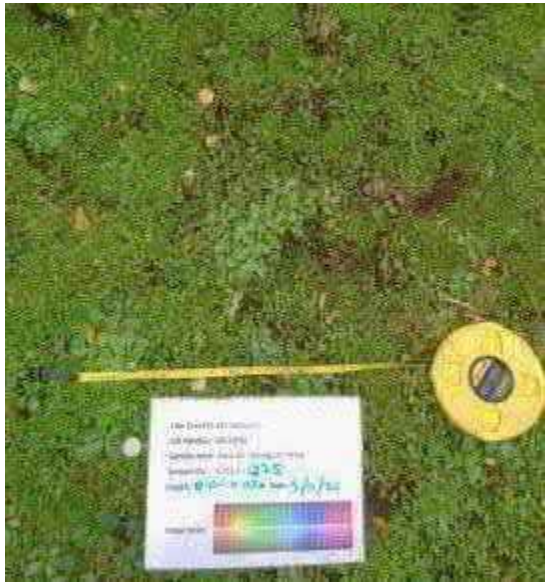
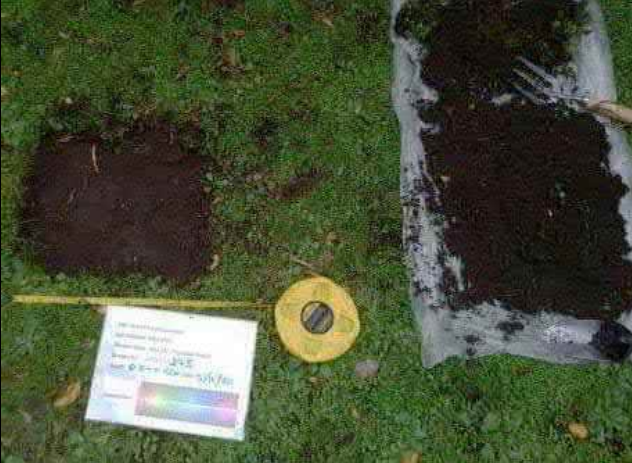
Sample Log:	Turf overlying topsoil composed of loose dark brown silty slightly gravelly sand. Gravel is fine to medium of sub-angular to sub-rounded flint, brick and quartzite. Occasional white plastic fragments (less than 0.5cm). Presence of rootlets.
Observed CoPC:	None
Notes:	Turf

Photo 1: Location prior to sampling	Photo 2: Excavated soil ready for sampling

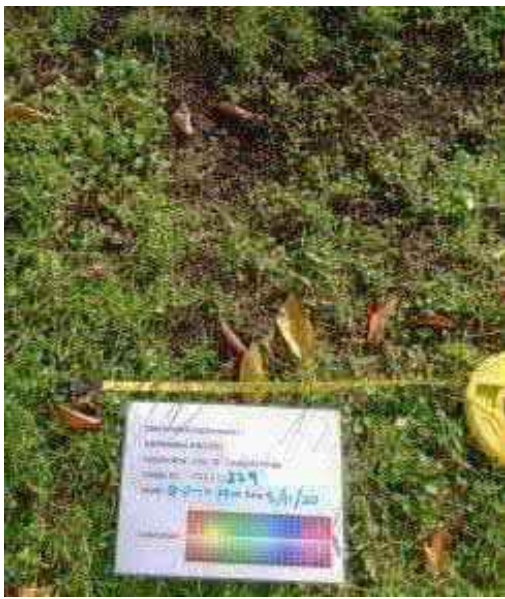
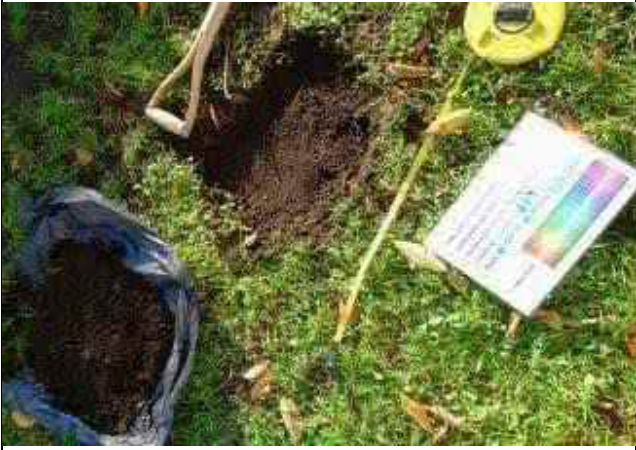
Sample Log:	Turf overlying topsoil composed of loose dark brown slightly clayey slightly sandy silt. Presence of 1cm white plastic fragment and rootlets.
Observed CoPC:	None
Notes:	Turf

Photo 1: Location prior to sampling	Photo 2: Excavated soil ready for sampling

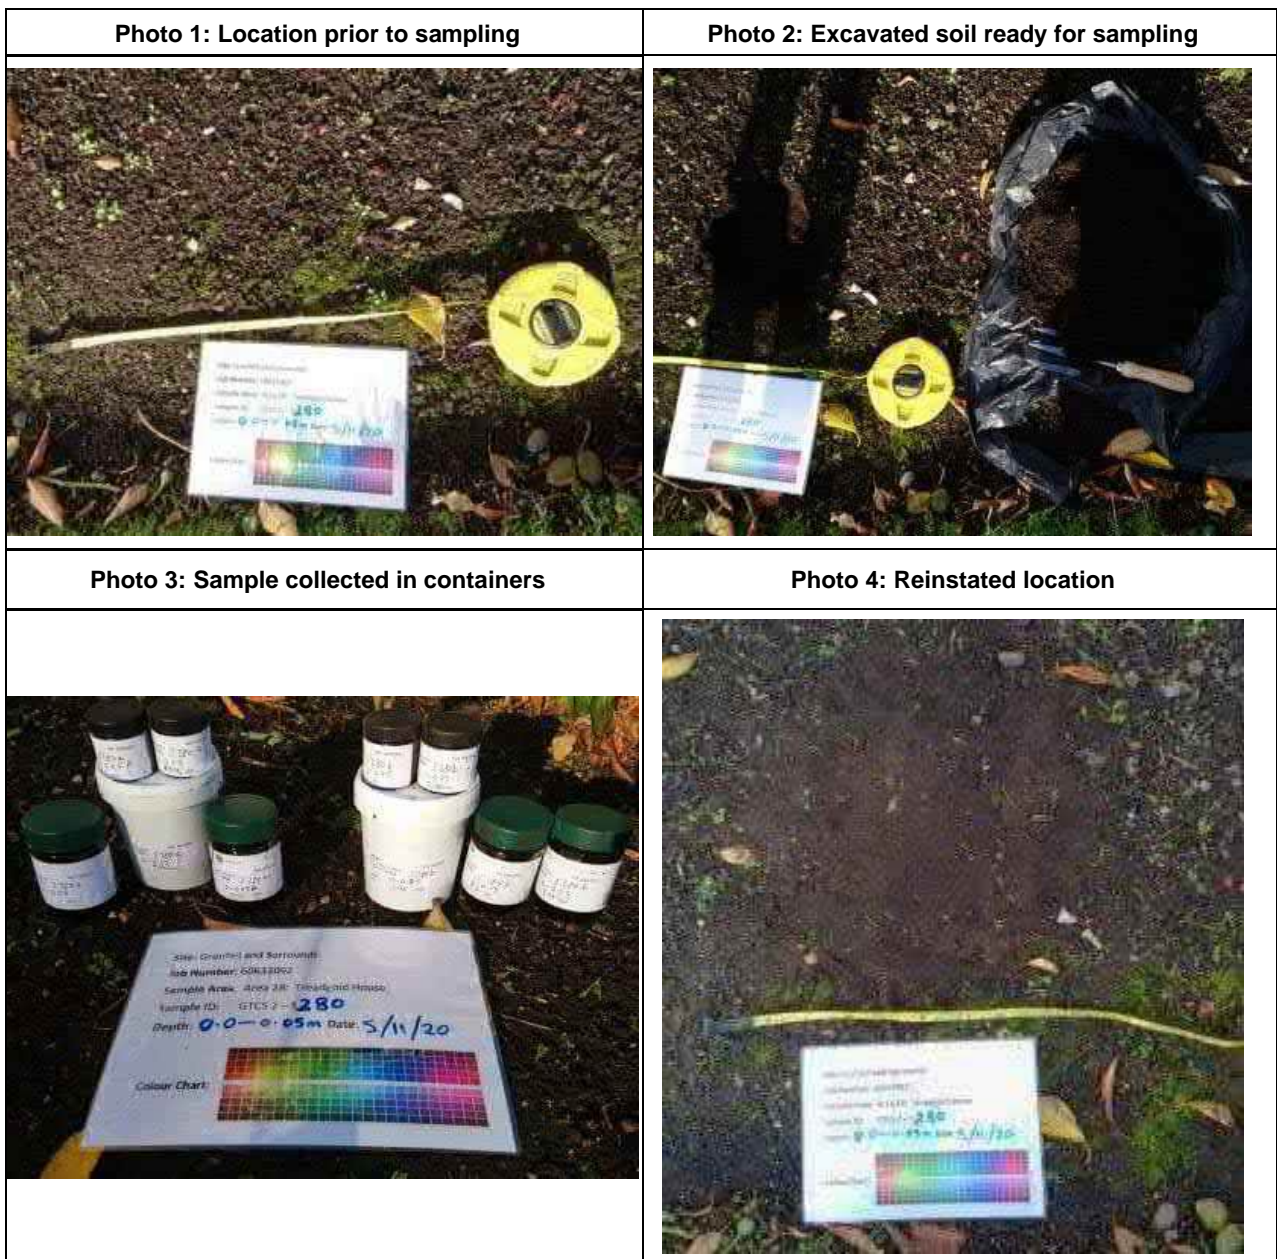
Sample Log:	Topsoil composed of loose dark brown silty sand with occasional gravel. Gravel is fine of rounded to sub-rounded flint and quartzite. Presence of occasional 2cm clear glass fragments and occasional strands of white plastic. Occasional rootlets.
Observed CoPC:	None
Notes:	Bare soil - disturbed
