## 2.5 Guidance

### Sensitive Sites

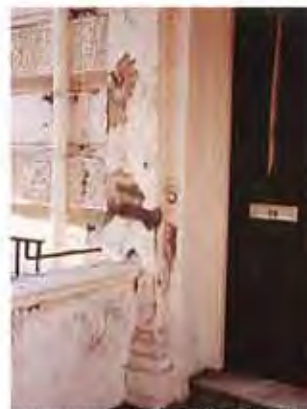
Example of badly deteriorating mid 19<sup>th</sup> C stucco in the Westbourne area (photo 1988)

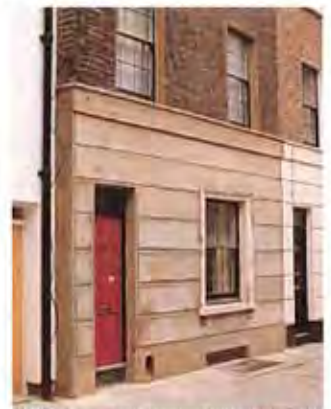
Middleton Buildings: Successfully detailed and finished reinstatement of band-rusticated stucco.

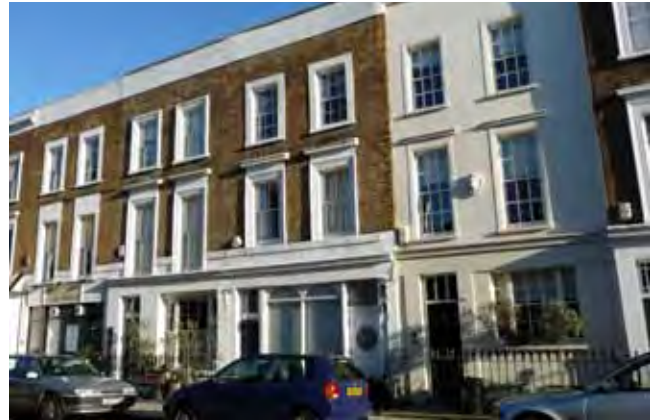
**54-60 Princedale Road.** It would be desirable to reinstate the original window designs.

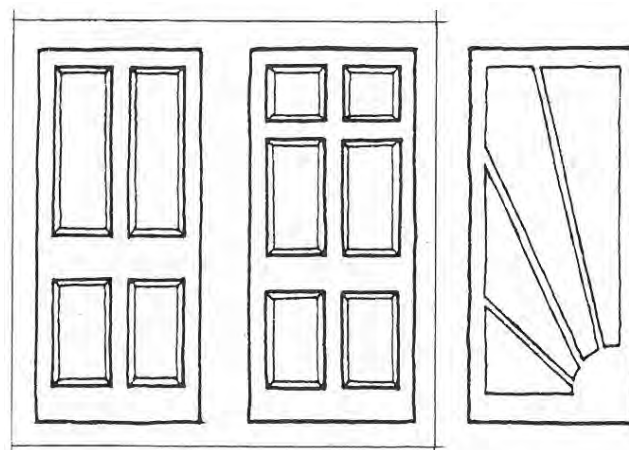
'Two acceptable doors compared to unacceptable patterns'

**2.5.74** There is no definitive front door pattern in the conservation area. However the majority of the original pattern doors are the four-panel type with a limited number of properties where the original door was the grander six-panel door. Another very attractive period pattern door type is the elegant two-panel door with the two panels spanning the whole door height.
