Trees and Basements

Partial Review of the Core Strategy

February 2014

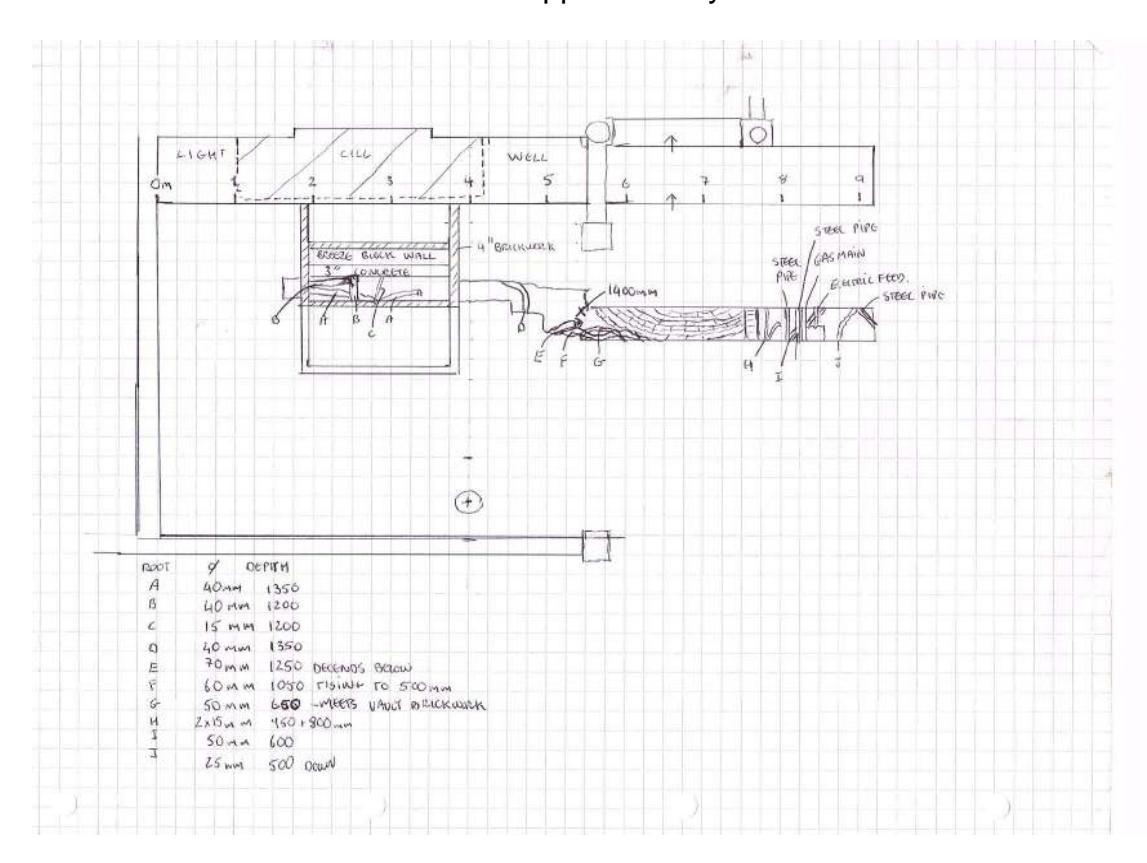
Case study 1. – Elgin Crescent, W11

Exploratory excavations at this property revealed a number of large structural roots, as deep as 1.3 metres, belonging to a tree of heaven. Below is a graph provided by the property owner's arborist showing the position, size and depth of the roots discovered. The excavations were approximately 3 metres from the tree.

- 2.1 Some representations to the previous consultation on the draft basements policy have indicated that the majority of tree roots are usually found in the upper metre of soil. However, studies such as the 'Kew Wind Blown Tree Survey' (Gasson and Cutler 1990) suggest that this isn't strictly the case. The survey results show that 56% of trees surveyed had a root plate depth of below 1 metre. It is also worth noting that the gravel subsoil type found at Kew is documented as being the same or similar to the subsoil found within a large area of RBKC. The Arboricultural Advisory and Information Service research note 'Tree Root Systems' (Dobson 1995) states that "All trees can develop a deep root system (2-3 metres deep) if soil conditions allow". However, this ability will be influenced by the capacity of different species to tolerate varying soil conditions.

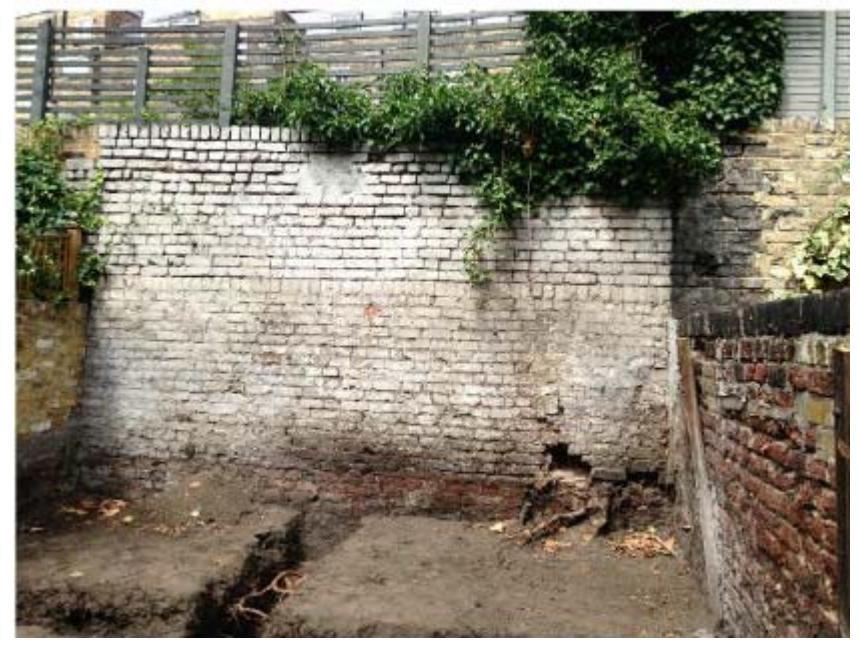
Trial excavations in the rear garden of the adjacent property in Walton Street revealed large structural roots from a mature London plane tree in Egerton Crescent in several areas of the Walton Street garden. The party wall surveyor representing the property owner of the Egerton Crescent property stated that the ground level of the Walton Street garden was approximately 1.8-2.1 metres lower than the ground level.

This photo was taken from the Walton St garden looking towards to party wall adjoining the Egerton Crescent property.

- 2.2 In the urban environment root spread is often constrained by building/wall footings, level changes, highly compacted soil etc. However, in some instances tree roots have been found to grow downwards under such constraints to utilise the soil beyond the property curtilage. A trial excavation carried out at a property in Elgin Crescent in 2012 revealed a number of large structural roots over a metre deep from a mature tree some three metres away. The largest root was 70mm in diameter and the deepest at a depth of 1350mm. Recently in 2013 at a property in Walton Street, roots from a tree in an adjacent garden directly beyond a party wall were found to have grown through and under the wall into the garden of the Walton Street property. The chartered surveyor representing the tree owner has stated the ground level of the Walton Street garden is approximately 1.8 to 2.1 metres lower than the ground level where the tree stands. The roots in the neighbouring garden were over 75mm in diameter and were effectively over 2 metres below the level of the property containing the tree.

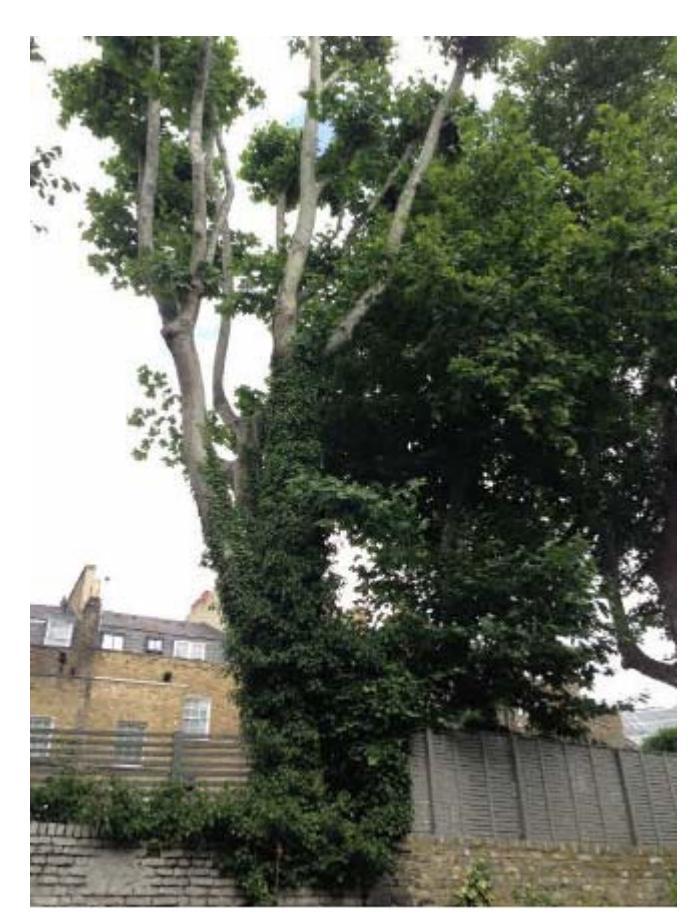
The London plane tree viewed from the Walton Street rear garden.

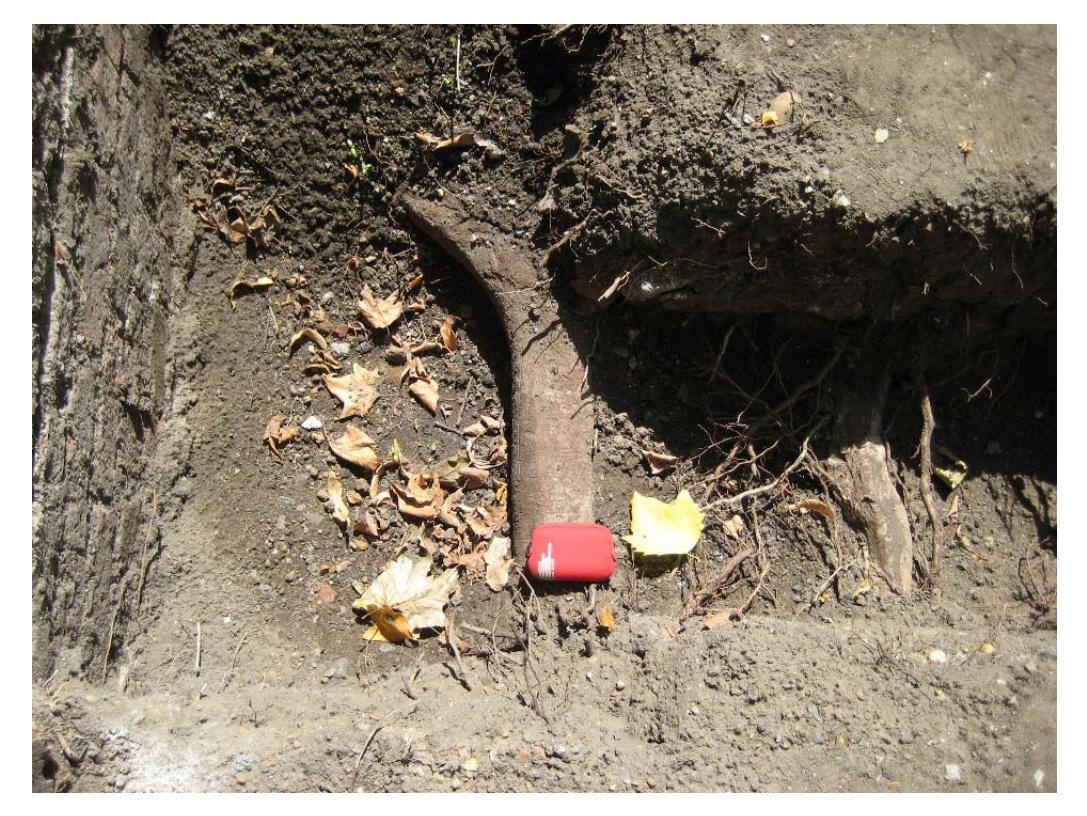
Large roots close to party wall in Walton Street garden.

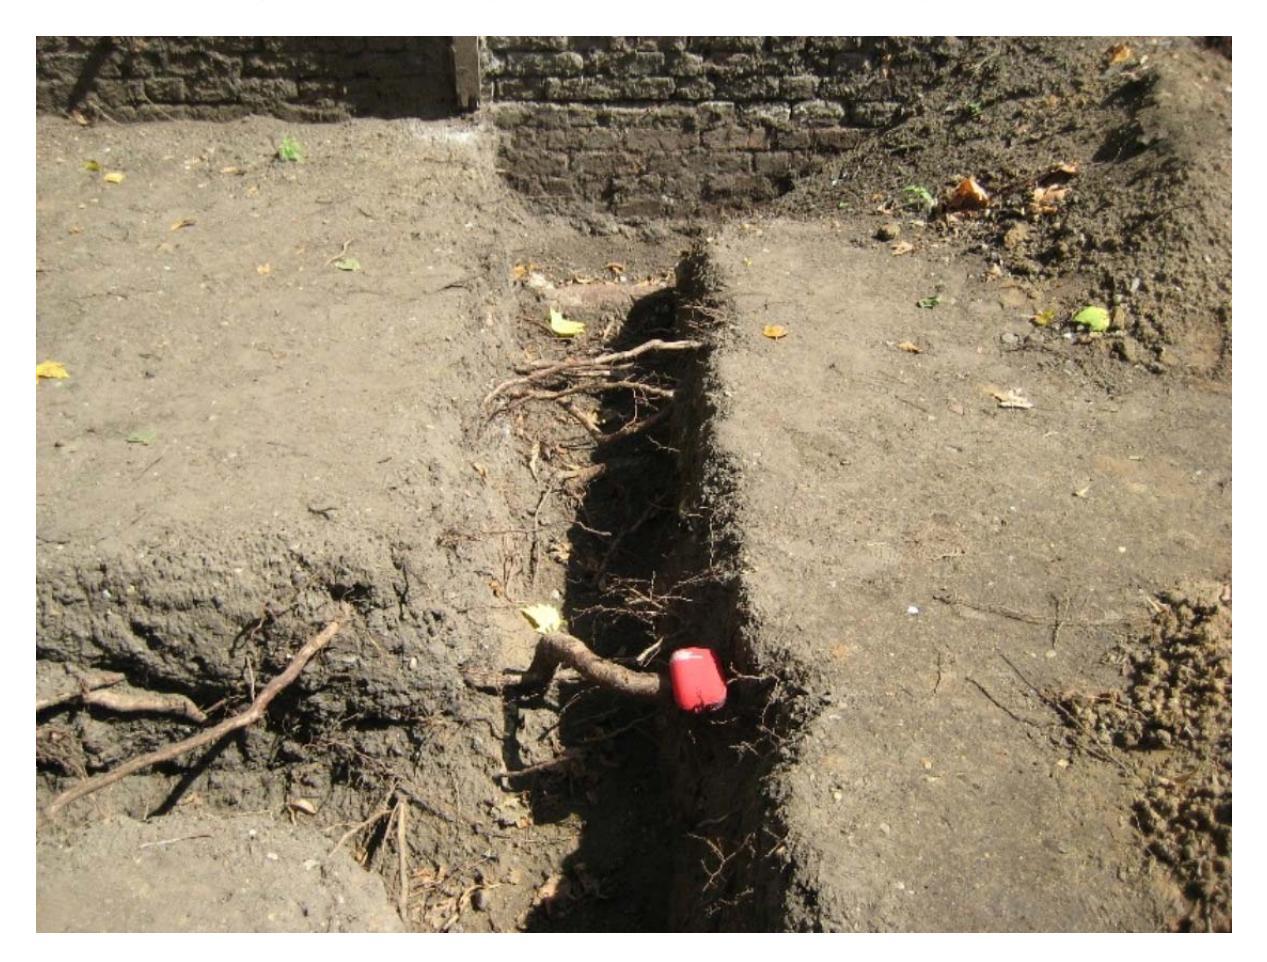
Trench exposing roots colonising the soil in the Walton Street garden.

This is a common representation of tree planting in RBKC as many trees are planted at the end of rear gardens close to party walls or building elevations due to the limited size of rear garden space in the borough. It provides an excellent example of tree roots adjusting to the various constraints found in RBKC and highlights the fact that roots are found much deeper than stated in a text book rooting scenario.
